STRUCTURAL RESPONSE AND FAILURE OF A FULL-SCALE STITCHED GRAPHITE-EPOXY WING

Dawn C. Jegley and Harold G. Bush
NASA Langley Research Center
Hampton, VA

Presented at the AIAA/ASME/ASCE/AHS 42nd Structures,
Structural Dynamics and Materials Conference

AIAA Paper No. 2001-1334-CP
Seattle, WA

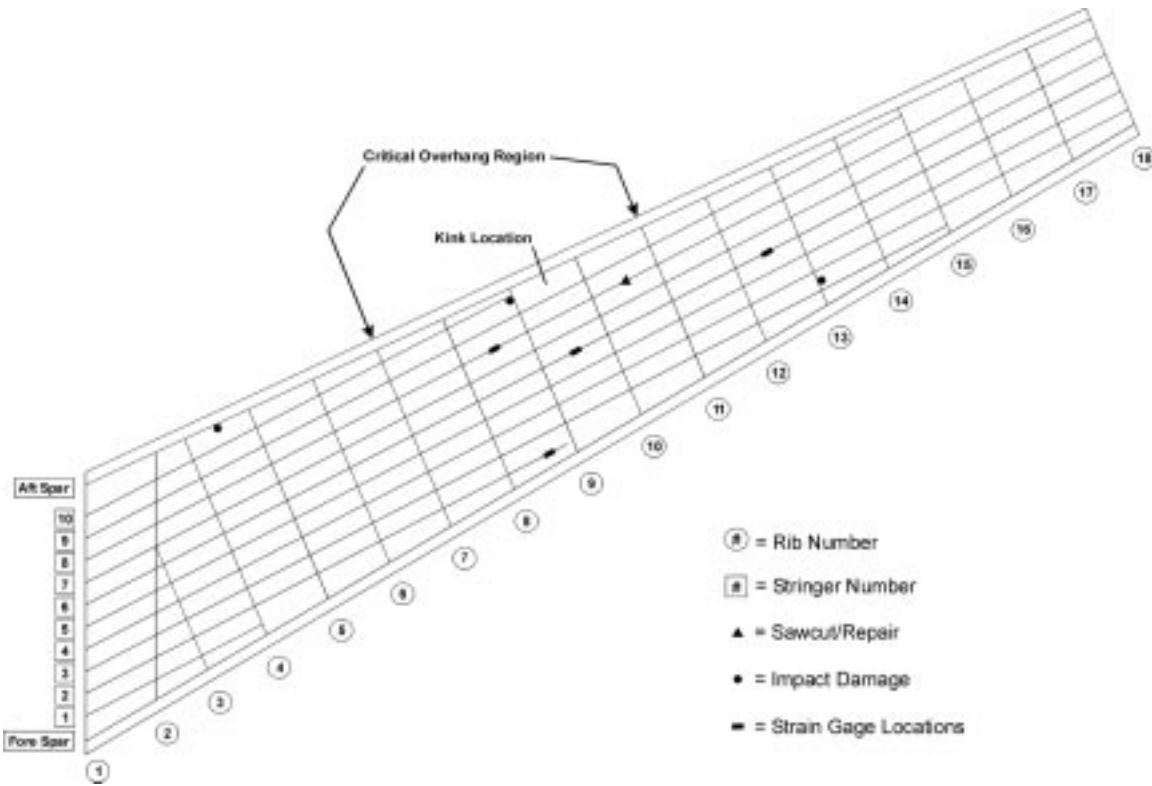
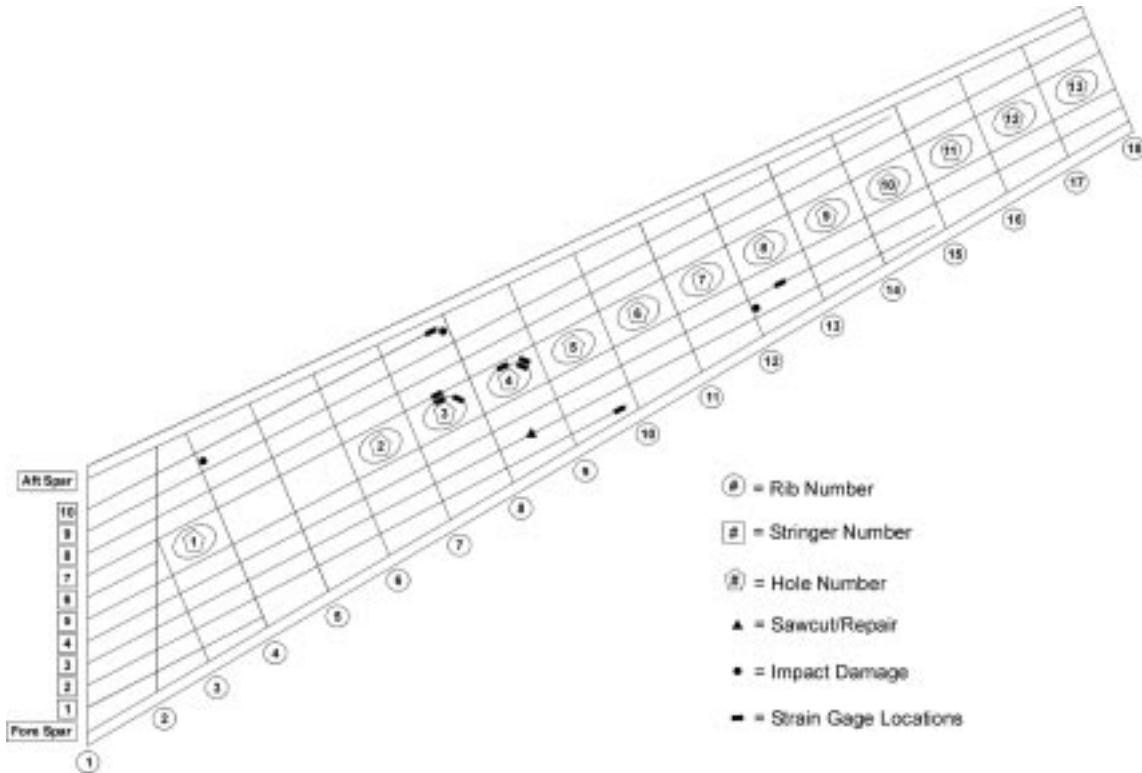
Fig. 2. Upper and lower panel configuration and strain gage locations.

Impact damage was inflicted by the use of a dropped-weight and an air-propelled projectiles.. Impact damage was inflicted to the upper and lower surfaces of the wing. Details of these damages are presented in reference 6. A dropped-weight impactor was used to inflict three impacts with an energy level of 100 ft-lbs to the upper cover panel. The locations of these damage sites are shown in figure 2a. A weight of 25 lbs with a 1-inch-diameter tup was dropped vertically from 4 feet, resulting in barely visible damage. The depth of the resulting damage ranged from 0.01 to 0.05 inches.

An air-propelled steel projectile was used to inflict three impacts with an energy level of 83-84 ft-lbs to the lower cover panel. The locations of these damage sites are shown in figure 2b. A steel sphere with a 0.5-inch diameter was accelerated to a speed of approximately 545 ft/sec, resulting in clearly visible damage with dent depths up to 0.135 inches.

The wing was subjected to discrete source damage in the form of seven-inch-long sawcuts to the upper and lower cover panels, as shown in figure 2. Each sawcut ran through two stinger bays and cut through a stringer. Metal patch repairs were used to restore the wing to full load-carrying capability. The

damaged region was removed prior to implementing the repair. The repairs consisted of a metal plate which conformed to the wing surface on the outer surface of the cover panels and internally spliced stringers. All parts of the repair were attached to the wing with mechanical fasteners.

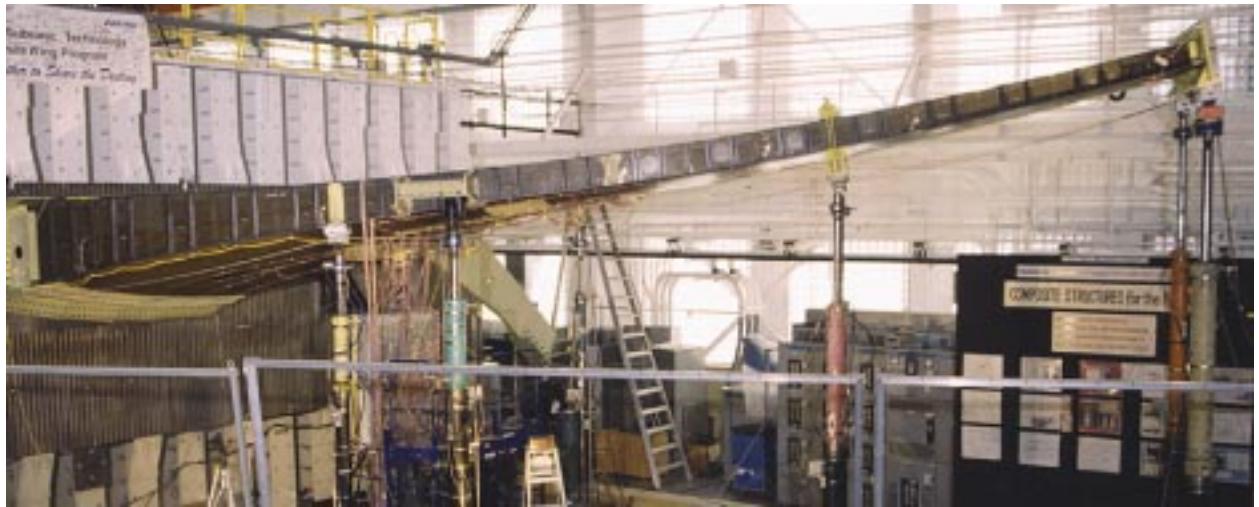
Fig. 6. Deformed test article loaded to 95% of Design Ultimate Load.

The test article supported 97% of its Design Ultimate Load (DUL) prior to failure in test 8. Design Ultimate Load is 150% of Design Limit Load. A photograph of the test article loaded at 95% DUL is shown in figure 6.

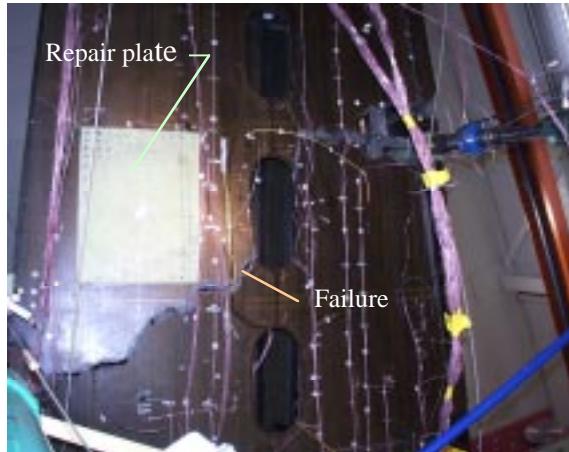
Fig. 8. Failure across lower cover panel.

The primary failure location is across the lower cover panel through access hole 4. This region of the lower cover panel after final failure is shown in figure 8.

The failure goes through all stringers but primarily remains between ribs 8 and 9. Both spars were also damaged. Other minor damage was found but appears to be unrelated to the initial failure event. The discussion of the failure will be limited to the regions between ribs 6 and 10.

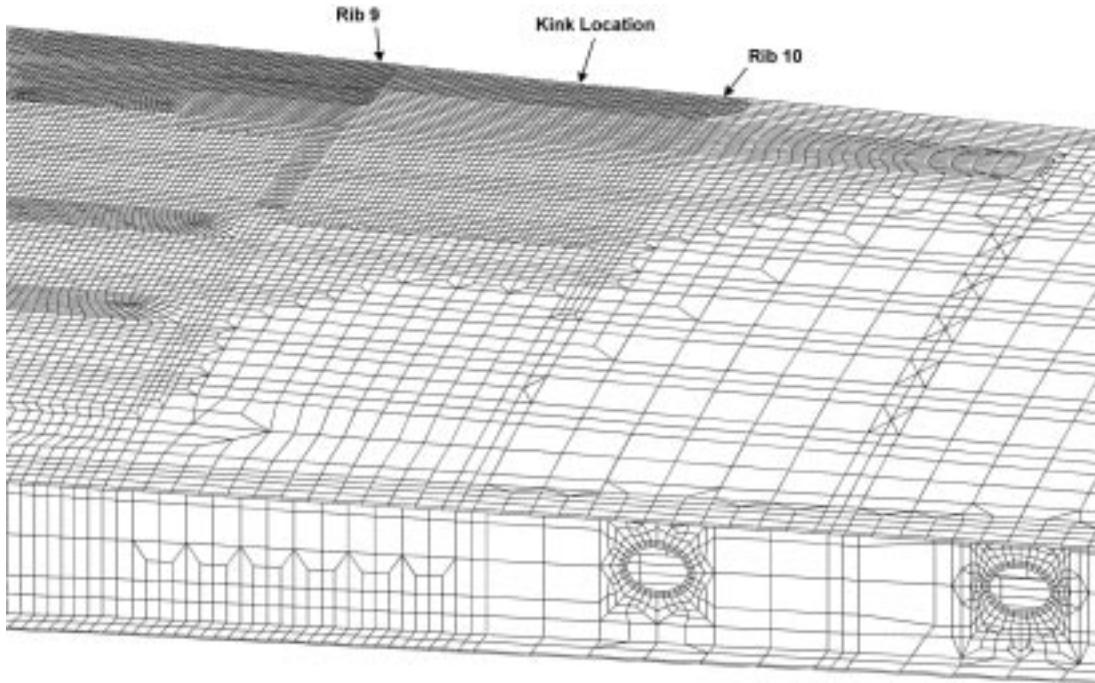
Fig. 16. Finite element model of kink region.

An overhang of the cover panels with a width of approximately four inches behind the rear spar left an unsupported edge along the length of the test article. This region is shown in figure 2a as the "critical overhang region." A small initial geometric imperfection in the form of a kink in the upper cover panel was present in the as manufactured structure.

This kink is centered half way between ribs 9 and 10 and has a maximum depth of 0.1 inches. The kink was initially considered minor enough that it would not influence the cover panel structural behavior. However, since the kink is in close proximity to a stringer runout and is in the region of the upper cover panel that displays nonlinear behavior, the kink influenced the behavior of the overhang region. Therefore, the kink was included in the post-test finite element model. This local refinement is shown in figure 16. The kink is a geometric imperfection in the skin.

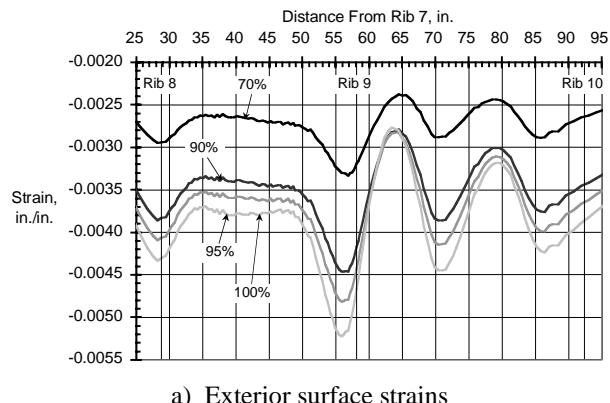
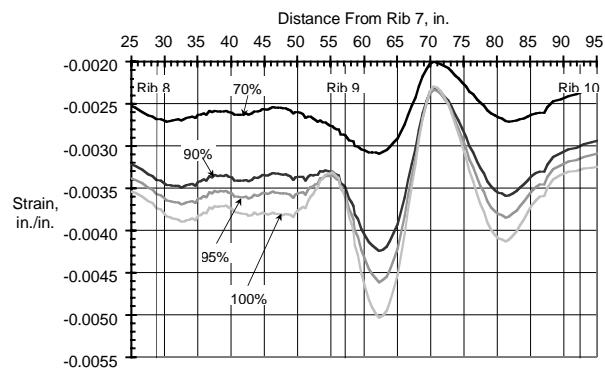
Fig. 17. Strains in the upper cover overhang region aft edge at several values of percent DUL.

Calculated strains along the rear overhang of the upper cover for the outer and inner skin surfaces for load levels of 70%, 90% and 95% and 100% DUL are shown in figure 17. Reversal of strain occurs in several places along the exterior cover surface. Strain reversal for the outer skin surface occurs 6-8 inches outboard of rib 9. Strain reversal for the inner skin surface occurs from 1-4 inches inboard of rib 9 and 13-15 inches outboard of rib 9. There were very few strain gages in this region, and hence experimental results are not presented.

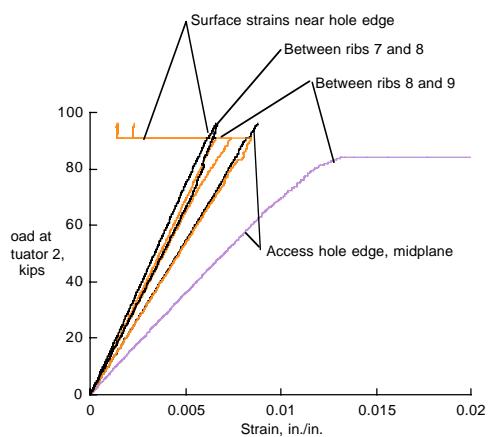
Fig. 18. Measured strain results at the edge of critical access holes.

Strain gages at the edges of the lower cover panel access holes indicate high strains at these locations. Measured strains at the outboard, rear corner of access holes 3 and 4, between ribs 7 and 8 and ribs 8 and 9, respectively, are presented in figure 18. The strain gage locations are shown in figure 2b. Nonlinearity in the load-strain behavior can be seen at these access holes. The most significant nonlinearity is at the outboard corner of access hole 4. The largest measured strain is at this location and is approximately 0.0096 in./in. at DLL. Final failure of the cover panel ran through this location. Since analytical results to date do not adequately capture the failure, comparisons of these strains for the access hole edges are not done with experimental results.
