Damage Detection in Rotorcraft Composite Structures Using Thermography and Laser-Based Ultrasound

Robert F. Anastasi¹, Joseph N. Zalameda¹, and Eric I. Madaras²

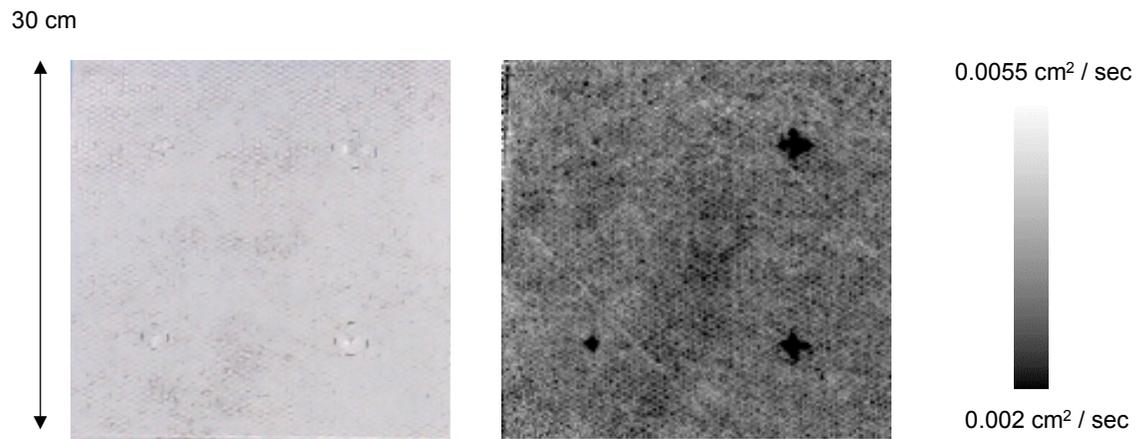
Single-Sided and Through-Transmission thermal inspections were conducted on the panels. For ease of inspection the honeycomb panel was divided into 6 inspection areas, four quarters on the front surface and two quarters on the back lower surface. Each of these areas was approximately 30 cm square. A single-sided measurement of a quarter of the panel that contained impact damage was conducted. For this thermal measurement 240 frames, or 4 seconds, of data was obtained. The results in figure 1 show a visual image of the inspection area with four impact areas outlined in pencil and a thermal image where the impact areas can be seen as darker spots and some mottled areas are seen that correspond to mottled areas in the visual image. The impact energies for the four impacts were 1 ft-lb and 4 ft-lb for the top left and right and 2 ft-lb and 3 ft-lb for the bottom left and right areas respectively. The size of the thermally-detected impact-damage areas correlates with the impact energy used in creating the damage. On other quadrants of the panel, impact areas and the inserts were also detected and the painted surface did not degrade the thermal images.

Figure 1. Visual (left) and thermal diffusivity inspection image (right) are area I of the honeycomb panel.

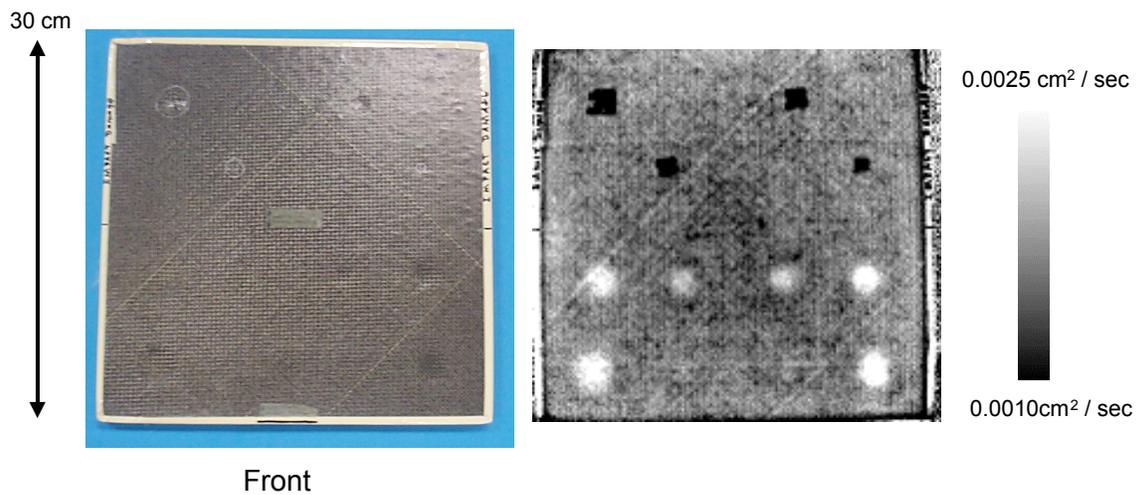
A single-sided measurement of the X-Cor™ panel was conducted. For this measurement 300 frames, or 5 seconds, of data was acquired. Figure 2 shows a visual and a thermal image of the panel. In the thermal image, four dark square areas can be seen in the top half of the panel and six brighter round areas can be seen in the bottom half of the panel. The top half corresponds to impact damage where the top left spot was damaged with an impact of 6 ft-lbs, the top right area 4.5 ft-lbs, the second row left area was damaged with 3.5 ft-lbs, and the second row right area with 2.5 ft-lbs. The size of the thermally-detected impact area correlates with the impact energies, thus higher impact energy correlates to larger damage area. The individual damaged areas appear square in shape and could in part be due to the weave pattern of the composite skin. The bottom half of the panel is where the pull-pin damage is located. In each bottom left and right quadrant the smallest pull-pin area cannot be seen. The areas detected correlate with the area of the pull-pin defects. It should be noted that the thermal

image is a thermal diffusivity image that is proportional to thermal conductivity divided by the density and specific heat. The black color of the defect indicates an area of effective diffusivity conductivity, and the white area indicates increased effective thermal diffusivity. The black areas may in part include broken fibers, broken matrix, and air inclusion, while the white area may in part be due to a lack of thermal conduction into the X-Cor™ material at the pull-pin areas.

Figure 2. Visual (left) and thermal diffusivity inspection image (right) are the front side of X-Cor™ panel.

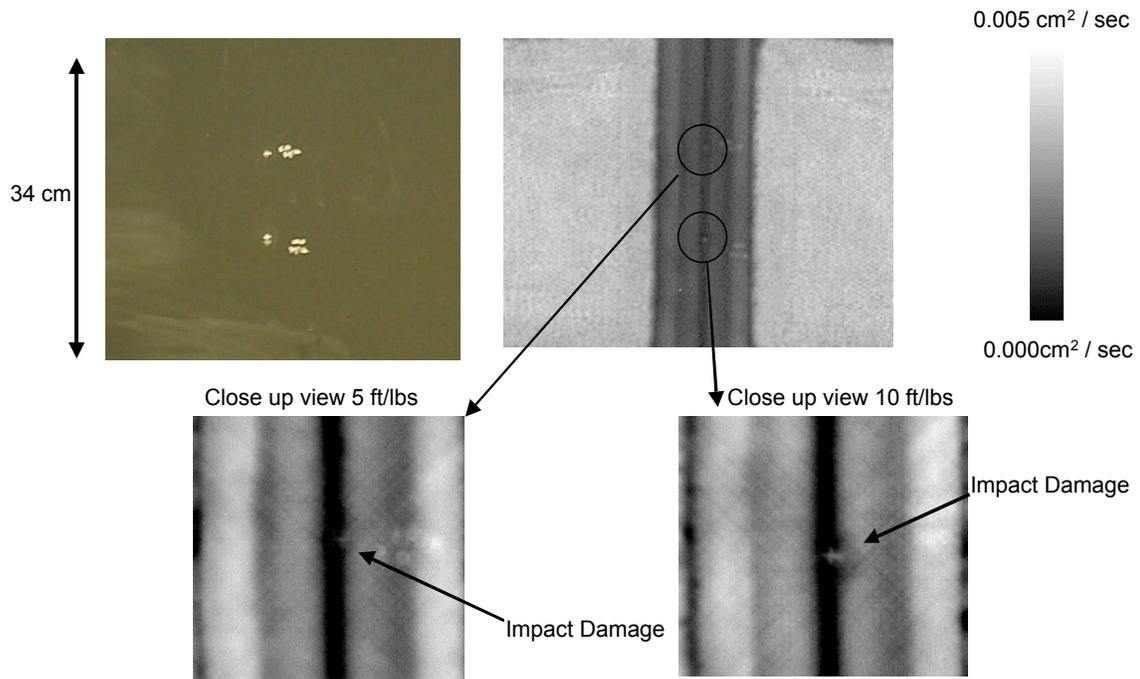
The T-blade panel was divided into three inspection areas. A single-sided inspection result is shown in figures 3 and 4 for the T-blade area. For these thermal measurements, 600 frames or 10 seconds of data was acquired. A visual image of the front surface is shown in figure 3 on the top left. This visual image shows two impact-area centers marked in white with a '+' and labeled to the right of the mark in white. The top impact-area was made with an energy of 5 ft-lb and the bottom impact-area was made with 10 ft-lb. The thermal image in figure 3 shows the impact areas circled along with enlargement of these areas. The vertical gray stripes in the thermal image correspond to the stepped flange thickness. Another thermal measurement, using the through-transmission setup, of the T-blade area is shown in figure 4. This figure shows a visual and thermal image of the damage area made with energy of 10 ft-lb and an area containing a 1.27 cm diameter insert.

Figure 3. Visual (left-top) and thermal diffusivity inspection image (top-right and bottom) show the T-blade area and close up views of the 5 ft-lb and 10 ft-lb impacts.

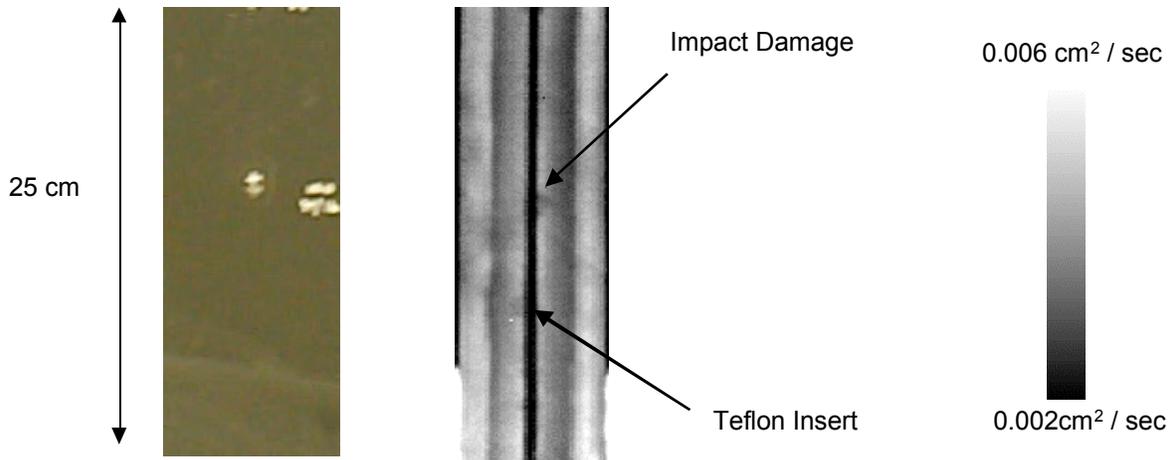
Figure 4. Visual (left) and thermal diffusivity inspection image (right) show the T-blade area and includes the 10 ft-lb impact area and material insert.

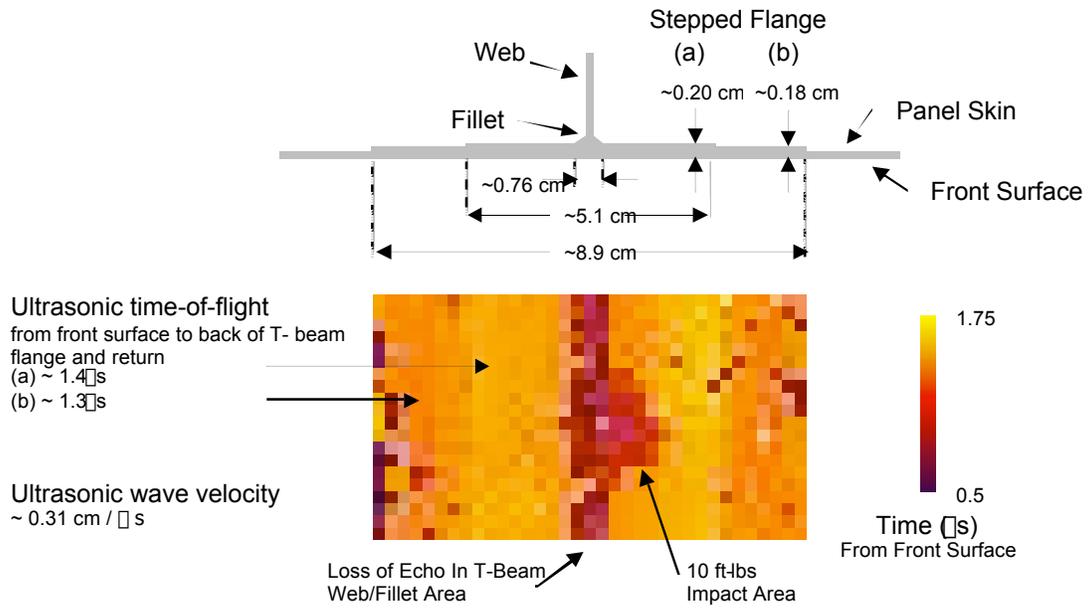
echo was not clear, a time-of-flight between the main bang and back-wall echo was assigned a value of zero. Figure 5 shows the T-blade profile and the time-of-flight C-scan. Thickness changes in the T-blade correspond to color changes in the C-scan. An ultrasonic signal loss was observed for the web/fillet area of the T-blade and is seen as a vertical strip in the center of the scan area. In the center of the scan is a circular area, approximately 1.9 cm wide by 1.0 cm high. This is the damage area around the 10 ft-lb impact. Additional sections were scanned with the same dimensions and incremental spacing. The processed images were then pasted together to form a composite image. This composite image included the 10 ft-lb impact and the area below it, almost to the edge of the sample. The composite C-scan is shown in figure 6 and covers an area 8.9 cm wide by 22.8 cm high. This image shows the loss of echo in the T-blade web area, the 10 ft-lb impact, and two embedded defects. The embedded defects are 1.27 cm in diameter and 0.65 cm in diameter. This C-scan images shows that the general structure of the T-blade and that it was possible to observe a 0.025 cm thickness changes in this structure. Material inserts could be detected, but inserts near the flange were partially obscured. The impact damage area for the 10 ft-lb site was readily seen, but partially obscured due to the flange.

Figure 5. T-blade profile and time-of-flight C-scan around the 10 ft-lb impact site.

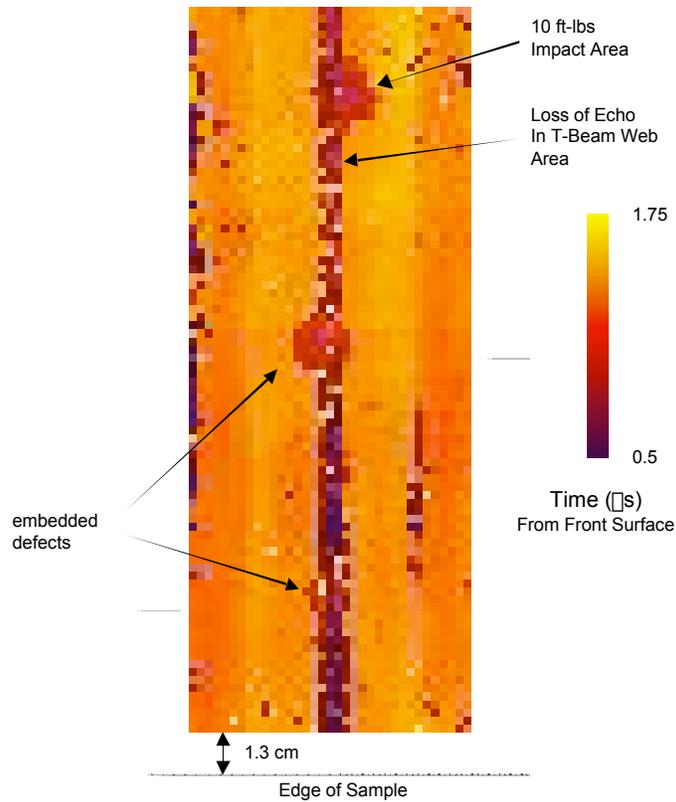
Figure 6. Time-of-flight C-scan image showing the loss of echo in the T-blade web area, the 10 ft-lb impact, and two embedded defects. The scan area is 8.9 x 22.9 centimeters.
