**BEHAVIOR OF COMPRESSION-LOADED COMPOSITE PANELS  
WITH STRINGER TERMINATIONS AND IMPACT DAMAGE**

Dawn C. Jegley  
NASA Langley Research Center  
Hampton, VA

AIAA Paper No. 98-1785-CP  
Long Beach, California

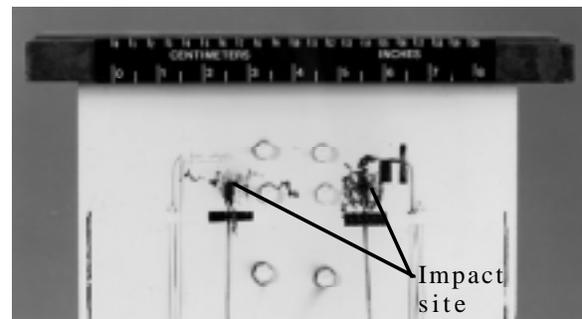
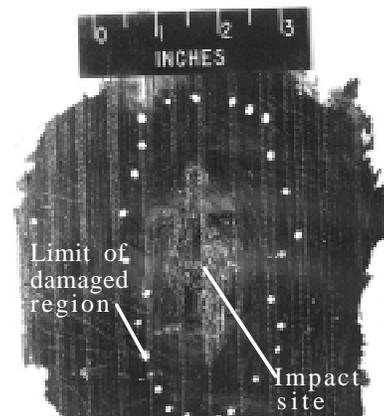
Figure 5. Typical impact damage.

Panel U-2 was initially loaded to 83,000 lb. The panel was not damaged during the initial loading. The panel was unloaded and subjected to a dropped-weight impact and a static indentation which resulted in two damage sites, each with dent depths of approximately 0.15 inches. The resulting damage was clearly visible. Descriptions of the damage are presented in Table 1 and a photograph of the damage is shown in figure 5.

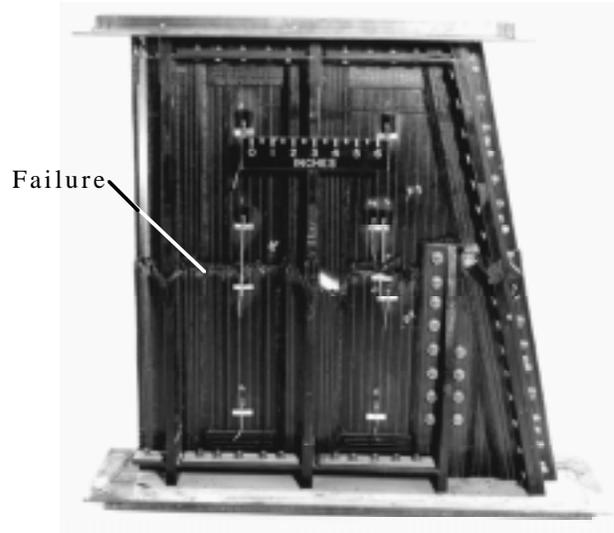
Panel L-1 failed through the impact site and the point of maximum strain in an undamaged skin with a load of 435,000 lb, and with damage 1.6 times as severe as required by the criterion. The panel failed with a stress at the impact site of 35.2 ksi, which is approximately 89 percent of the design stress. An undamaged panel would have had a strain of approximately .0037 in/in. at the impact site for the load at which the damaged panel failed. The maximum midplane strain (based on the measured surface strains) near the impact site was equal to .0052 in/in. The predicted maximum strain in the panel away from the impact site is equal to .0043 in/in., which is significantly less than the allowable strain in undamaged structure. These results indicate that failure was caused by the strain in the region of the impact site. A photograph of panel L-1 after failure is shown in figure 15.

Figure 15. Failed panel L-1.
