# Development of a Flexible Seal for a 60 psi Cryogenic Pressure Box

*David E. Glass*  
*Analytical Services & Materials, Inc., Hampton, VA*

May 1998

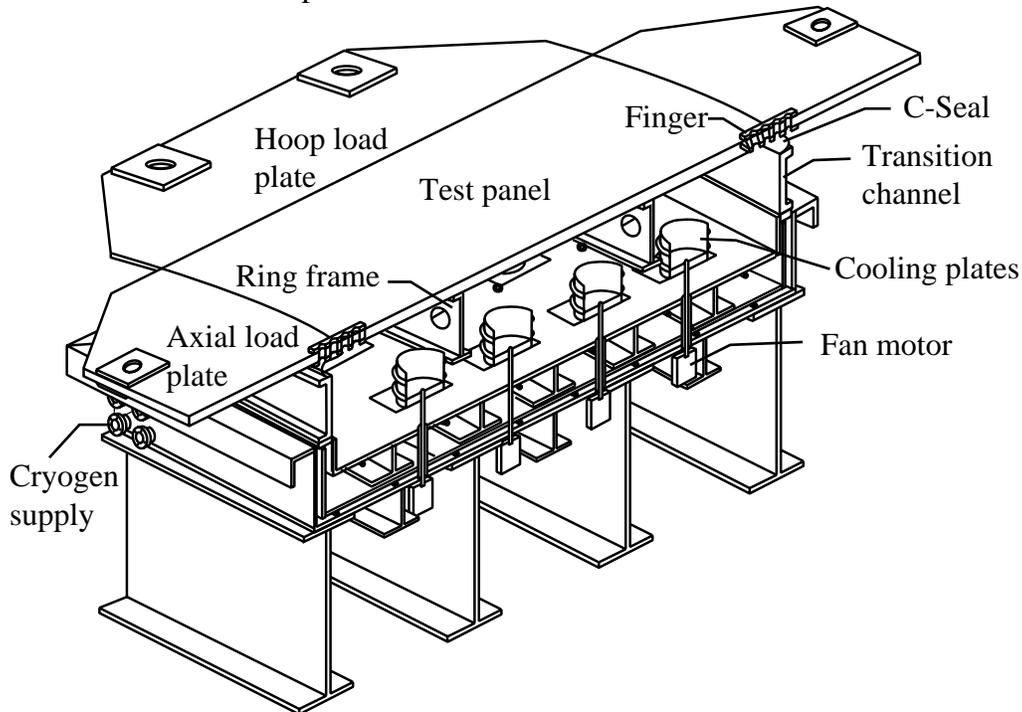
Figure 2: Schematic drawing of the cryogenic pressure box showing the location of the C-seals.

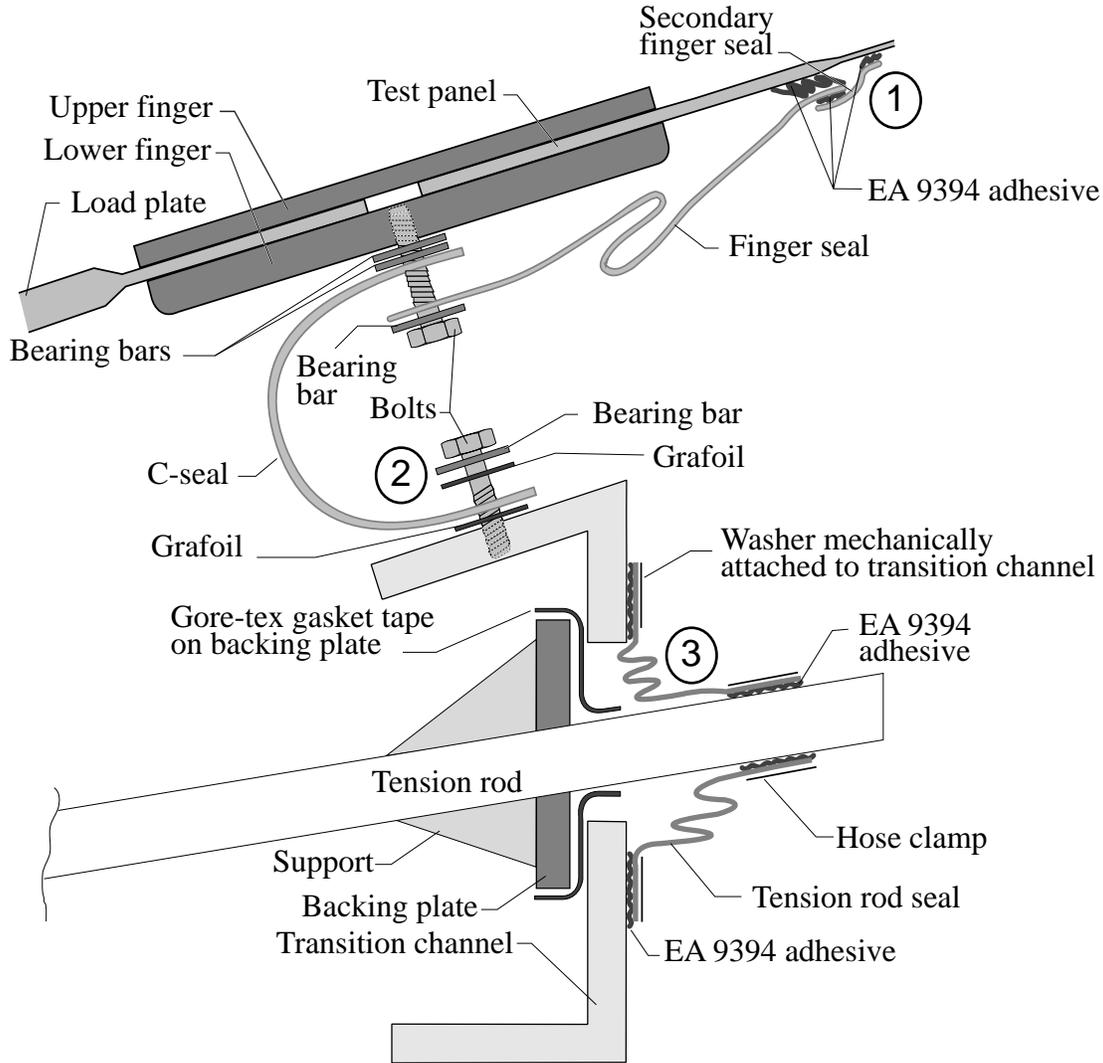
Figure 3: Schematic drawing of the cross-sectional view of the seals and the transition channel.

Three seals were required to seal the pressure box, assuming the test panel has ring frames. Each of these seals are illustrated in Figure 3. One is a finger seal which seals the leak paths between the fingers and the C-seal. The second seal is the C-seal, which connects the panel to the transition channel, and the third seal is a tension rod seal that seals the penetration for the tension rod. Each of the different seals uses the same Gore-tex<sup>®</sup> material and is discussed in detail below.

Due to the space between the fingers and the space between the load plate and the panel, a leak path exists that is sealed by the finger seal. The finger seal, indicated by number 1 in Figure 3, carries minimal tensile loads since the seal rests against the panel and fingers. The finger seal is bonded to the panel forward of the fingers with EA 9394 ambient temperature cure adhesive. A secondary finger seal, 2-in. wide, is bonded over the edge of the finger seal where it is bonded to the panel as a safety measure. The opposite end of the finger seal is bolted between bearing bars with the C-seal under the fingers.

The C-seal seals the region between the fingers and the transition channel. The C-seal must remain flexible at -423°F, carry the tensile loads generated by the 60 psi internal box pressure, and maintain minimal pressurization gas leakage. Due to the fact that the test panel must be allowed to move relative to the fingers (resulting from the biaxial loading), the fingers cannot be tightened against the test panel. Thus, the C-seal attachment to the fingers is through three bearing bars, the top one which is bolted to the finger with freedom to allow motion. The middle bearing bar is then bolted tightly to the upper bearing bar. The lower bearing bar, with the C-seal and finger seal sandwiched between the lower and middle bearing bars, is tightly attached to the middle bearing bar. The bottom of the C-seal is bolted down to the transition channel with another bearing bar.

A 1 7/8 in. diameter stainless steel tension rod will penetrate the transition channel, as shown in Figure 3, and attach to the ring frame of one panel planned for testing. Due

to the possibility of the test panel lifting up to 2 in. upon box pressurization, the hole where the tension rod penetrates must be able to allow for that vertical motion. A stainless steel bellows seal was initially considered. However, due to the magnitude of the required length (~36 in.) and diameter (~ 6 in.) of the bellows seal, a more compact sealing mechanism was required. It is anticipated that the tension rod seal will use the same seal material used for the C-seal and finger seal. However, the seal design has not been finalized and is thus not included in the figure.

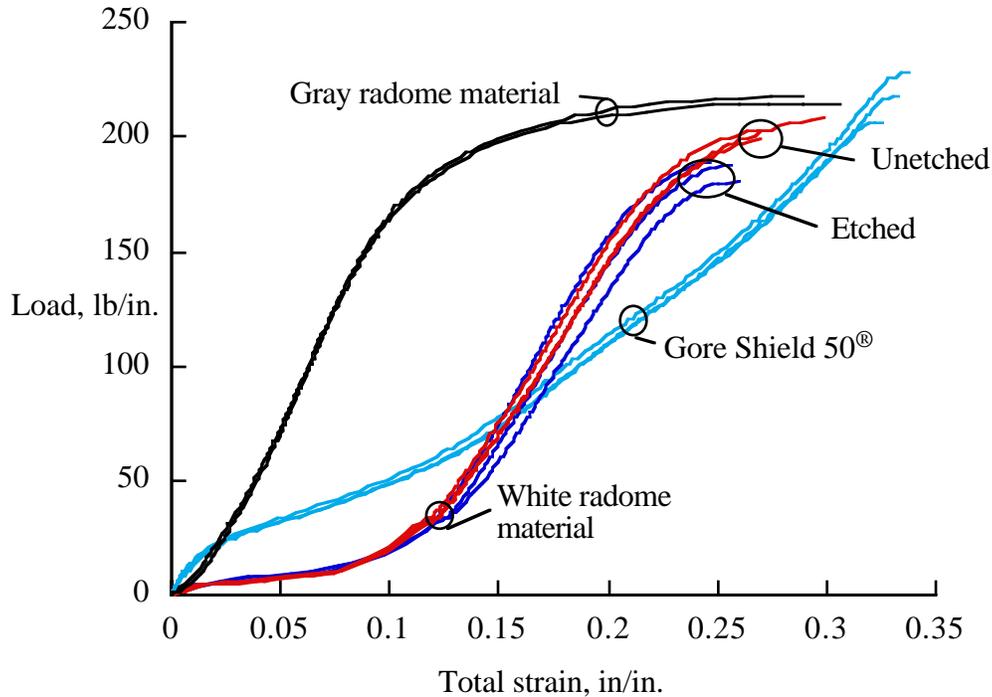
Figure 4: Load versus strain for the seal material under ambient temperature tensile testing.

Three samples of each specimen were tested. The gray radome material was loaded in the white thread direction, perpendicular to the gray threads. The samples were 4-in. wide with a test length of 3 in. Figure 4 shows the load per inch width of material versus the strain. The load per inch was obtained by dividing the total load by the initial 4-in. width of the samples. There was significant necking down of the samples, on the order of 0.5 in., as the load was increased. The test length was initially 3 in. and the strain shown in the figure is the total displacement divided by 3 in. The gray and white radome material and the Gore Shield 50<sup>®</sup> all failed at similar loads. However, the path each material followed to failure was radically different. The white radome material experienced a large initial strain at very low loads. After the initial strain, the white radome material experienced an increase in the strain similar to the gray radome material. The Gore Shield 50<sup>®</sup> material demonstrated a behavior unlike the radome material. Though it initially was thought that the Gore Shield 50<sup>®</sup> would be stronger due to its heavier weight (i. e., greater stiffness and thickness), it experienced significantly more strain with increased load than the gray radome material. Testing was also performed to evaluate the effect of etching on the strength of the white radome material. As can be seen in the figure, the etching decreased the failure load slightly, but had little effect on the properties prior to failure. Though the strain characteristics of the three different materials were very different, failure occurred in each at a strain of approximately  $0.3 \pm 0.05$  in/in.

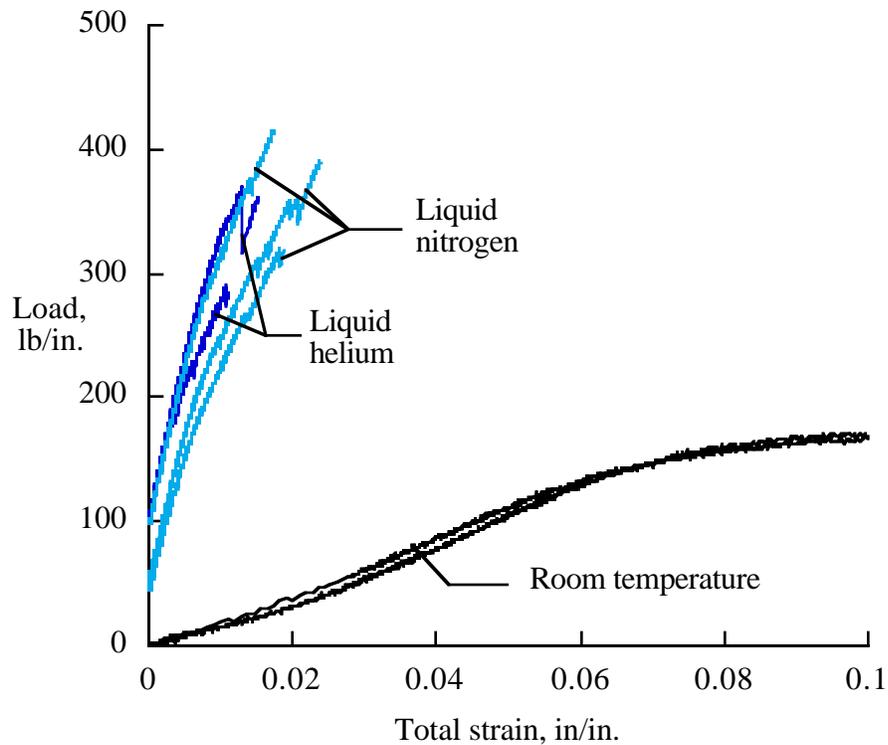
Figure 5: Load versus strain for 1-in-wide samples at ambient temperature, LN2 and LHe temperatures loaded in the gray thread direction with a load rate of 100 lb/min/in.

Tests were also performed at liquid nitrogen (LN2) and liquid helium (LHe) temperatures. For these tests, the entire fixture, along with the 1 in. x 7 in. specimen test area, was inserted into a dewar of the cryogen. The results are shown in Figure 5 for each of the LHe and LN2 exposed samples and ambient temperature controls. All specimens were loaded in the gray thread direction (load direction in actual seal) with a load rate of 100 lb/min/in. The ambient temperature controls failed at a strain of approximately 0.1 in/in. One of the specimens failed at the grip, while the other one failed between the grips. As can be seen in the figure, the specimens were much stronger when tested in LHe and LN2. All three of the LN2 tested specimens failed at the grip, while both of the LHe specimens failed between the grips. The LN2 and LHe samples experienced an offset in the load due to the contraction of the fixturing (due to cooling) in the cryogen during the test. The offset increased the load throughout the test, but was only known at the final load position. The offset increased the failure load of the LN2 samples to 398 lb/in. and 458 lb/in., while the LHe failure load was increased to 413 lb/in. and 423 lb/in. When the offset was included in the data, there appeared to be no significant difference between the LN2 and LHe test results. The LHe and LN2 samples also had a preload on them after installation in the fixture prior to testing. The preload was 50 lb/in. for the LN2 samples and 100 lb/in. for the LHe samples. The stroke (strain) was zeroed at the preload value, and thus any strain resulting from the preload was neglected. This may account for the different shape in the ambient temperature and cryogenic temperature tests, i.e., no inflection point at the early load values.

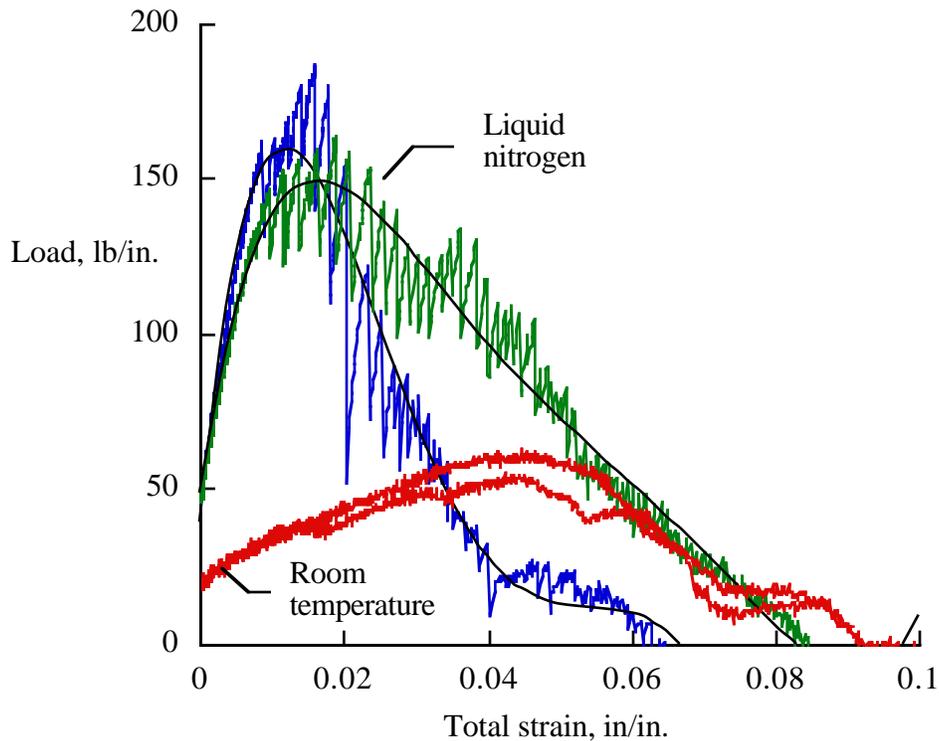
Figure 6: Load versus strain for 1-in-wide sewn joint samples at ambient temperature, LN2 and LHe temperatures loaded in the white thread direction with a load rate of 100 lb/min/in.

The seal will have several seams joining different pieces of fabric. The strength of the sewn joints was thus investigated. In the actual application, the seams will run parallel to the load, while in the test specimens, the seams were perpendicular to the load. Thus the test was conservative relative to the actual seal conditions. Figure 6 shows the

load versus strain for the 1-in-wide sewn joint samples. In each case, two pieces of the seal material were sewn together with a double seam, the two seams being approximately 0.25 in. apart. The load rate was again 100 lb/min/in., and the preload and offset are not included in the figure. However, unlike the prior tests, these samples were loaded in the white thread direction. The ambient temperature samples had a maximum load of approximately 50 lb/in, while the two LN2 samples had a maximum load of approximately 150 lb/in. The LN2 samples experienced much more oscillating in the data than in prior tests, and thus a curve fit is provided for the LN2 data. The cause of the noise in the data is uncertain. All of the joint tests failed in a similar manner regardless of the test temperature. In each case, the white thread (load carrying thread) broke at one of the seams. However, the gray threads, perpendicular to the load, separated approximately 0.3 in. from the seam. The reason for the gray threads separating away from the seam is unclear.

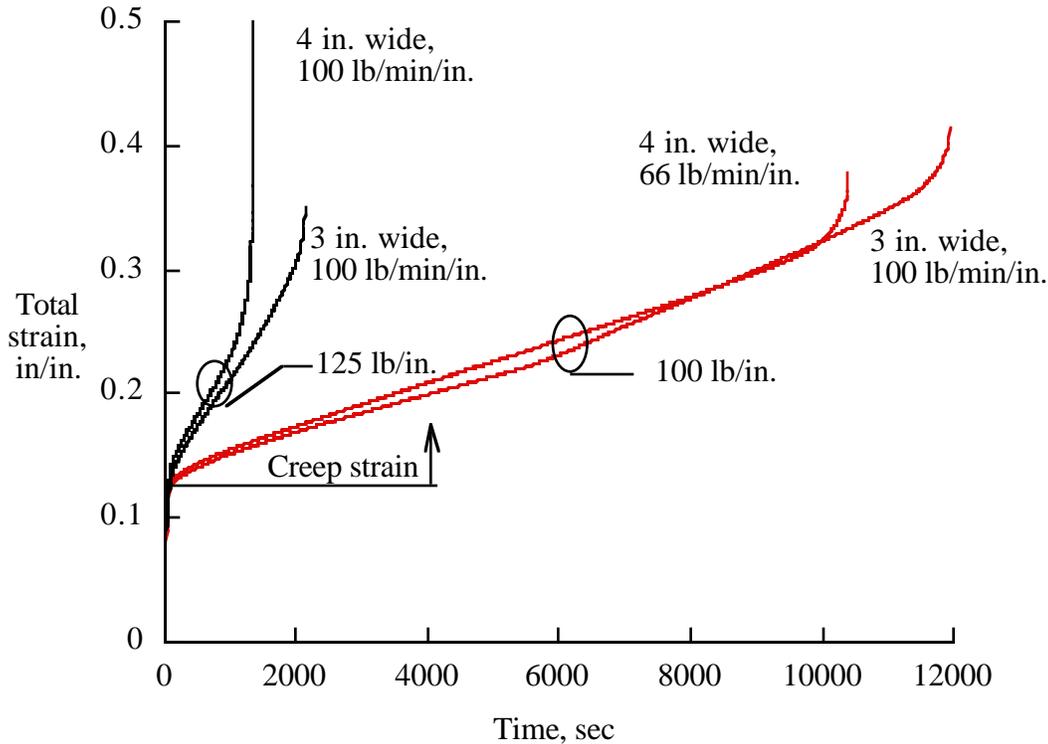
Figure 7: Effect of specimen width on creep for 3-in-wide and 4-in-wide samples loaded at ambient temperature in the gray thread direction with an initial load rate of 100 lb/min/in.

held at that load level and the time varying strain was measured. From the figure, it can be seen that the width had an effect on the creep of the specimen. For both values of the maximum load, the 4-in-wide samples failed sooner and at a slightly lower strain. It should be pointed out that the 4-in-wide specimen at a load of 100 lb/in. was loaded at a slower initial rate than the other specimens. However, as will be seen later, a slower rate results in a longer time to failure and a higher total strain. Thus the 66 lb/min/in. initial loading rate provided a longer time and higher strain than would have been obtained with a 100 lb/min/in. initial loading rate as in the other specimens.

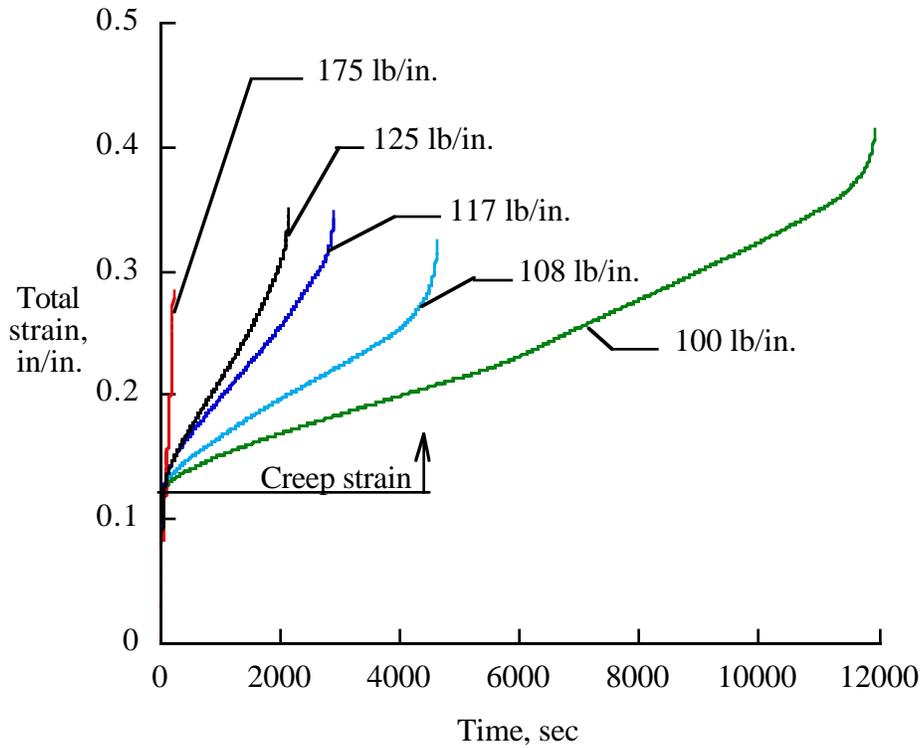
Figure 8: Effect of test load on creep of seal material with 3-in-wide samples loaded in the gray thread direction with an initial load rate of 100 lb/min/in.

Figure 8 shows the effect of the test load on the creep for 3-in-wide samples. All the samples were loaded in the gray thread direction, and the load was increased at 100 lb/min/in. up to the test load condition. As expected, the time to failure increased as the load decreased. The decrease in load from 125 lb/in. to 100 lb/in. was in relatively uniform increments, but the time to failure increased non-linearly with each decrease in load. The failure strain for 100 lb/in. was slightly larger than for the higher load rates.

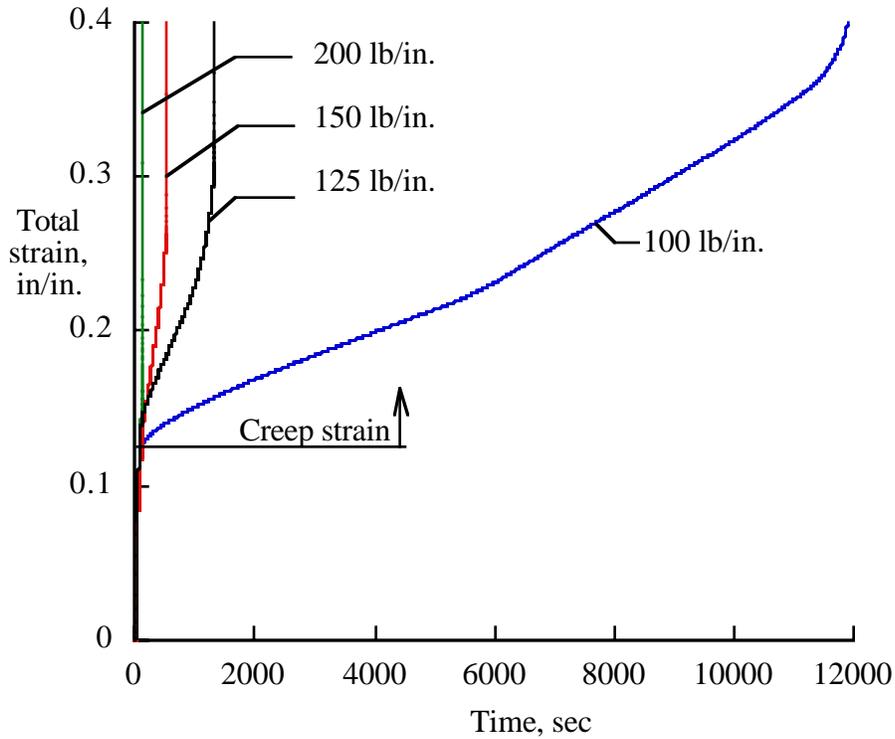
Figure 9: Effect of maximum load on creep of seal material with 4-in-wide samples loaded in the gray thread direction with an initial load rate of 100 lb/min/in.

Samples with a width of 4 in. were also tested for creep, with the results shown in Figure 9. As in Figure 8, the time to failure increased non-linearly as the load was decreased. The samples were again loaded in the gray thread direction.

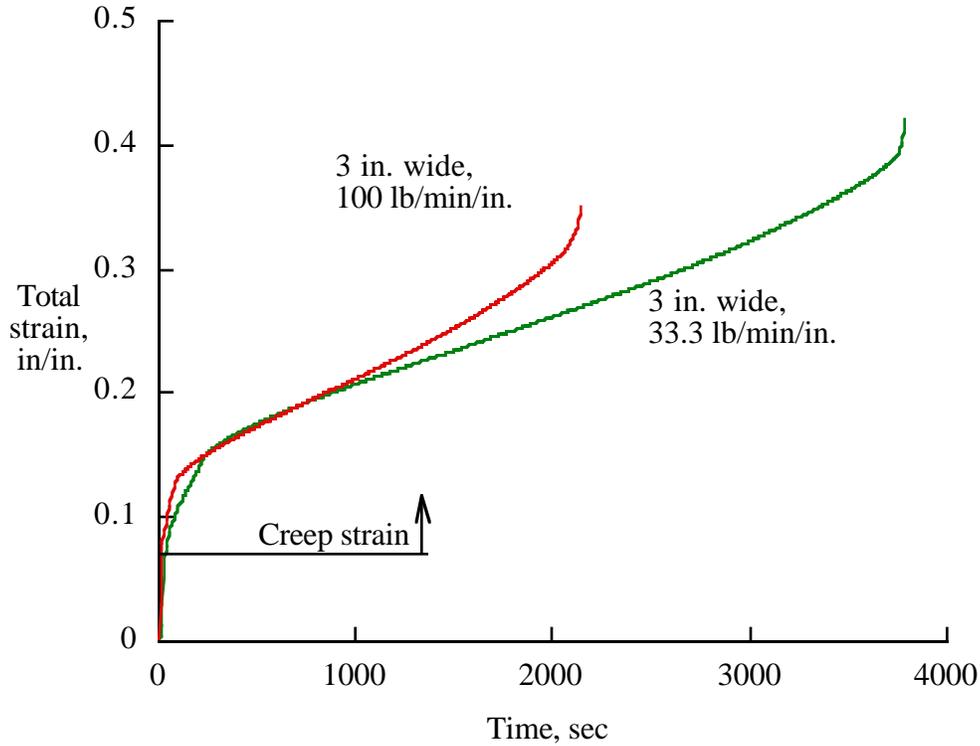
Figure 10: Effect of initial load rate on the creep of 3-in-wide specimens at 125 lb/in. loaded in the gray thread direction at ambient temperature.

The effect of the initial load rate on the creep was also evaluated. Figure 10 shows the strain as a function of time for 3-in-wide samples with 100 lb/min/in. and 33.3 lb/min/in. initial load rate for a test load of 125 lb/in. Again, the samples were loaded in the gray thread direction and the testing was performed at ambient temperature. The slower initial load rate resulted in a longer time to failure and an increased strain capability.

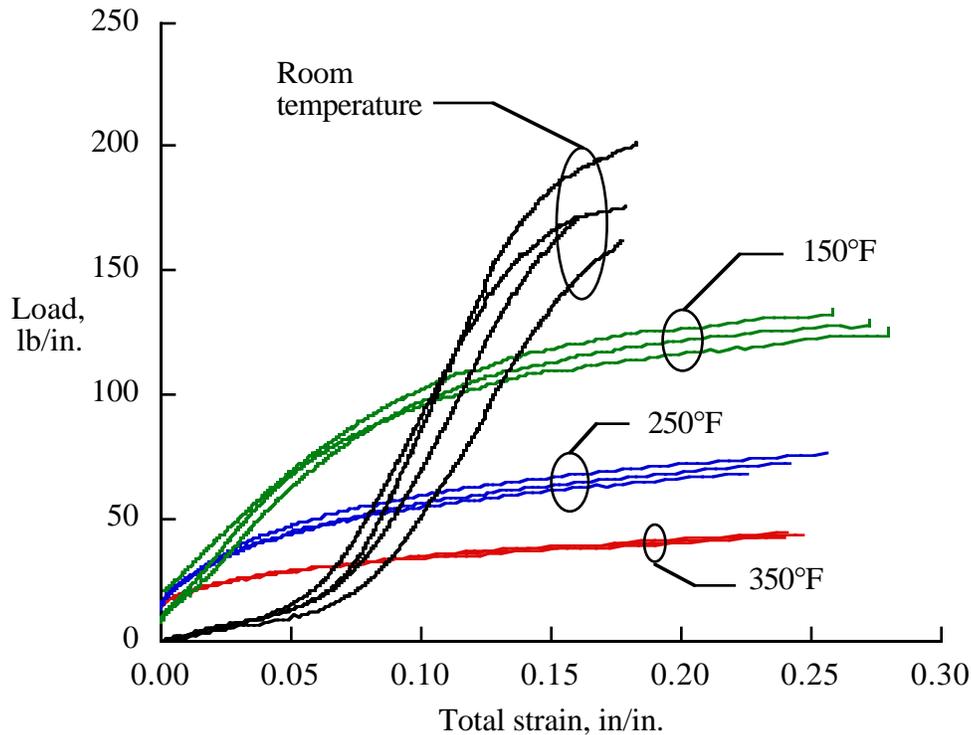
Figure 11: Effect of temperature on the load versus strain for 1-in-wide samples loaded in the gray thread direction with a load rate of 20 lb/min/in.

Figure 11 shows the effect of temperature of the strength of the material, as shown by plotting load versus strain. The specimens for the static testing were 1-in. wide and were loaded in the gray thread direction. In each case, the specimen test length was 4 in. The load rate was 20 lb/min/in. until failure. For all of the heated specimens, the test machine stroke limit was reached prior to failure. As expected, the maximum load decreased with temperature. The ambient temperature data are similar to data shown in previous figures. The ambient temperature specimens did not have a pre-load from which displacement measurements are referenced, and thus appear to initially have a large strain with only a small load. The elevated temperature specimens had a pre-load of 10 lb (150°F) and 15 lb (250°F and 350°F).

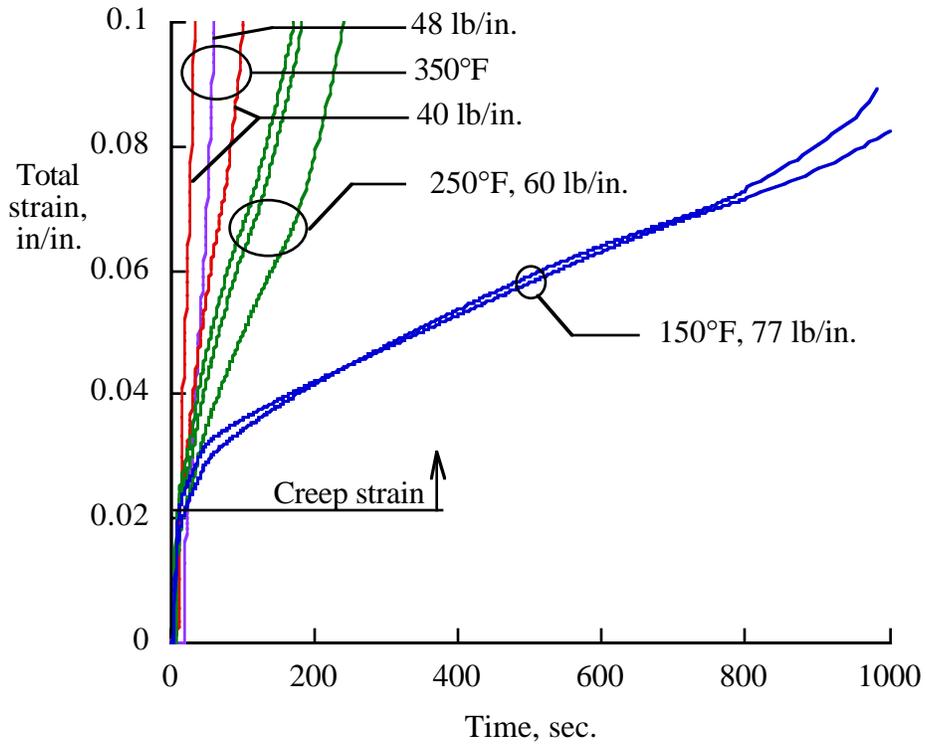
Figure 12: Effect of temperature on creep for 1.5-in-wide samples loaded in the gray thread direction with an initial load rate of 100 lb/min/in. up to the test load specified.

Creep testing was also performed at elevated temperature, and the results are shown in Figure 12. The specimens were 1.5-in. wide and were loaded in the gray thread direction at an initial load rate of 100 lb/min/in. up to the test load. The fact that the test loads chosen decreased with temperature implies the effect of temperature is even more than it appeared in the figure. Thus, if the 250°F and 350°F tests were performed at 77 lb/in, the time to failure would be even less. The tests at 350°F were performed at two different loads, 48 lb/in. and 40 lb/in. However, the different loads does not appear to be

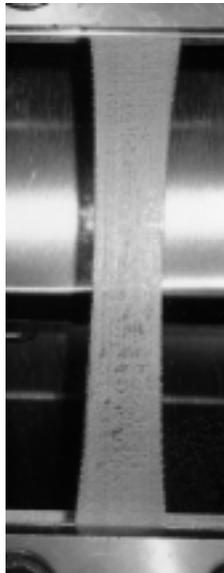
Figure 13: Photograph of seal failure after creep testing at elevated temperature.

significant as the 48 lb/in. lies between two 40 lb/in. tests. A photograph of a specimen after creep testing is shown in Figure 13. The necking down of the specimen is shown quite well with this specimen. However, most of the specimens did not fail in the manner shown in Figure 13.

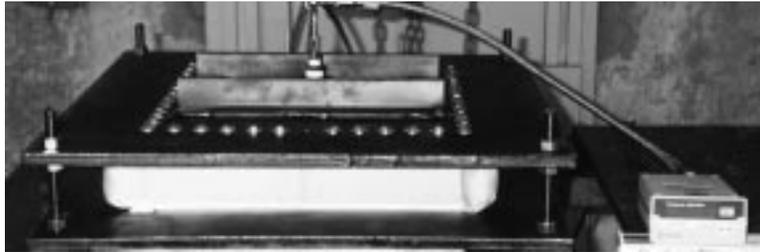
Figure 14: Photograph of the modified fixture for pressure testing the seals to 200 psi.

A fixture was fabricated to test the C-seals at ambient temperature to failure. The fixture was designed to withstand an internal pressure of 200 psi over an area 13.5 in. x 13.5 in. The 200 psi was chosen to give enough margin so that the pressure could be increased to a level to fail the seals. A photograph of the test fixture is shown in Figure 14. The seal, pressurized to 6.1 psi, can be seen between the two 0.5-in-thick steel plates in the photograph.

The final test on the seal was a burst test at ambient temperature. The seal was placed back in the high pressure, ambient temperature test fixture shown in Figure 14. The seal was pressurized at a rate of approximately 5 psi/min with nitrogen gas. The seal failed at an internal pressure of 103 psi, 16 minutes after starting the pressurization, with an applied pressure of 125 psi. From a post-test video examination of the seal failure, it

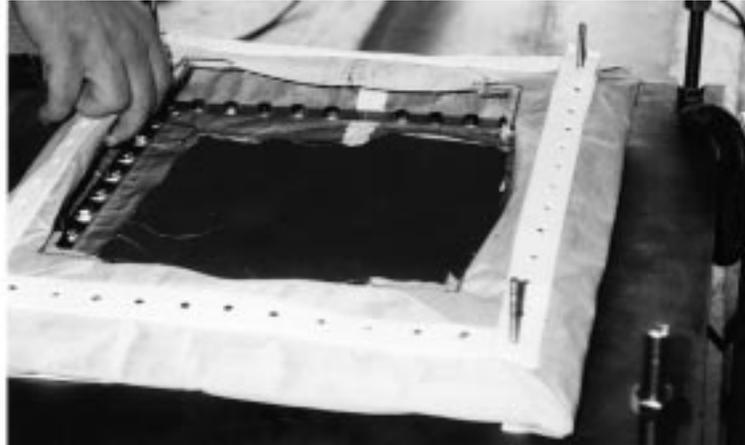
Figure 15: Photograph of Gore seal #1 prior to final assembly in fixture.

Gore Seal #1: The first seal tested was provided by W. L. Gore & Associates. The corners of the seal were folded multiple times and sewn together to form a pleated corner, as shown in Figure 15. Also shown in Figure 15 is the Gore-tex<sup>®</sup> gasket tape with adhesive backing placed on the outside surfaces of the seal over the bolts holes. On the inside surface of the seal can be seen a strip of seam seal material to reduce leaks at the seam. The bearing bar can also be seen in the photograph. When the C-seal was placed in the fixture, all the bolts were tightened with a torque wrench to 60 in-lb. The seal was then pressurized to 6.1 psi and examined for leaks with a soapy solution for detecting leaks. Small leaks were observed in the corners of the seal where there was a step change in the seal thickness from approximately 6 layers to one layer. The pressure was then gradually increased to 60 psi. The time to 60 psi was approximately 18 minutes. At 60 psi, a large leak was present and 400 psi was required from the high pressure nitrogen bottle to maintain 60 psi in the seal. The 60 psi pressure was maintained for only a few

seconds and the nitrogen supply was shut down. Upon examining the seal, it was observed that the seal material had been forced out of one of the corners at the step change between the multiple layers of the corner and the single layer of seal. The seal material that was forced out had a portion of a bolt hole through the edge of the fold. Thus when it was forced out (and tried to inflate) a 0.3-in-diameter hole was present in the seal. The data implied that this occurred at approximately 48 psi. It was also observed that the seal material had several pinhole leaks. In addition, the bolts on top of the plate leaked much more than the bolts on the bottom plate.

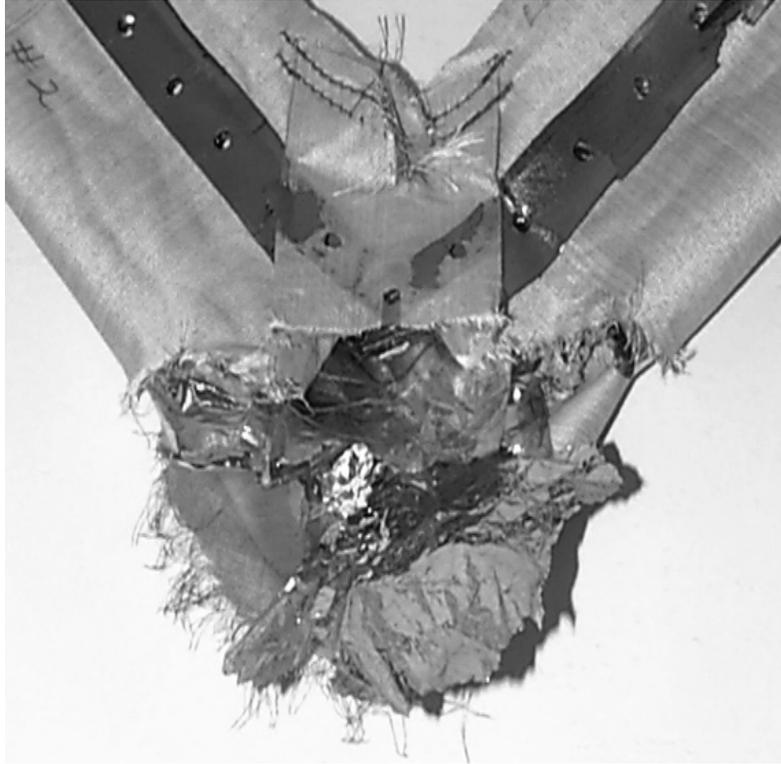
Figure 16: Photograph of the failed corner of LaRC Seal #2.

LaRC Seal #2: A second LaRC seal was fabricated exactly like the first LaRC seal. Grafoil<sup>®</sup> was used between the seal and the fixture instead of the Gore-tex<sup>®</sup> gasket tape in an effort to avoid the relaxation observed with the Gore-tex<sup>®</sup> gasket tape. In addition, an aluminized mylar liner was used on the inside in an attempt to reduce gas leakage through the seal. No attempt was made to seal the seam. Bolts were torqued to 130 in-lb. During an initial observation at several psi, leakage occurred between the seal and the plates at the location of the seams, but the seams did not leak. The seal was pressurized to 20 psi, and only 30 psi was required from the nitrogen bottle. The seal pressure was gradually increased to 60 psi over a period of 5 minutes and held for approximately 30 minutes. At 60 psi, the applied pressure was 70 psi. The Grafoil<sup>®</sup> seemed to do a better job of sealing than the Gore-tex<sup>®</sup> gasket tape. In prior tests, the Gore-tex<sup>®</sup> would be forced out of corners at the higher pressures causing excessive leakage. That kind of failure was not noticed with the Grafoil<sup>®</sup>. After approximately 29 minutes, the seal failed. A photograph of the failed portion of the seal is shown in Figure 16. The failure was symmetric about the top corner. Upon examining other corners, it was noticed that the corner of the inside bearing bar was beginning to tear the corner of the seal. It was determined that modifications to the bearing bar were required. The bearing bars were modified by cutting off the corners and radiusing the edges that were cut. Cutting off the corners eliminated the corner bolt hole.

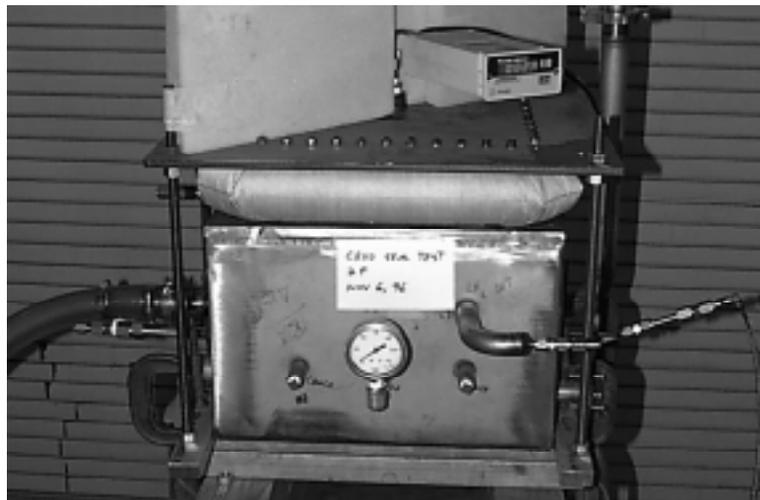
Figure 17: Photograph of the small cryogenic test box with LaRC Seal #5 ready for pressure testing.

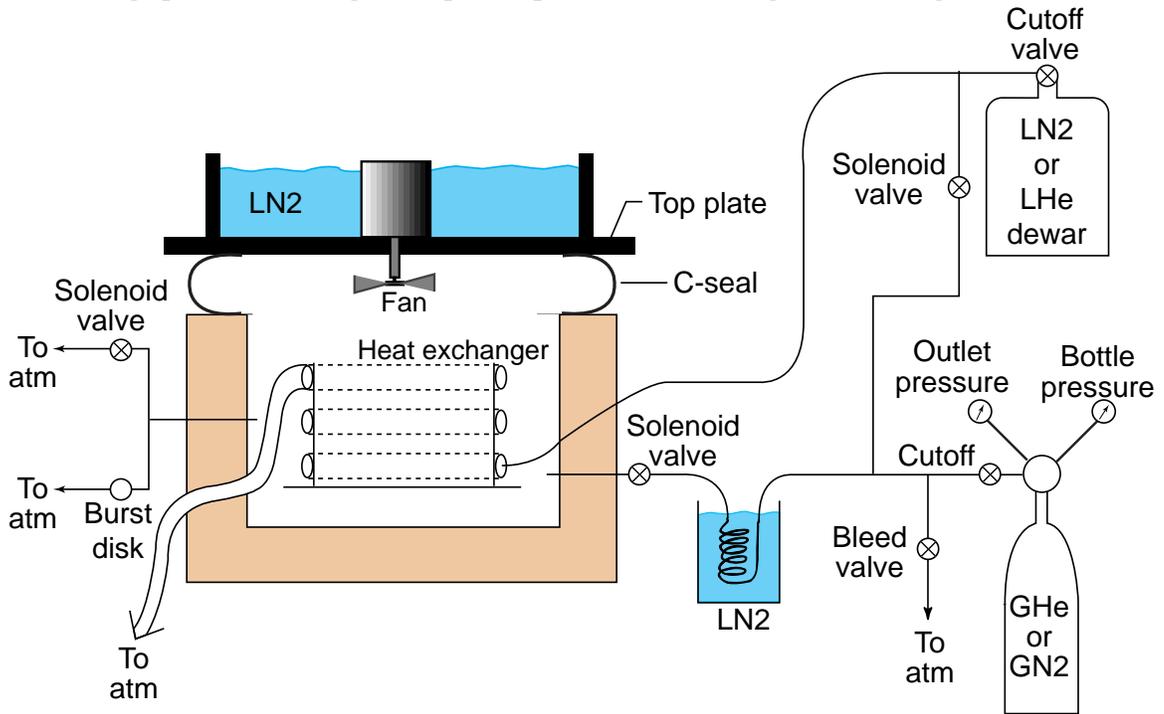
Figure 18: Schematic diagram of pressurization and cooling lines for the small cryogenic pressure box.

A schematic diagram of the pressurization and cooling systems used for the small cryogenic pressure box is shown in Figure 18. The schematic diagram shows a fan penetrating the top plate and a LN2 bath on the top plate. The fan was initially used without the LN2 bath, but was determined to be a source of leaks and to not cool effectively. The LN2 bath was added and used to supplement cooling the seal. The pressurization gas was supplied from a high pressure nitrogen or helium bottle. The pressurization gas was precooled in a LN2 bath prior to pressurizing the box. A solenoid valve and burst disk were utilized on the box to facilitate releasing pressure in the box. In

addition to the LN2 bath on the top plate, cooling was provided by LN2 or LHe in the heat exchanger in the box. The liquid coolant was provided by a dewar. The coolant lines were purged with gaseous helium (GHe) or gaseous nitrogen (GN2) (same gas as used for cooling) prior to flowing the liquid to prevent condensing and freezing air.

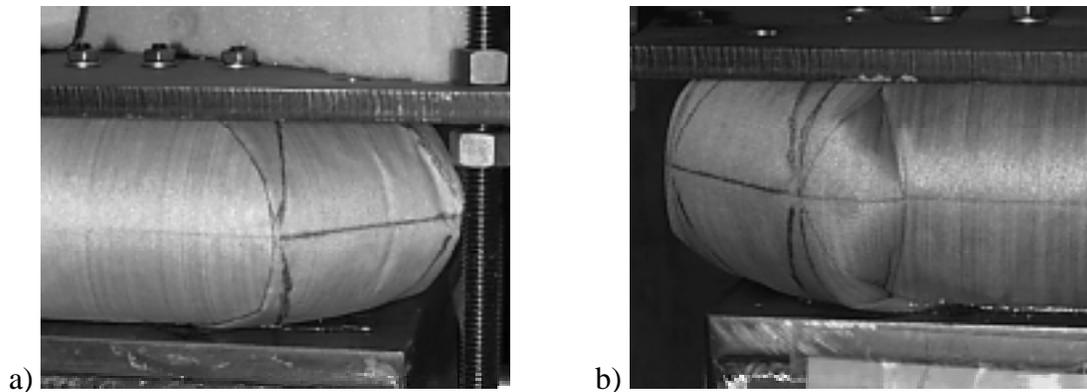
Figure 19: Photograph of the seal a) prior to full pressurization where initial folds can still be seen, and b) after pressurization, where prior folded regions are now “puffed” out.

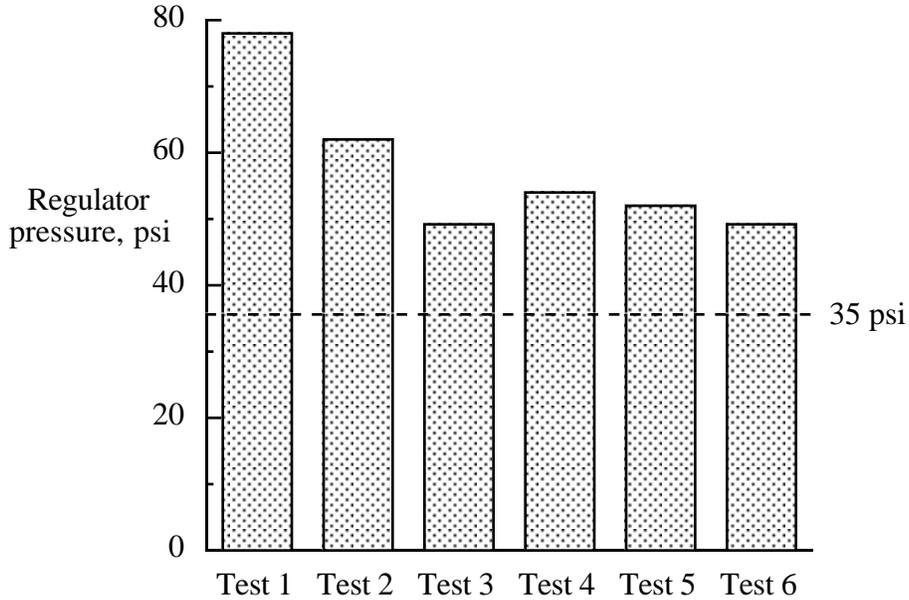
Figure 20: Regulator pressure for LaRC seal #5 ambient temperature tests when internal pressure was 35 psi.

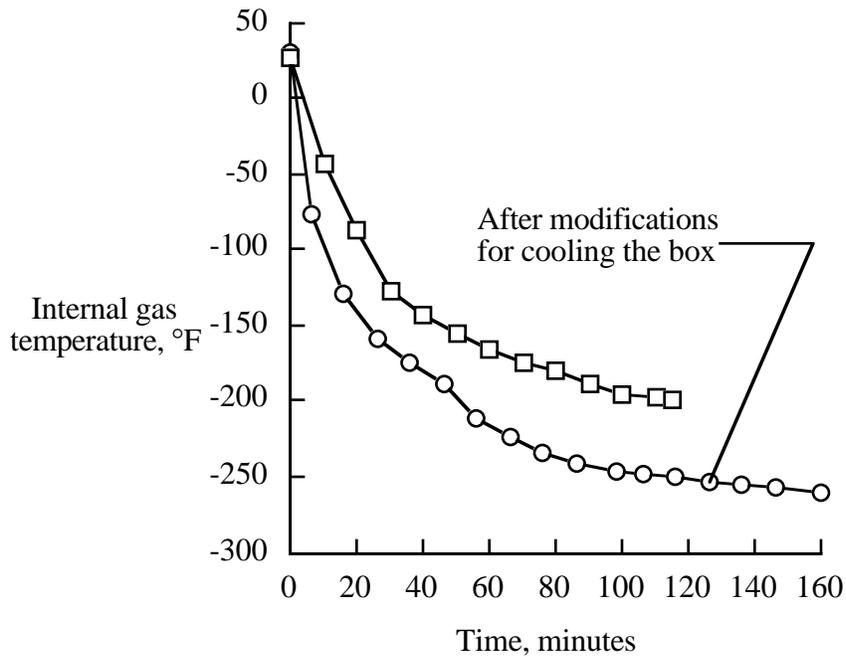
Figure 21: Internal gas temperature as a function of time during cooldown of LaRC seal #5 and test fixture.

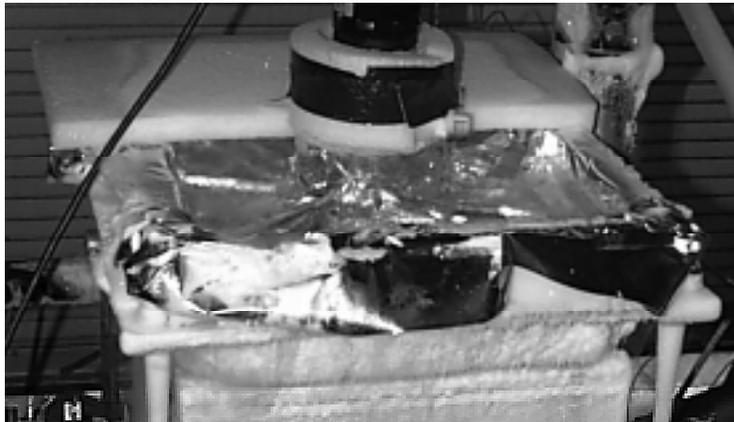
Figure 22: Photograph of the LN2 trough on top of the top plate.

Due to the large heat capacity of the stainless steel plate (3/8-in. thick), a large amount of time was required to cool the plate. Prior to the next test, a modification was made to cool the top plate by means other than internal convection. A trough was fabricated on top of the plate to contain LN2. The trough was lined with aluminized mylar to contain the LN2, as shown in Figure 22. The figure also shows the fan motor on top and the frosted seal under the top plate. By maintaining LN2 in contact with the plate, the plate could be cooled much quicker and the cold gas in the box could cool the remaining components.

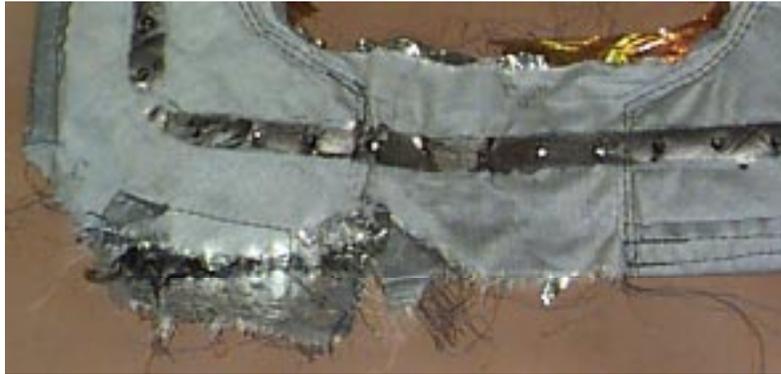
Figure 23: Photograph of LaRC seal #7 after failure at 103 psi.

was noticed that the corner reinforcement opposite the corner that burst, failed just prior to the seal failure. Within seconds of the corner reinforcement failure (stitching pulling apart on the reinforcement), the seal failed at the opposite corner. From an examination of the burst region, it appeared that the failure originated at the edge of the corner reinforcement where it was sewn onto the seal. The torn region of the seal was centered about that stitching, as shown in Figure 23. The top plate deflected approximately 0.5 in. at the maximum pressure of 103 psi. The plate deflection increased the chordlength of the curved seal, and thus increased the radius of curvature of the seal. For the undeflected plate, with a plate separation distance and seal diameter of 3 in, the load on the seal material was 154 lb/in. at 103 psi. With a 0.5-in-plate deflection, the load on the seal material in the hoop direction was approximately 185 lb/in. Since the plate was deflected the greatest between the corners where it was held down, the center of each side was where the maximum loads were experienced in the seal.

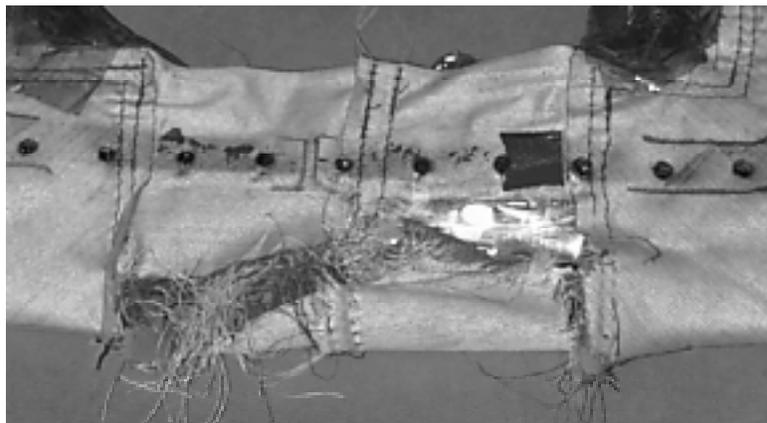
Figure 24: Photograph of LaRC seal #8 after failure at 100.2 psi.

numerous times prior to bursting. As in the prior test, the top plate was deformed significantly during the test. The bottle pressure dropped during the test from an initial 2000 psi to ~1700 psi. Figure 24 shows a photograph of the seal after failure. On this seal, the torn seal was confined to the region between the corner reinforcements. It appeared that the failure may have originated at the center between the two corners. At this location, the seal radius was larger due to the plate deflection, resulting in larger loads in the seal.
