NASA / CR-2001-211025

Development and Evaluation of Stitched Sandwich Panels

*Larry E. Stanley and Daniel O. Adams
University of Utah, Salt Lake City, Utah*

June 2001

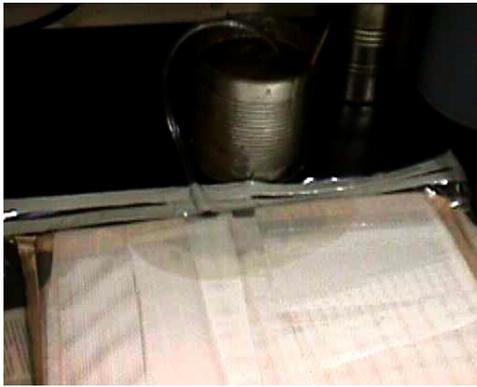
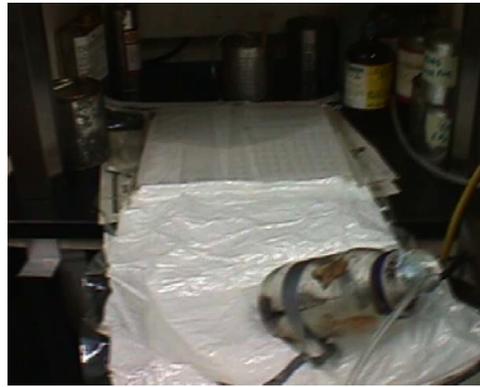
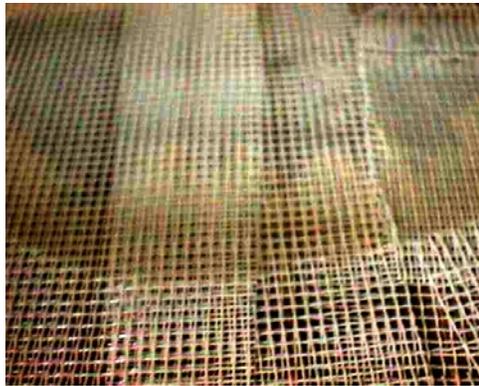
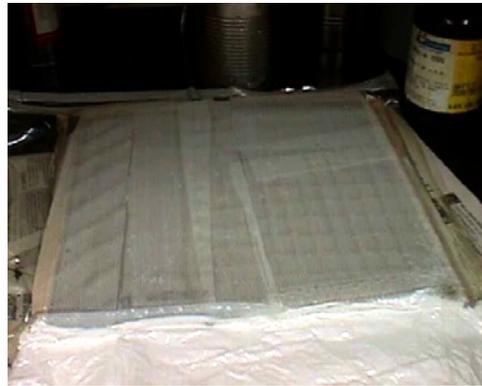
a. Beginning of Infiltration.

b. Midpoint of Infiltration.

c. Close-up view of Infiltration.

d. Fully Infiltrated.

Figure 3.8 VARTM Infiltration Process

After the resin and hardener were mixed, the resin inlet tube was placed into the resin pot and the vacuum pump was turned on. Resin was pulled through the tube and into the vacuum bagged panel assembly, infiltrating the facesheets as well as the Kevlar stitches as shown in Figures 3.8a through 3.8d. The through-the-thickness stitching produced resin paths that allow resin to flow freely between the top and bottom facesheets of the panel. Thus, the facesheets were infiltrated and bonded to the core in the same processing step.

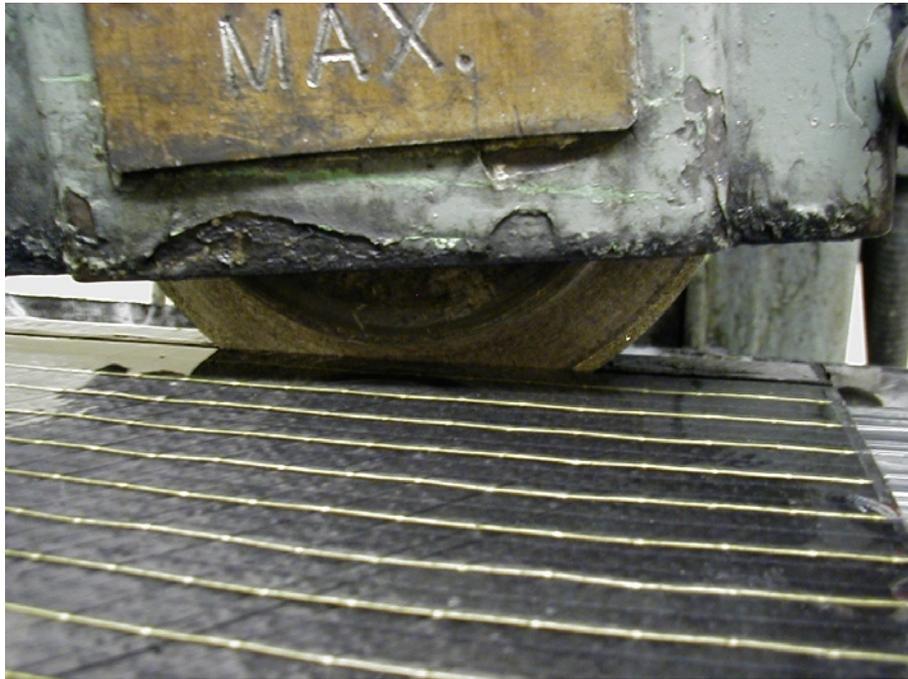
Figure 3.9 Cutting of specimens with water-cooled diamond saw.

The finished panels were cut to the appropriate size using a water-cooled diamond saw as shown in Figure 3.9. To avoid damage to the soft foam core, clamping pressure applied to the panel was minimized during the cutting process. Special care was taken to insure that the cuts were made at equal distances from the stitches on each side of the specimen. The Utah panels were cut into specimens with dimensions 2.0 in. x 2.0 in. for flatwise tension, 1.0 in. x 10.0 in. for flexure, 8.0 in. x 2.0 in. for core shear, and 2.0 in. x 2.6 in. for edgewise compression. Because of the different densities of stitching and to minimize waste, the NASA panels were cut to different specimen dimensions than the Utah specimens. Specimens from the NASA panels were 1.93 in. x 1.93 in. for flatwise tension, 1.93 in. x 8.0 in. for core shear, 1.93 in. x 10.0 in. for flexure, and 1.93 in. x 2.5 in. for edgewise compression. A width of 1.93 in. rather than 2.0 in. accounted for the width of the cutting blade and centered the stitch rows within the specimens.

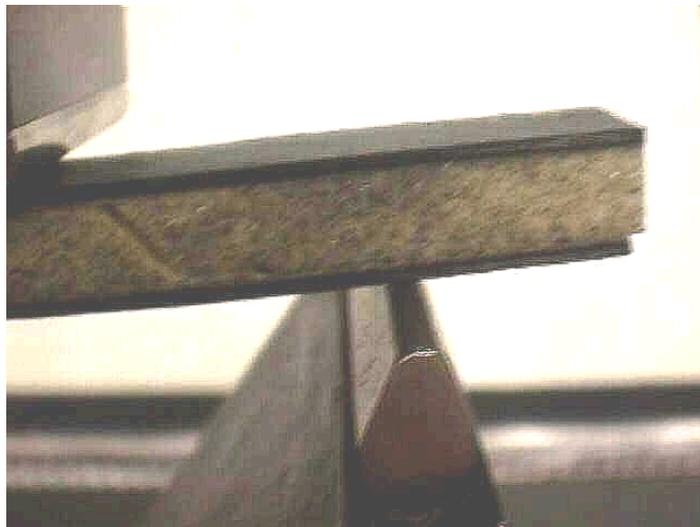
b. Close-up of crack extending to specimen end.

Figure 5.4. Unstitched Utah specimen subjected to four-point flexure testing.

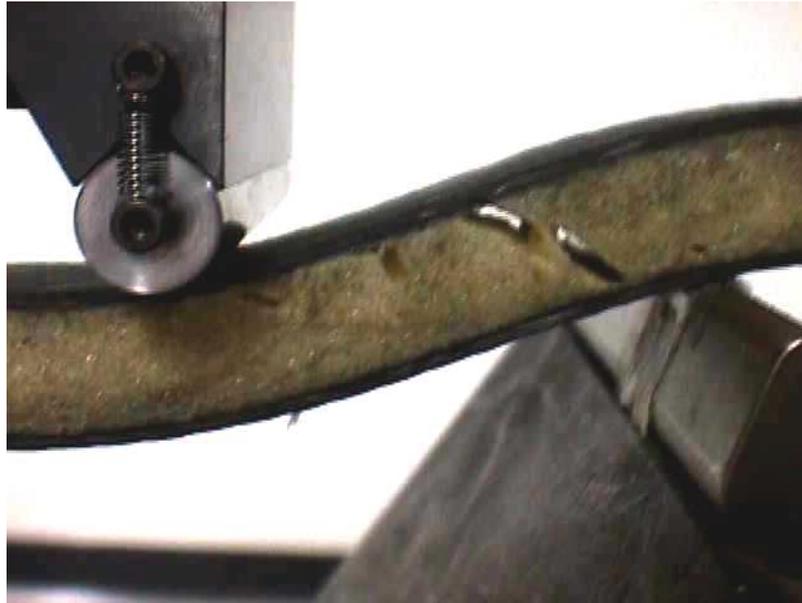
Figure 5.5 Initial failure in stitched Utah specimen in four-point flexure loading.

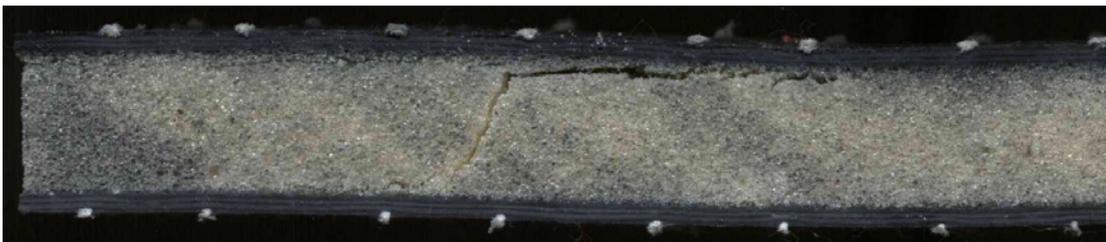
Figure 5.8 Failed angled stitched specimen.

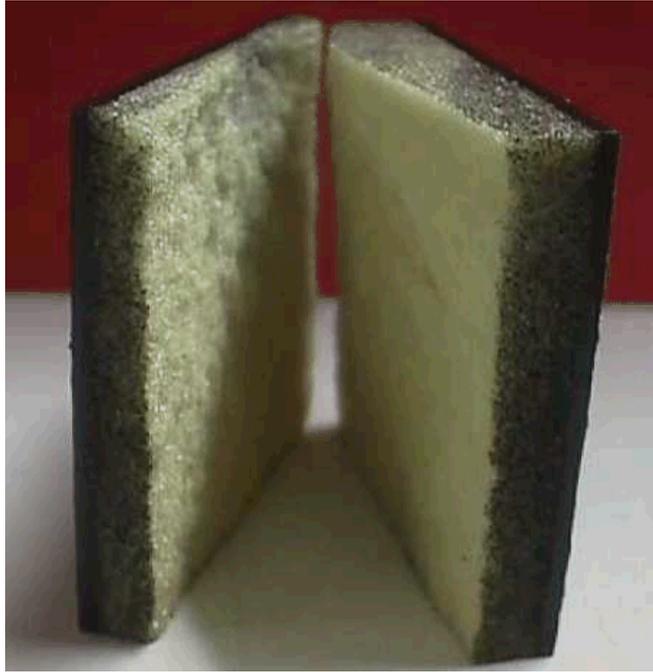
Figure 5.14 Failed unstitched Utah specimen from flatwise tensile loading.

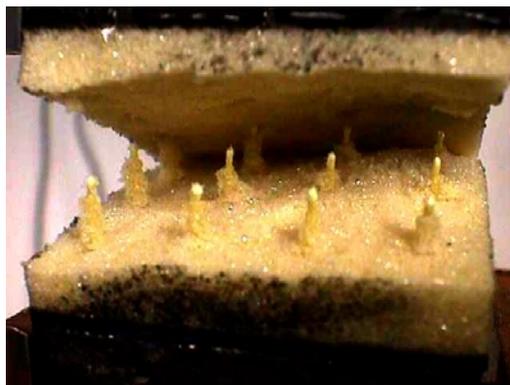
Figure 5.17 Failed Utah specimen stitched with 1600 denier bobbin thread.

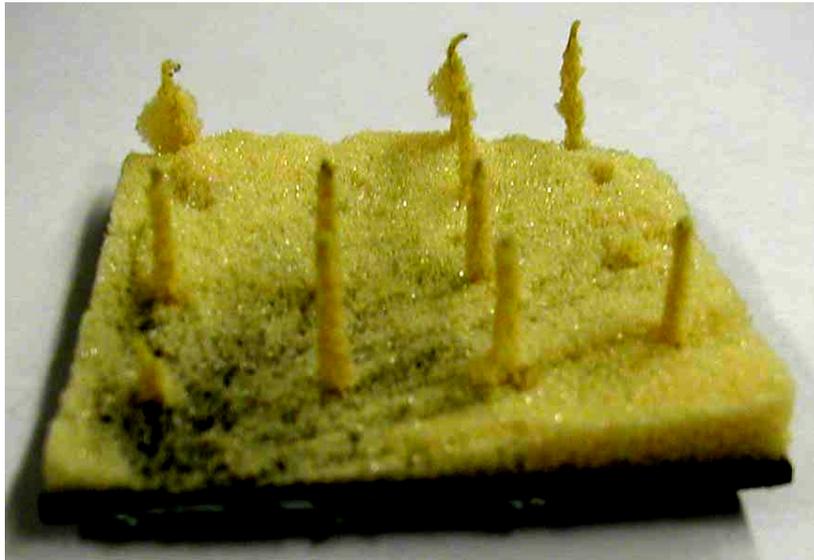
Figure 5.18 Failed Utah specimen stitched with 3200 denier bobbin thread.

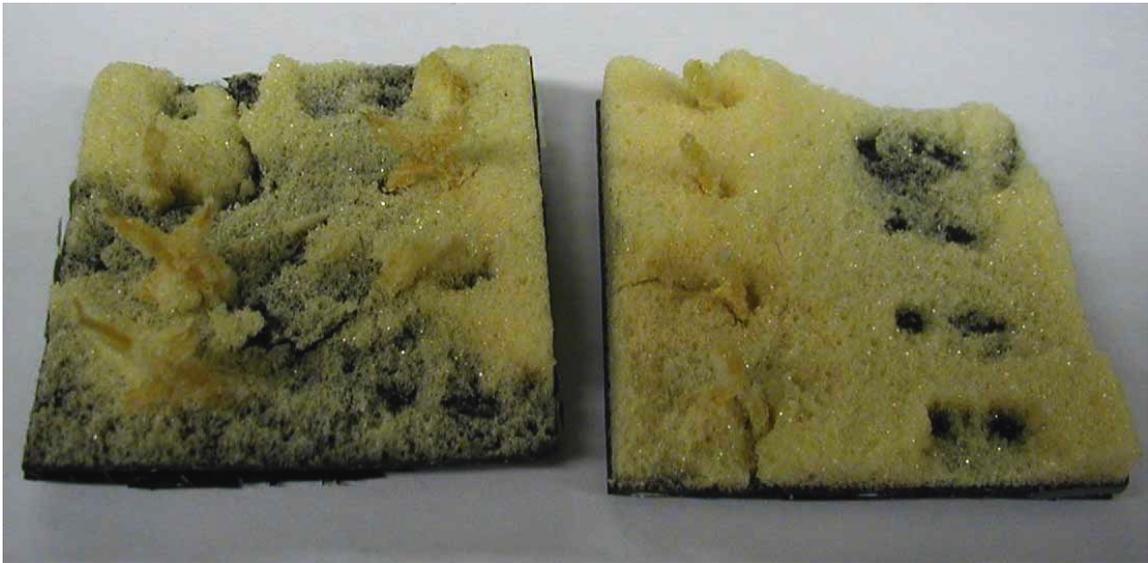
Figure 5.19 Failed angled stitched tension specimens

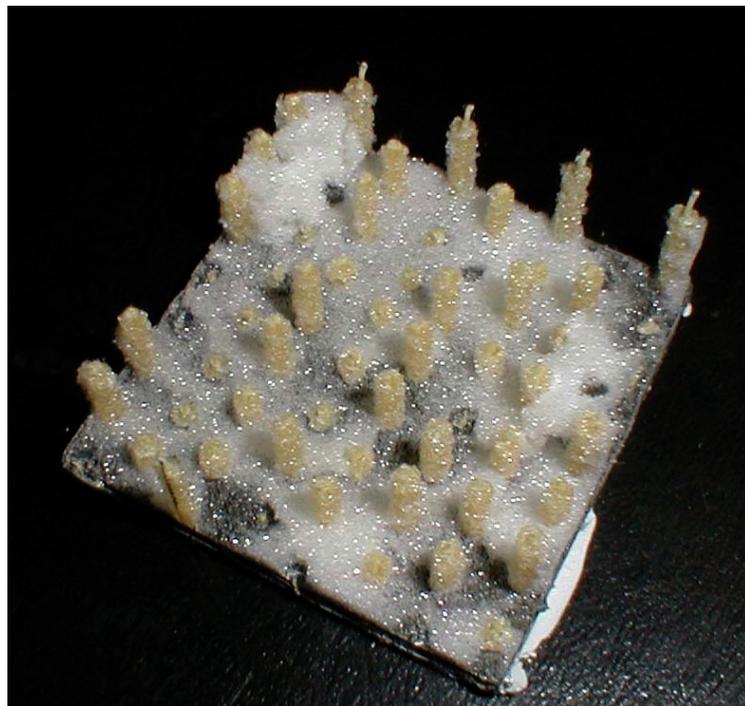
Figure 5.22 Failed NASA specimen with 1.0 in. core and 0.25 in. stitch spacing.

Further differences between the Utah and NASA panels were observed when inspecting the failed flatwise tensile specimens. In the Utah specimens, which had a single layer of warp-knit fabric in each face sheet, the stitches nearly always failed at the intersection between the stitch loop and the bobbin thread as discussed previously. In the NASA specimens, the stitches rarely failed at this location. As shown in Figure 5.21, approximately one-half the stitches failed at the interface between the face sheet and core. A majority of the remaining stitches failed at other locations within the core. A small number of stitches, usually at the edges of the specimen, still failed at the stitch loop/bobbin connection as shown in Figure 5.22.

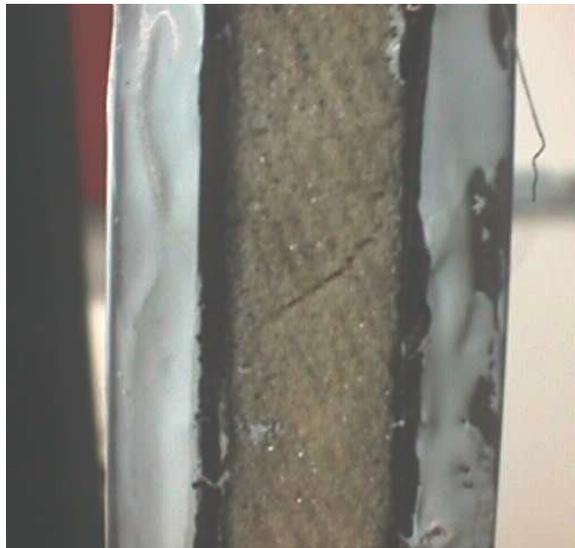
Figure 2.26 Initial failure of stitched specimen during core shear testing.

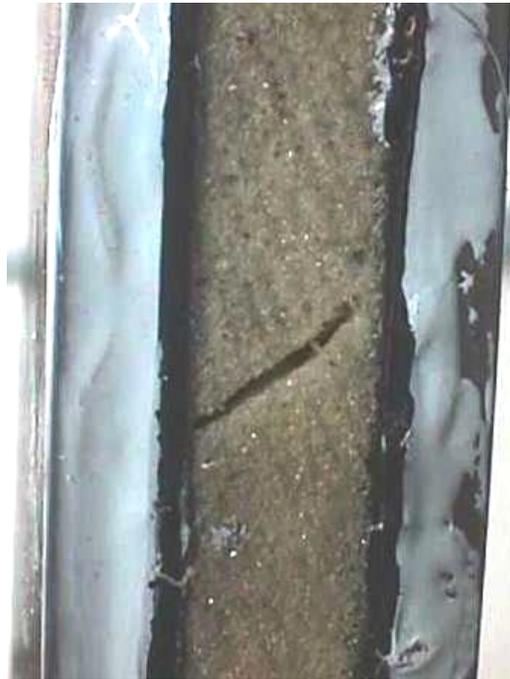
Figure 5.27 Widening of core crack under increasing loading for stitched specimen

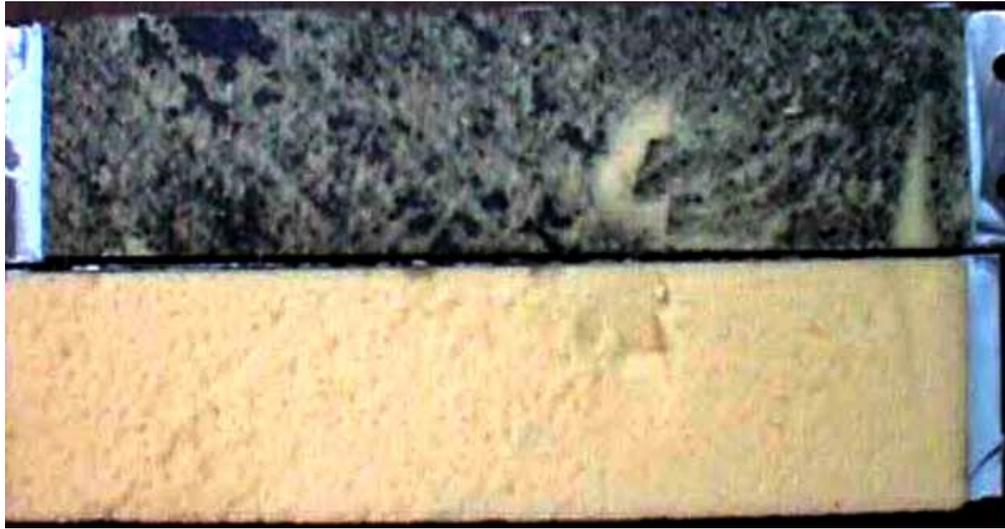
Figure 5.29 Failed Utah unstitched core shear specimen

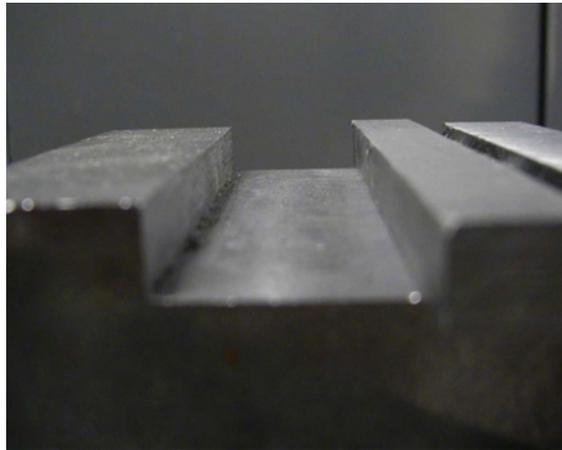
Figure 5.34 Machined channel to prevent “brooming”

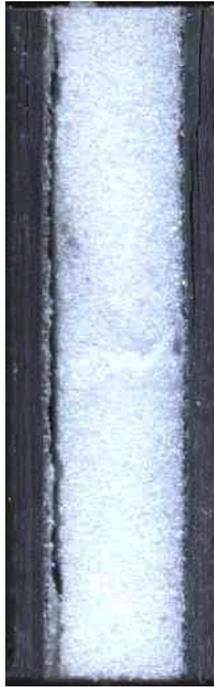
Figure 5.38 Failed unstitched NASA edgewise compression specimen

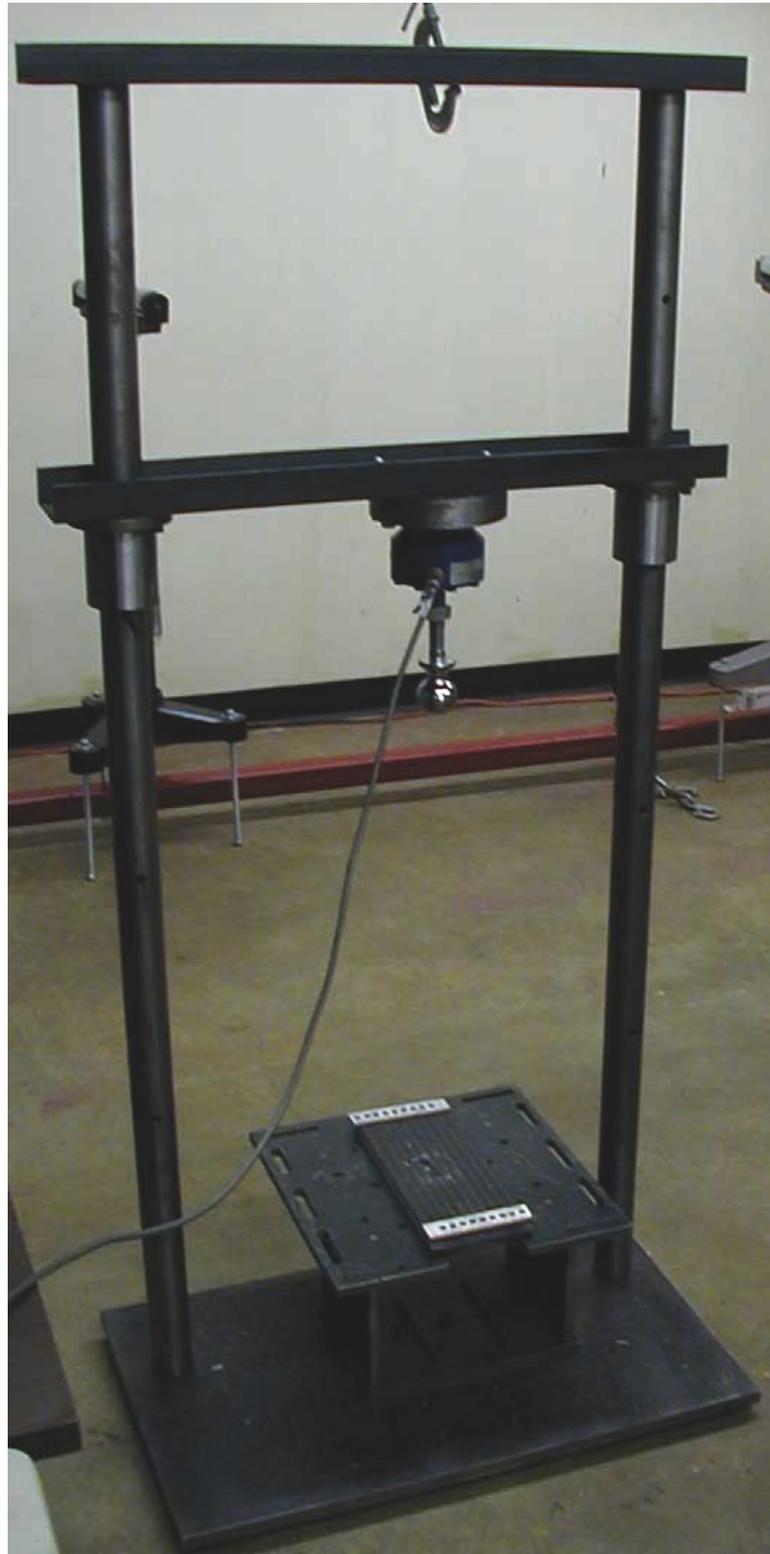
Figure 6.1 Impact frame
