NASA / CR-1998-207642

Fabrication and Testing of Mo-Re Heat Pipes Embedded in Carbon/Carbon

Abstract

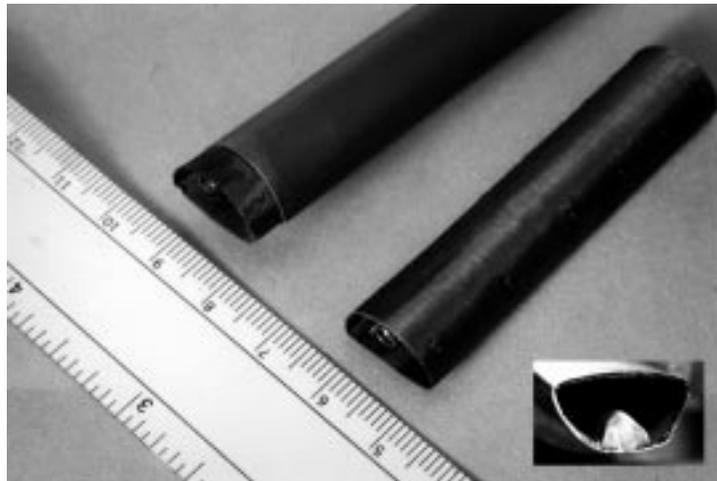
Figure 4: Photograph of a section of “D-tube” and screen wick.

The heat pipe was fabricated from a Mo-41Re “D-shaped” tube that was drawn from an arc-cast bar at ThermoElectron Tecomet, Wilmington, MA. A screen wick was fabricated by wrapping four layers of 400 x 400 mesh Mo-5Re screen around a “D-shaped” mandrel. Figure 4 shows a photograph of a section of the “D-tube” and the screen wick. A 0.10-in-diameter artery was included in the wick. The artery is located in the top center of the curved portion of the heat pipe and has a spring in it to help maintain its shape. Superimposed in Figure 4 is a photograph of the closeout at one end of the wick. One end of the wick is closed out as in the photograph, while the other end is open and is covered by a pool of liquid lithium during operation. Mo-41Re end caps were machined and welded to the ends of the heat pipe. A photograph of all of the individual parts prior to the final assembly is shown in Figure 5.

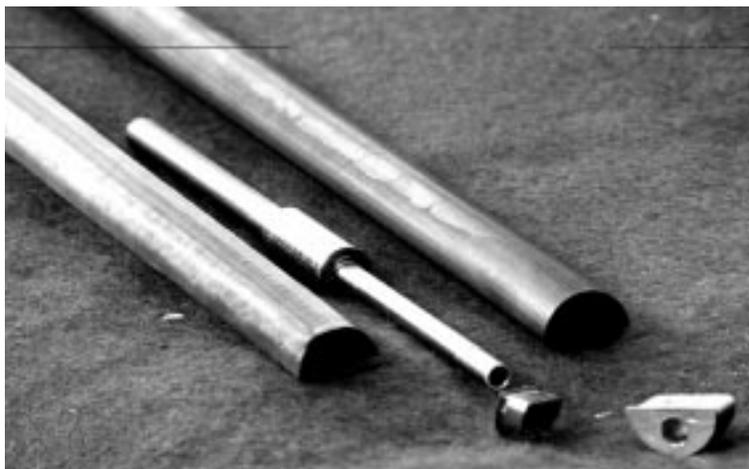
Figure 5 Photograph of the parts of the heat pipe prior to final welding, showing the “D-shaped” screen wick, heat-pipe container, end caps, and fill tube.

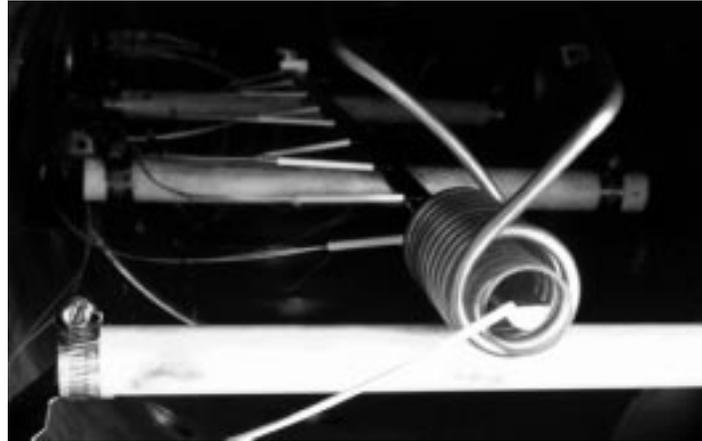
Figure 8: Photograph of the heat pipe in the vacuum chamber showing the heat pipe with thermocouples mounted on the flat surface and induction heating coils wrapped around a portion of the heat pipe.

The "D-shaped" Mo-Re heat pipe was placed in a vacuum chamber and heated by induction heating. The induction heating coils initially heated approximately 4 in. of the heat-pipe length. After several preliminary tests in which the "D-shaped" Mo-Re heat pipe was checked to ensure proper operation, the steady state throughput of the heat pipe was measured at different power supply settings. The throughput was the total integrated heat flux into the evaporator that was transferred to the condenser and radiated away by the outer surface of the heat pipe. The calorimeter that was used to determine the throughput is shown in Figure 9 along with the instrumented heat pipe. Prior to calibration, the length of the induction heating coils was reduced from 4 in. to 2 in. This reduction enabled the heat flux to be doubled while maintaining the same throughput and maximum operating temperature.
