NASA / TM-1998-208742

Room Temperature and Elevated Temperature Composite Sandwich Joint Testing

Testing of composite sandwich joint elements has been completed to verify the strength capacity of joints designed to carry specified running loads representative of a high speed civil transport wing. Static tension testing at both room and an elevated temperature of 350°F and fatigue testing at room temperature were conducted to determine strength capacity, fatigue life, and failure modes. Static tension test results yielded failure loads above the design loads for the room temperature tests, confirming the ability of the joint concepts tested to carry their design loads. However, strength reductions as large as 30% were observed at the elevated test temperature, where all failure loads were below the room temperature design loads for the specific joint designs tested. Fatigue testing resulted in lower than predicted fatigue lives.

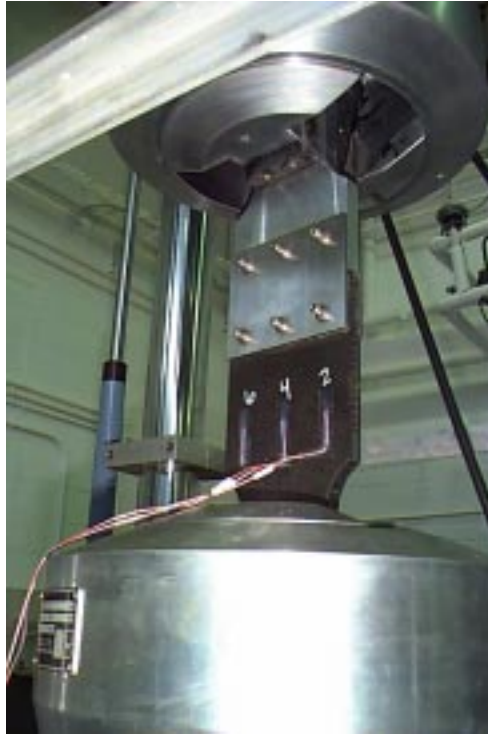
Figure 1. Single-row joint specimen mounted in test machine using hydraulic grips for the room temperature test.

The room temperature specimen was tension tested using hydraulic grips in a 220 kip test machine. A photograph of the specimen mounted in the test machine is shown in Figure 1. The load was applied to the end grip tabs of the joint specimen through the hydraulic grips using a grip pressure of 5500 psi. The test machine was set in stroke control and a displacement rate of 0.01 in/min was used to apply the load to the joint specimen. The applied load versus ram displacement is plotted in Figure 2. The first indication of initial damage was observed at 31 kips, where a 10% reduction in the load was recorded and a cracking noise was heard. Subsequently, loading of the joint continued until an ultimate load of 40 kips was obtained. At the ultimate load, a 10 kip reduction in the load was observed, and the test was stopped. Since the first load reduction was less than 20%, which was considered in this test to indicate ultimate failure, the load of 40 kips was considered the ultimate failure load. The measured back-to-back strains from strain gauges, SG3 and SG4, located at the center of the specimen, are plotted in Figure 3 with the applied load. The location of SG2, SG4, and SG6 can be observed in Figure 1, where SG1, SG3, and SG5 correspond to the same locations on the opposite facesheet, respectively. The strains measured from SG1 and SG2 are plotted in Figure 4 with the applied load. At the ultimate failure load of 40 kips, a maximum strain of 2530 $\mu\text{in./in.}$ was measured at SG4 in the center of the specimen and a minimum strain of 1944 $\mu\text{in./in.}$ was measured at SG2. Examination of the specimen after testing to failure showed bearing damage at all three bolt hole locations in the composite sandwich specimen. A photograph indicating the bearing damage is given in Figure 5. Later inspection of the specimen also revealed a confined area of delamination in the composite laminate, in the neck down region to the grip end.

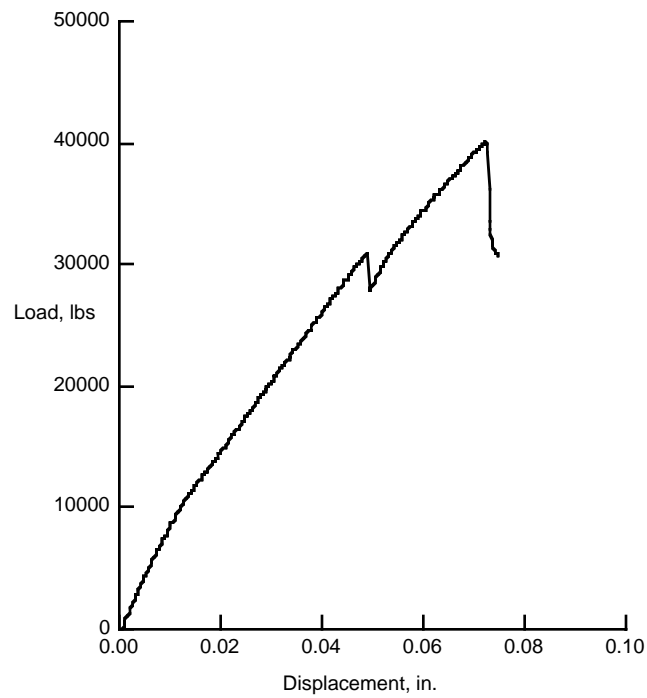
Figure 2. Load versus displacement for the room temperature single-row joint test.

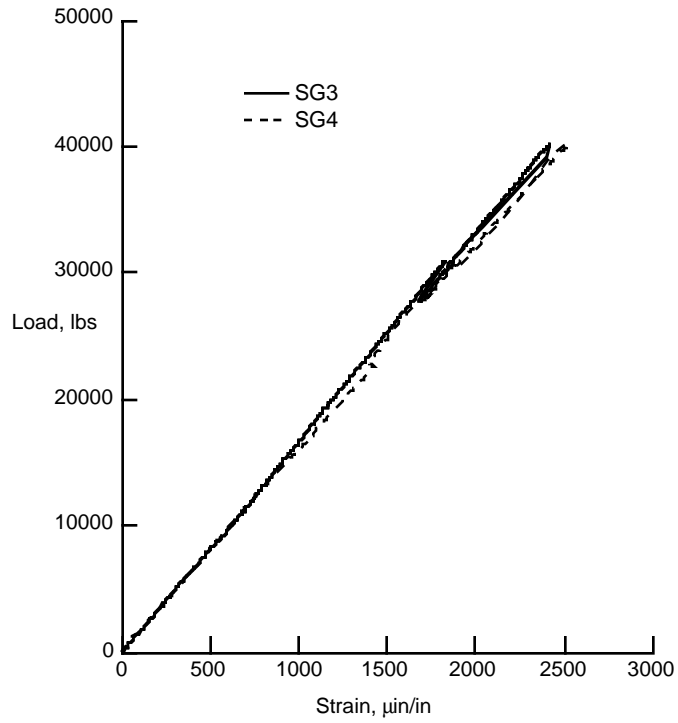
Figure 3. Back-to-back measured strains at the center of the room temperature joint specimen.

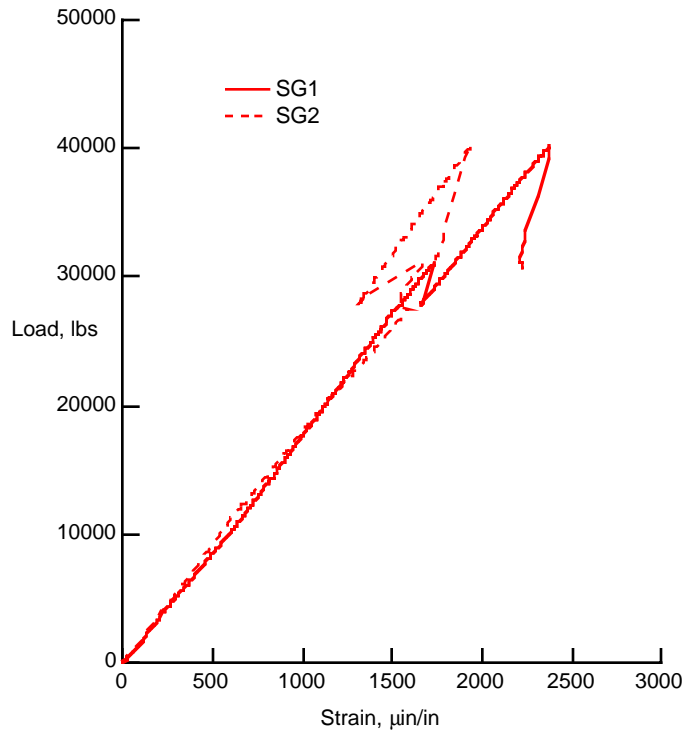
Figure 4. Measured strains from strain gauges SG1 and SG2 of the room temperature joint specimen.

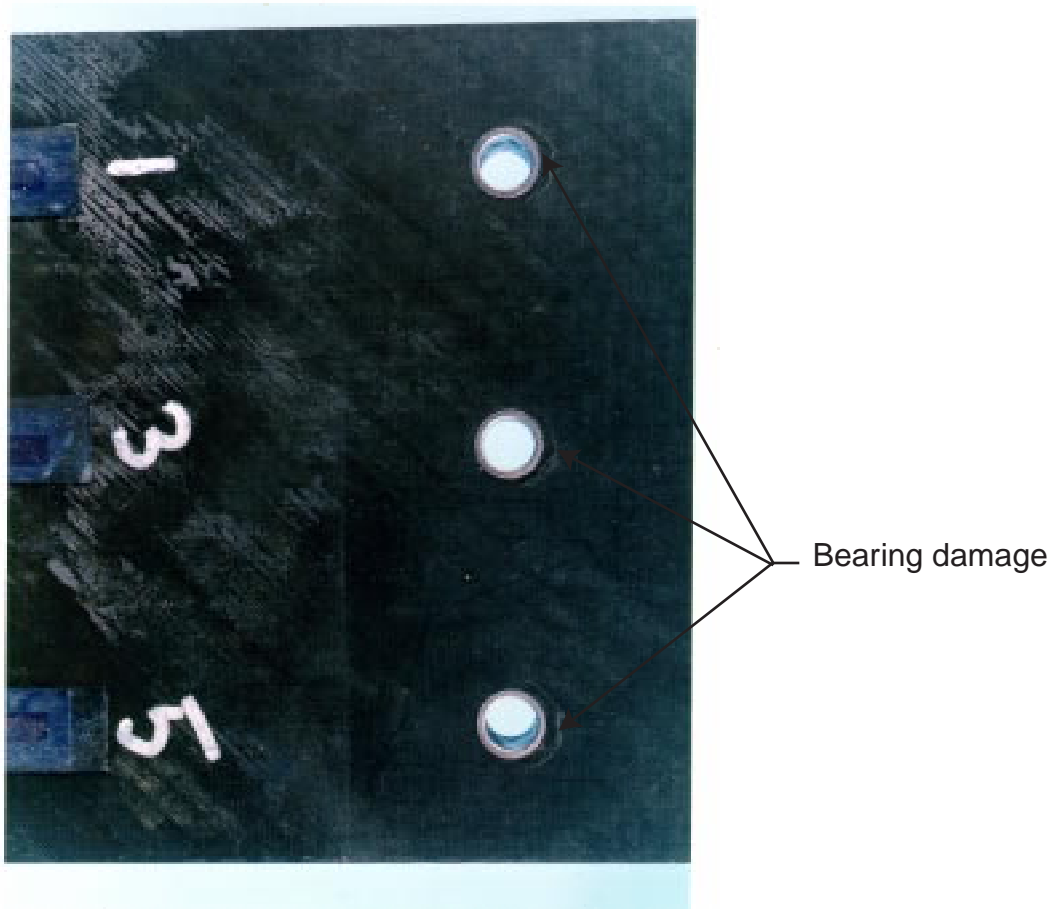
Figure 5. Single-row joint Specimen 1 after testing to failure.

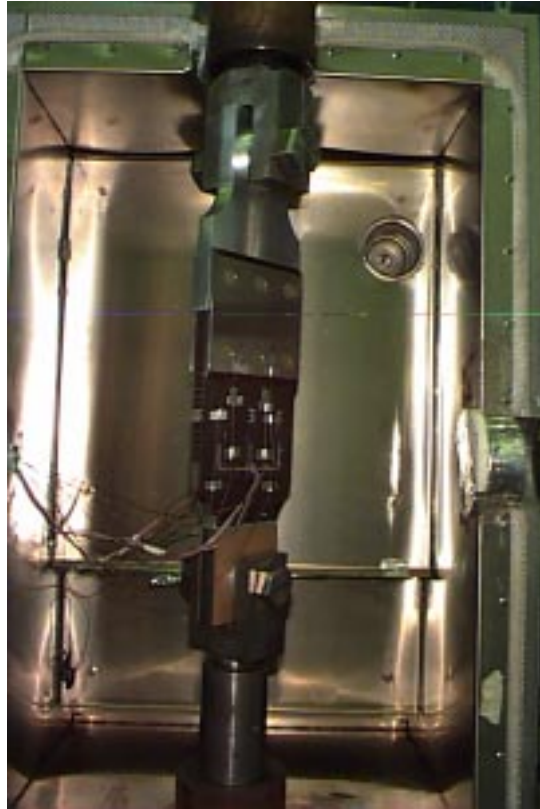
Figure 6. Single-row joint specimen mounted in test machine for elevated temperature testing.

The elevated temperature specimens were modified to allow for a pinned connection to introduce the load and use of an existing oven in the 110 kip test machine. A one inch diameter hole was drilled in the center on the composite grip end tab and a 1.25 inch diameter hole was drilled in the metallic grip end tab to allow for the pin connections on each specimen. The oven enclosed both the specimen and fixturing as shown in Figure 6. Prior to heating the specimen in the oven, coupon samples of the fiberglass material that was bonded to the composite grip ends were heated in an oven to 350°F. The fiberglass is used to protect the composite from damage when hydraulic grips are used and there were concerns that the fiberglass material might burn at this test temperature. No material changes were observed when the fiberglass coupons were heated nor when the joint specimens with the fiberglass tabs bonded to the composite material were heated. Eight thermocouples were mounted on the composite specimen, four on each facesheet. The specimens were heated to approximately 350°F while the test machine maintained a load of approximately 200 lbs on the specimens. Temperature variations were minimal and all temperature measurements ranged between 348°F and 354°F on the specimen throughout the duration of the test. When the desired temperatures were reached, the specimen was loaded using a displacement rate of 0.01 in/min. The load-displacement diagram and strain measurements are given in Figures 7-9 for Specimen 2 and Figures 10-12 for Specimen 3. Of the two specimens tested at 350°F, Specimen 2 failed at an ultimate load of 26 kips and Specimen 3 failed at 24 kips. Unlike the room temperature specimen tested, the elevated temperature tests reached an ultimate failure load without any prior load reductions. The ultimate strain measurements ranged from 1641 $\mu\text{in./in.}$ at the center gauge SG4 to 1354 $\mu\text{in./in.}$ at gauge SG1 for Specimen 2 and from 1560 $\mu\text{in./in.}$ at the center gauge SG3 to 1288 $\mu\text{in./in.}$ at SG6 for Specimen 3. Also, unlike the room temperature test where all three bolt hole locations displayed bearing damage, both elevated temperature specimens showed significant bearing damage only at the center and one side bolt hole with almost no visible bearing damage at the third bolt hole location. A non-uniform distribution of the load between fasteners would partially attribute to the strength reduction for the elevated temperature test specimens.

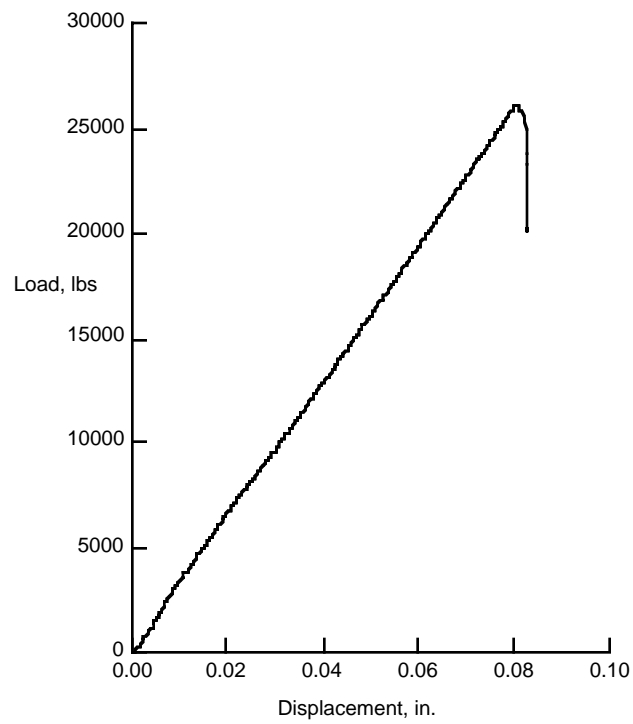
Figure 7. Load versus displacement for Specimen 2 tested at 350°F.

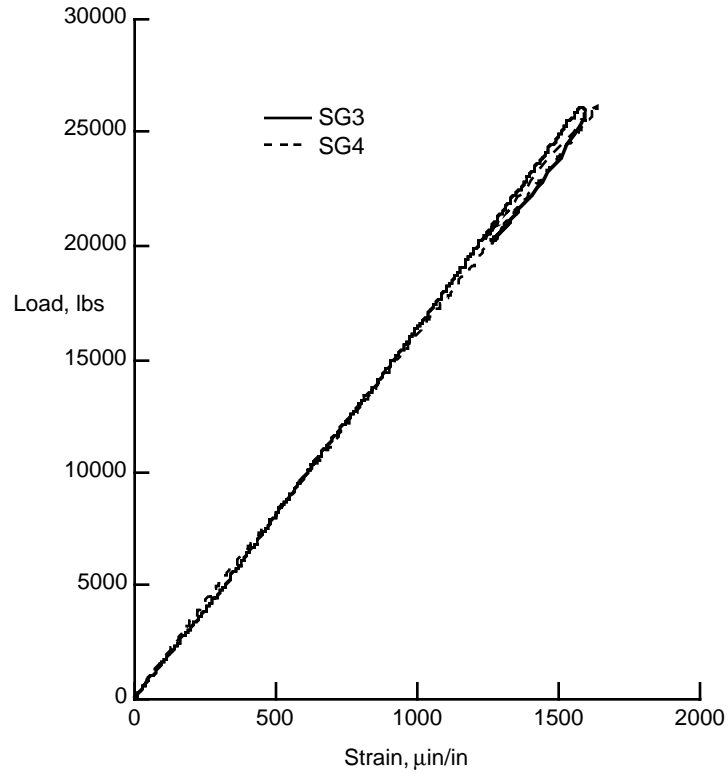
Figure 8. Back-to-back measured strains at the center of Specimen 2 tested at 350°F.

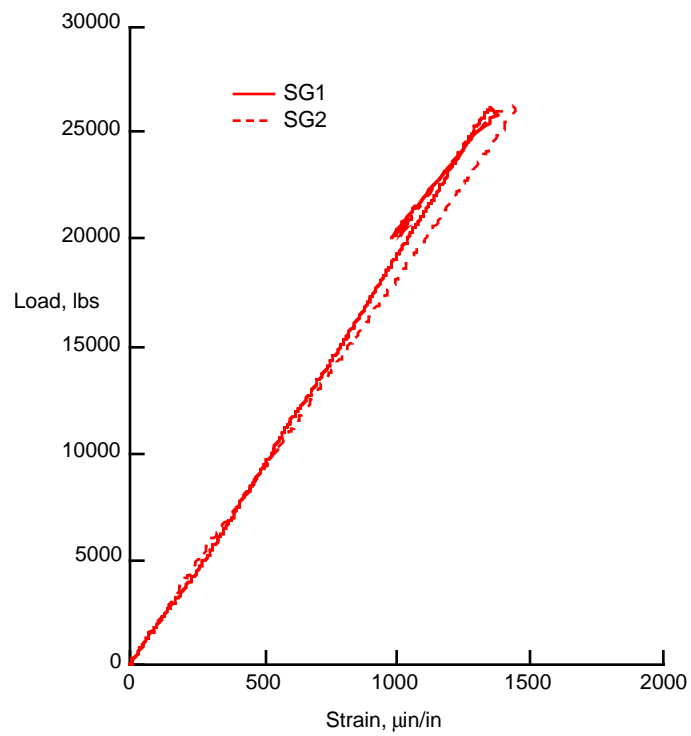
Figure 9. Measured strains from strain gauges SG1 and SG2 on Specimen 2 tested at 350°F.

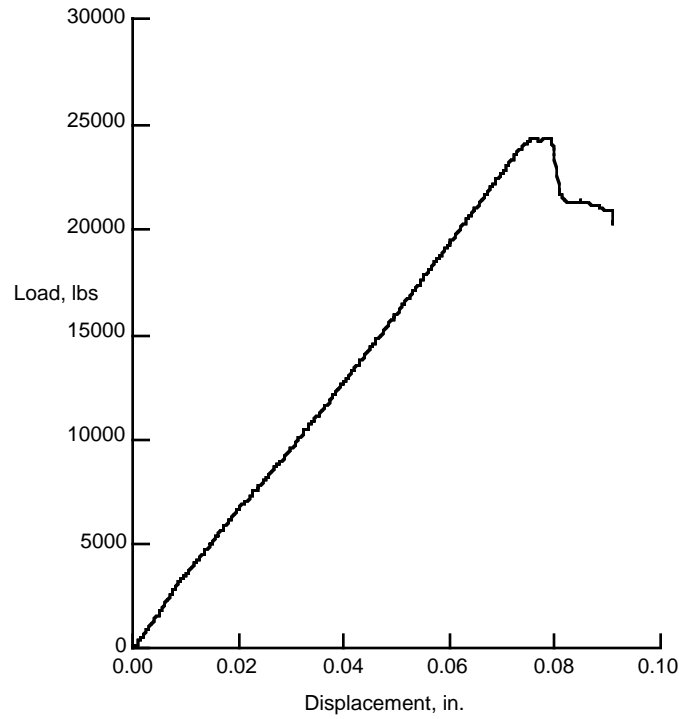
Figure 10. Load versus displacement for Specimen 3 tested at 350°F.

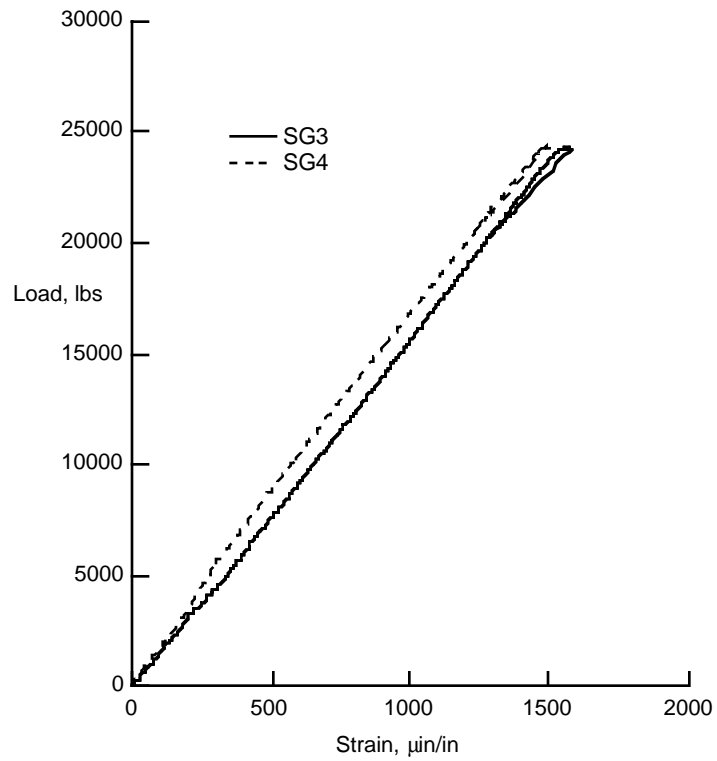
Figure 11. Back-to-back measured strains at the center of Specimen 3 tested at 350°F.

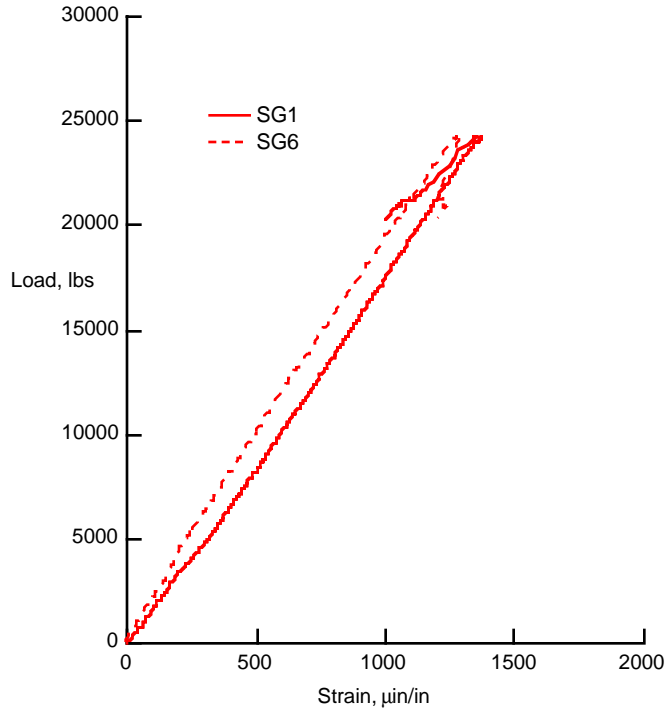
Figure 12. Measured strains from strain gauges SG1 and SG6 on Specimen 3 tested at 350°F.

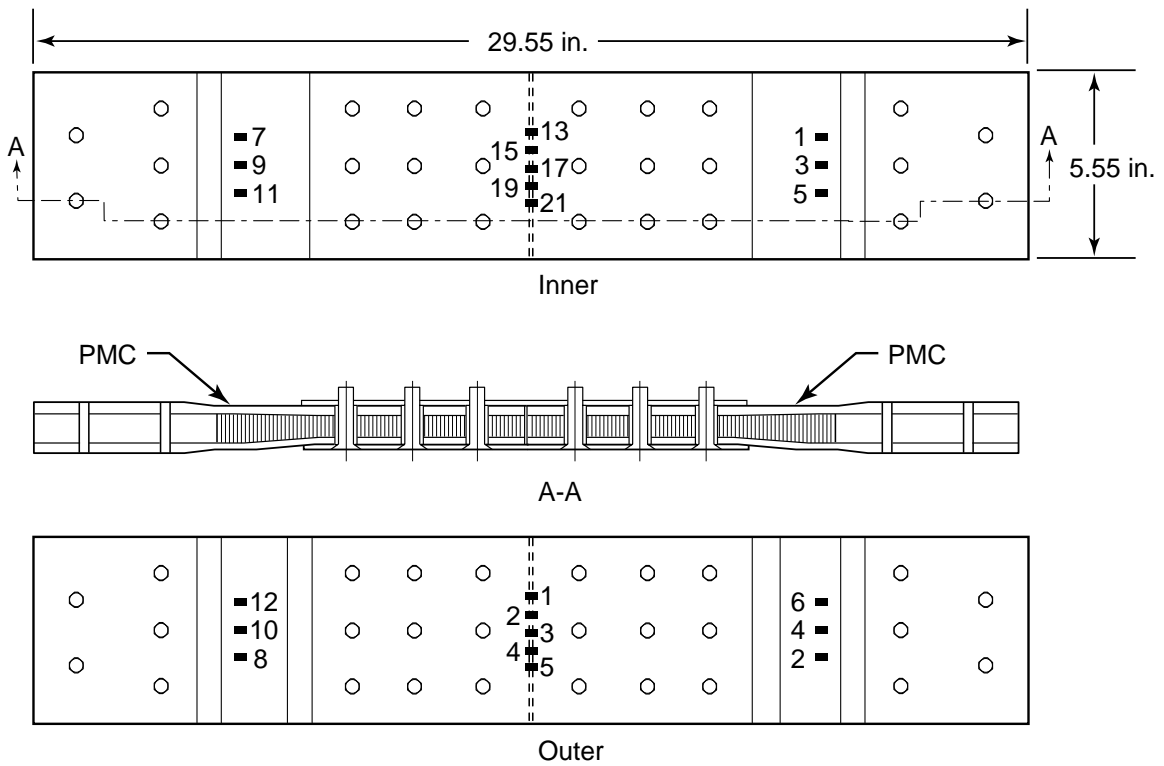
Figure 13. Schematic drawing of PMC to PMC multi-row joint specimen including strain gauge locations.

to be tested in static tension and the remaining two were to be tested in fatigue. A sketch of a PMC to PMC joint specimen and a sketch of a PMC to SPF/DB specimen, including strain gauge locations, are given in Figures 13 and 14, respectively. As can be observed in the figures, both joining components were tapered down under the outer splice plate to provide a smooth aerodynamic surface between the splice plate and joining components. On the inner (spar) side, the PMC to PMC specimen was designed with a flat inner splice plate and the PMC to SPF/DB specimen had a tapered T-section inner splice plate. The tapering splice plate design was included to provide a more uniform fastener load distribution. A photograph of the two specimens is shown in Figure 15 where a top view (outer wing surface side) of a PMC to PMC specimen and a bottom view (wing spar side) of a PMC to SPF/DB specimen are shown.

The PMC to PMC specimens were instrumented with 22 back-to-back strain gauges as shown in Figure 13. On each side, five gauges were located across the center of the splice plates and three were located on each composite sandwich about 1.5 inches from the edge of the splice plate. The PMC to SPF/DB specimens had a total of 17 strain gauges as shown in Figure 14. On the outer splice plate, five gauges were located across the center as on the PMC to PMC specimen. Three back-to-back gauges were located on the PMC sandwich about 2 inches from the edge of the splice plate. On the SPF/DB component, four gauges were located on the outer surface and two on the inner surface. The two back-to-back gauges were located 0.4 inch from the edge of the splice plate and the other two gauges on the outer surface were located about 2.5 inches from the splice plate.

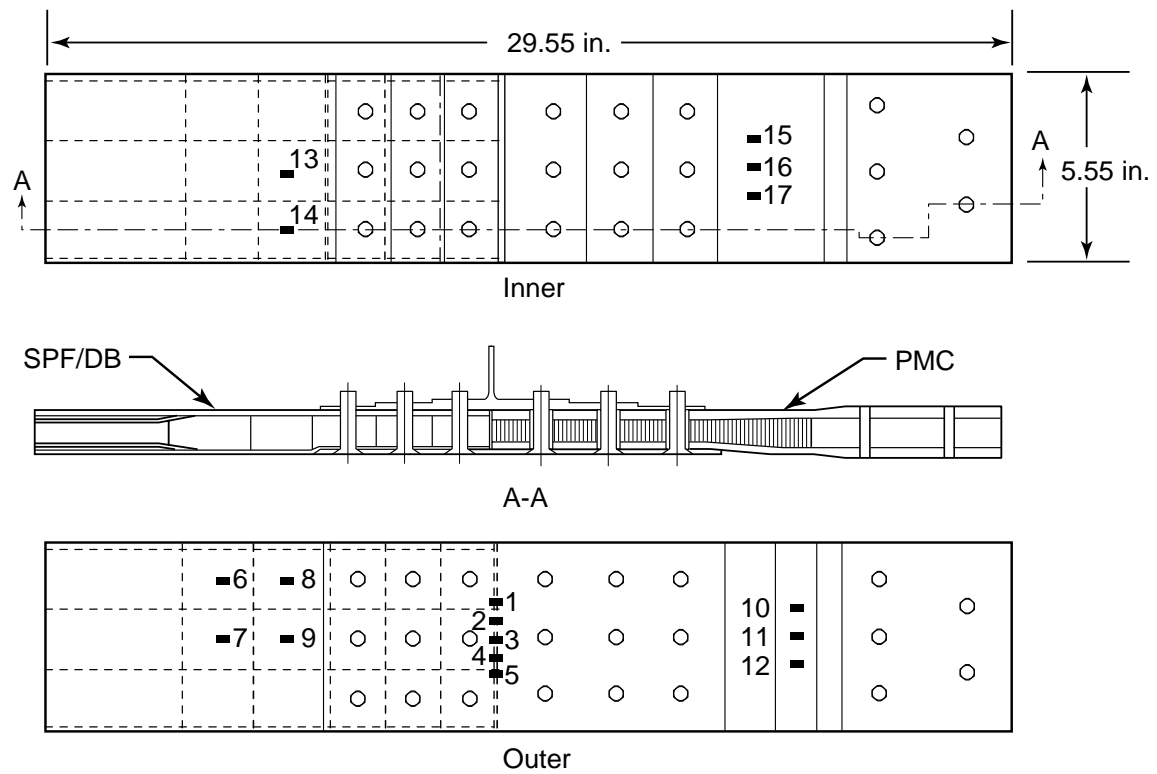
Figure 14. Schematic drawing of PMC to SPF/DB multi-row joint specimen including strain gauge locations.

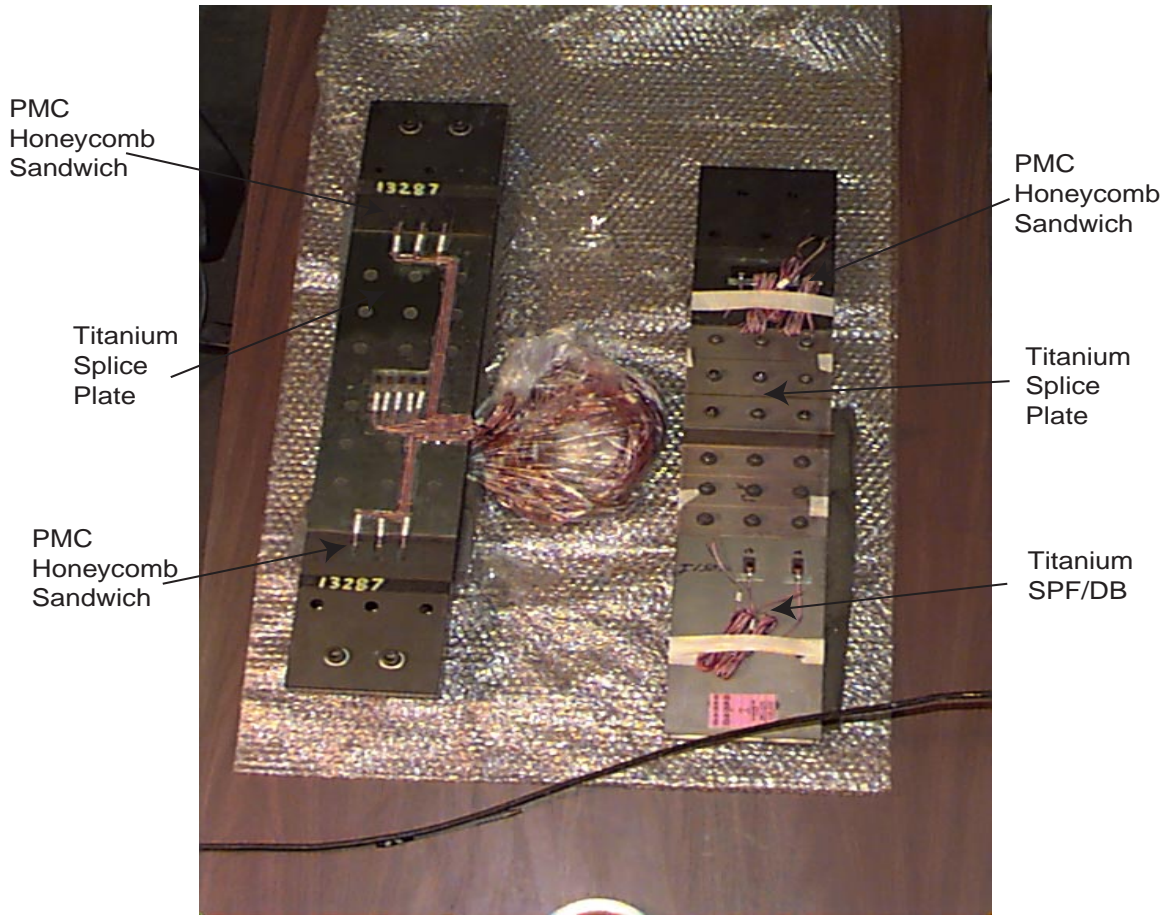
Figure 15. Multi-row joint test specimens.

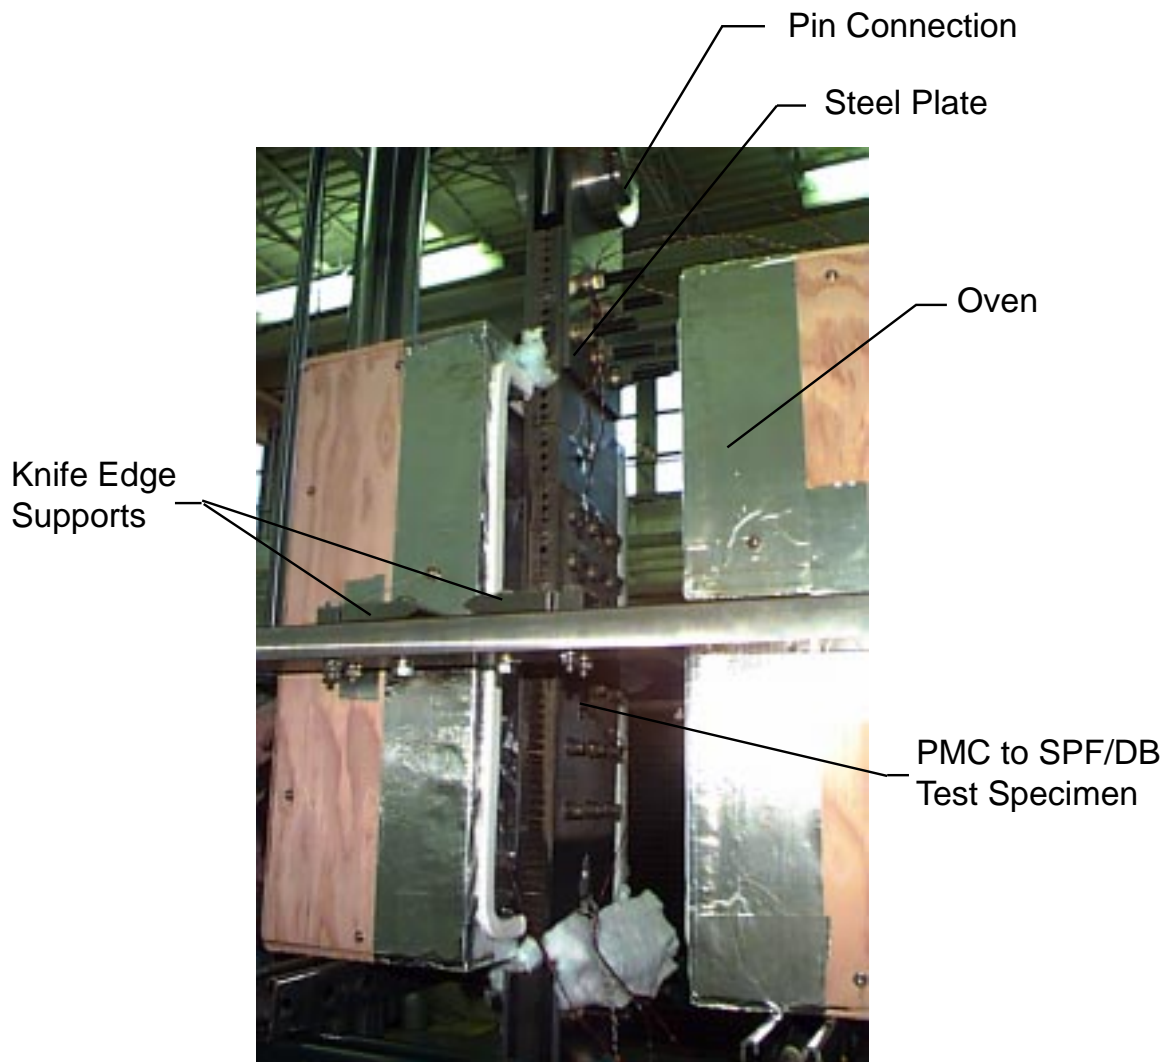
Figure 16. Multi-row joint static tension testing configuration.

All four static tension tests were conducted using the same fixtures for connecting the test specimen to the 220 kip test machine. A photograph of one of the PMC to SPF/DB specimens mounted in the test machine is shown in Figure 16. The specimen fixtures were designed and fabricated at NASA Langley Research Center. Two steel plates are attached on each end of the specimen by five steel 0.5 inch diameter bolts. The steel plates are also attached to the test fixture through a pin connection on each end as pointed out in Figure 16. Back-to-back horizontal knife edge supports are used to prevent out-of-plane displacement along the centerline of the test specimen while it is being loaded in tension. Without this constraint, there would be significant out-of-plane motion under tensile loads due to eccentricities in the specimen as was revealed by a finite element analysis of the test specimen.¹

For the elevated temperature tests, a Thermatron heater was used to blow hot air through a duct and into an oven that was built to enclose the specimen. The oven box along with a specimen mounted in the test fixture can be seen in Figure 16. The specimens were heated while the test machine maintained a preset load of approximately 100 lbs. Six back-to-back thermocouples were located on the specimen and monitored during heating until a nearly uniform temperature of 350°F was reached. Once acceptable temperatures were achieved, load was applied to the specimens at the displacement rate of 0.04 in./min. During the application of the load to the specimens, the temperatures ranged from 342°F to 352°F on the PMC to PMC joint specimen and from 344°F to 350°F on the SPF/DB to PMC joint specimen. The load-displacement diagram for the PMC to PMC specimen tested at 350°F is given in Figure 26. After an ultimate load of 110 kips was achieved, a 25% increase in the displacement was observed as the load slightly dropped. The specimen was then considered failed and the applied load was removed. Examination of the specimen after testing revealed a slight bending in the splice plates, apparently due to fastener bending. Removal of the splice plates showed significant bearing damage in the composite sandwich as can be viewed in Figure

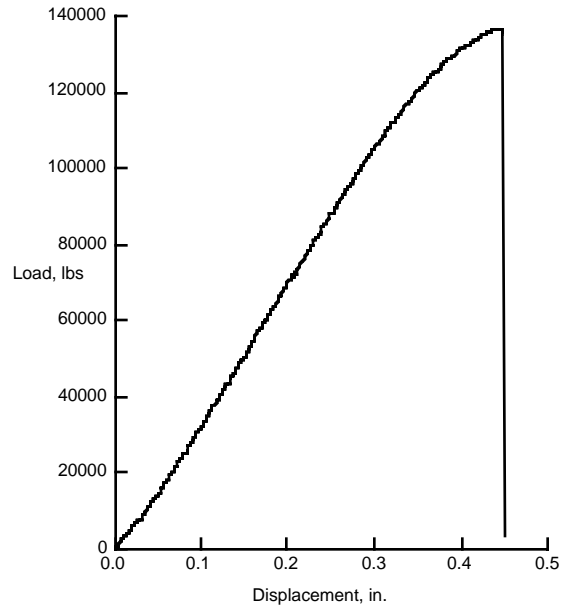
Figure 17. Load versus displacement of the PMC to PMC joint specimen tested at room temperature.

The room temperature tests were conducted with the test machine set on stroke control with an applied displacement rate of 0.04 in./min. The applied load and displacement were monitored during testing and testing continued until ultimate failure occurred, which is defined here as a 20% decrease in the applied load. The load-displacement graph for the PMC to PMC joint specimen tested at room temperature is shown in Figure 17. As can be observed in the figure, the load continued to increase until ultimate failure at 137 kips applied load. A gradual decrease in the slope near failure indicates plastic behavior prior to ultimate failure. Ultimate failure appeared to be a consequence of shearing

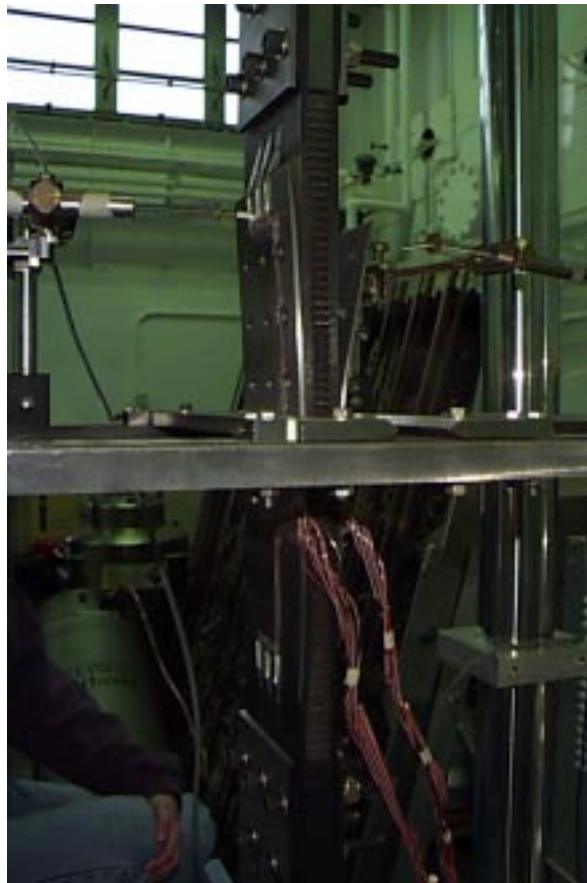
Figure 18. Failed PMC to PMC joint specimen tested at room temperature.

off of the fastener head. A photograph of the failed specimen is given in Figure 18. During loading, an audible “crack” was identified at 61 kips and splice plate bending induced by fastener bending became visible at 120 kips applied load. Examination of the failed specimen after removing the splice plates showed significant bearing damage in the composite sandwich. Back-to-back strains measured at the center of the specimen splice plates are shown in Figure 19. The back-to-back strain gauges SG17 and SG18 were at the center and SG13 and SG22 were closest to the edge as indicated in Figure 13. The maximum strain measured at failure was 14,174 $\mu\text{in./in.}$ at SG17 in the center. However, the strain measured at SG17 was suspiciously higher than the surrounding strain gauges, raising the issue that SG17 may be defective. The next largest strain next to SG17 was 8871 $\mu\text{in./in.}$ measured by SG15 where SG19 on the other side of SG17 measured 8823 $\mu\text{in./in.}$ Back-to-back strains measured on the composite are shown in Figure 20. The minimum strain measured was 4277 $\mu\text{in./in.}$ by SG6 on the composite. The load-displacement graph for the PMC to SPF/DB specimen tested at room temperature is shown in Figure 21 and a photograph of the failed specimen is shown in Figure 22. An ultimate load of 123 kips was observed and the ultimate failure appeared to be due to a tension failure of the inner splice plate along the outer row of fasteners. Bending of both splice plates was apparent in the failed specimen as can be observed in Figure 22. Examination of the failed specimen after removing the splice plates revealed no visible sign of bearing damage in the PMC to SPF/DB specimen. During loading, at 70 kips an audible “crack” was heard and as with the PMC to PMC specimen, outer splice plate bending was also observed at 92 kips applied load. Measured strains are plotted as a function of applied load in Figures 23-25. Figure 23 shows the measured strains on the center of the upper splice plate (SG3 was at the center and SG1 and SG5 were the outer most strain gauges as can be seen in the sketch in Figure 14). Figure 24 shows strains measured on the SPF/DB component and Figure 25 shows strains measured on the PMC sandwich component. At approximately 70 kips applied load, the load where the audible “crack” was heard, Figure 25 reveals an almost instantaneous drop in the strains on one PMC facesheet with a corresponding instantaneous increase in the strains on the opposing facesheet. The cause for this behavior is uncertain, but it could possibly be attributed to a very localized failure of the inner PMC facesheet which caused the outer facesheet to accept a localized instantaneous increase in load and consequently strain. As also revealed in Figure 25, the subsequent instantaneous strain increase in the inner facesheet at approximately 114 kips is also uncertain, but it may be due to another localized failure resulting in instantaneous redistribution of the load.

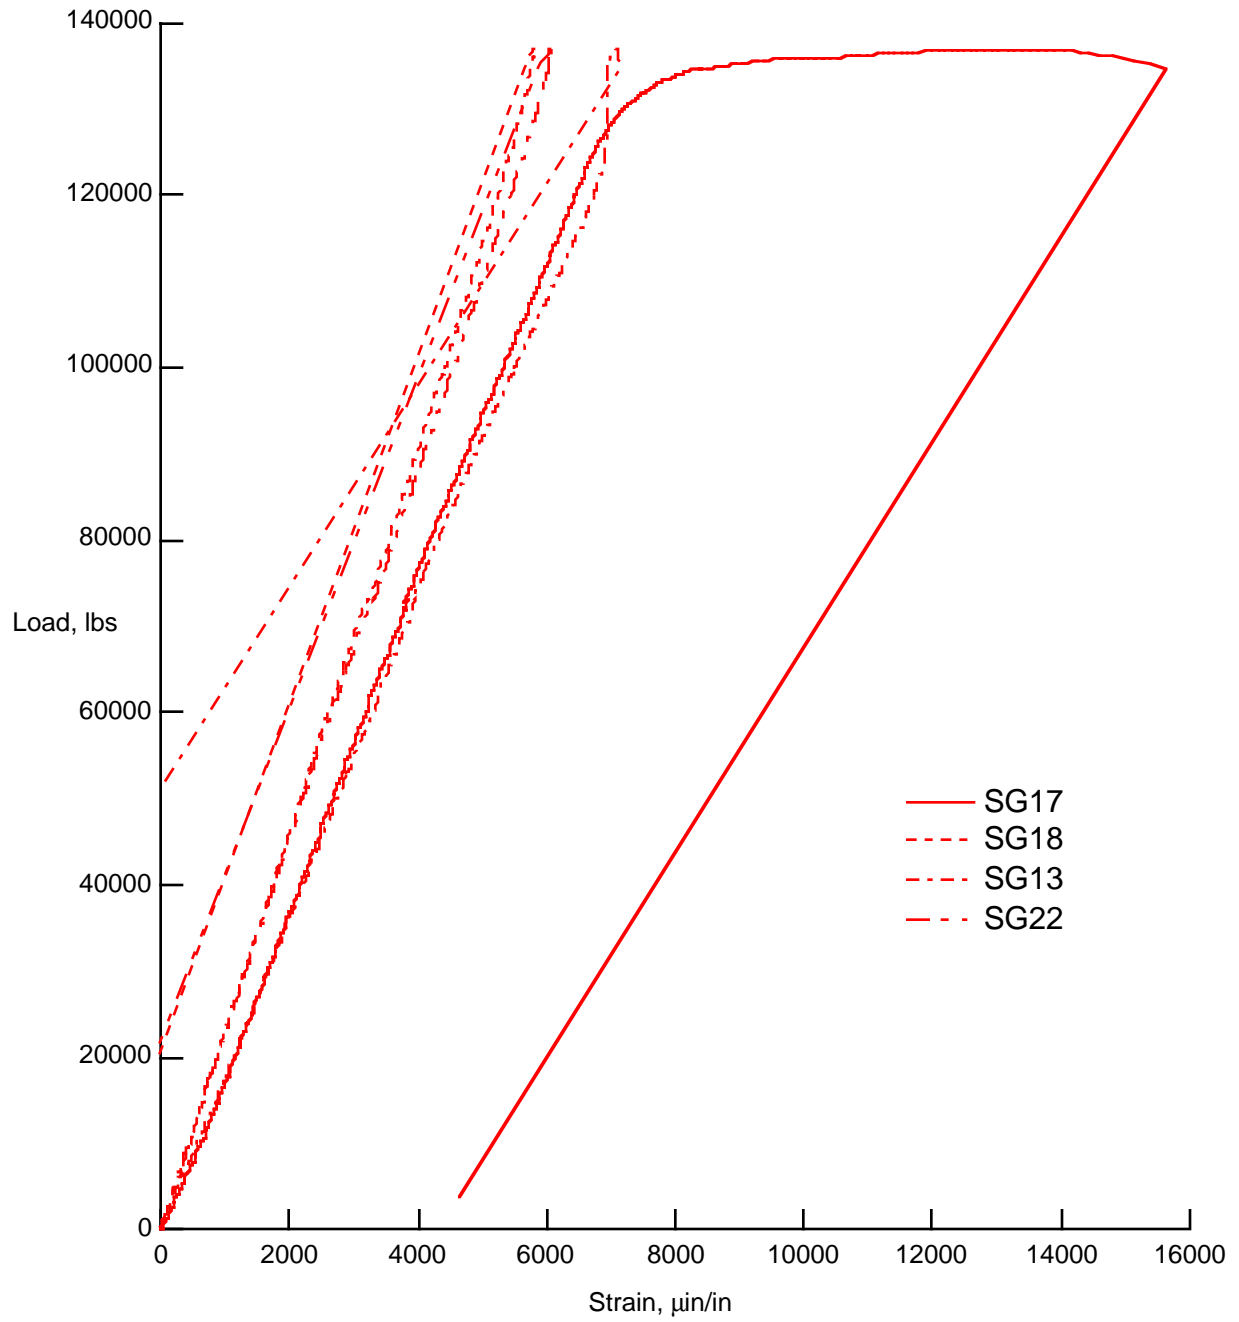
Figure 19. Strains measured at the center of the splice plate for the PMC to PMC joint specimen tested at room temperature.

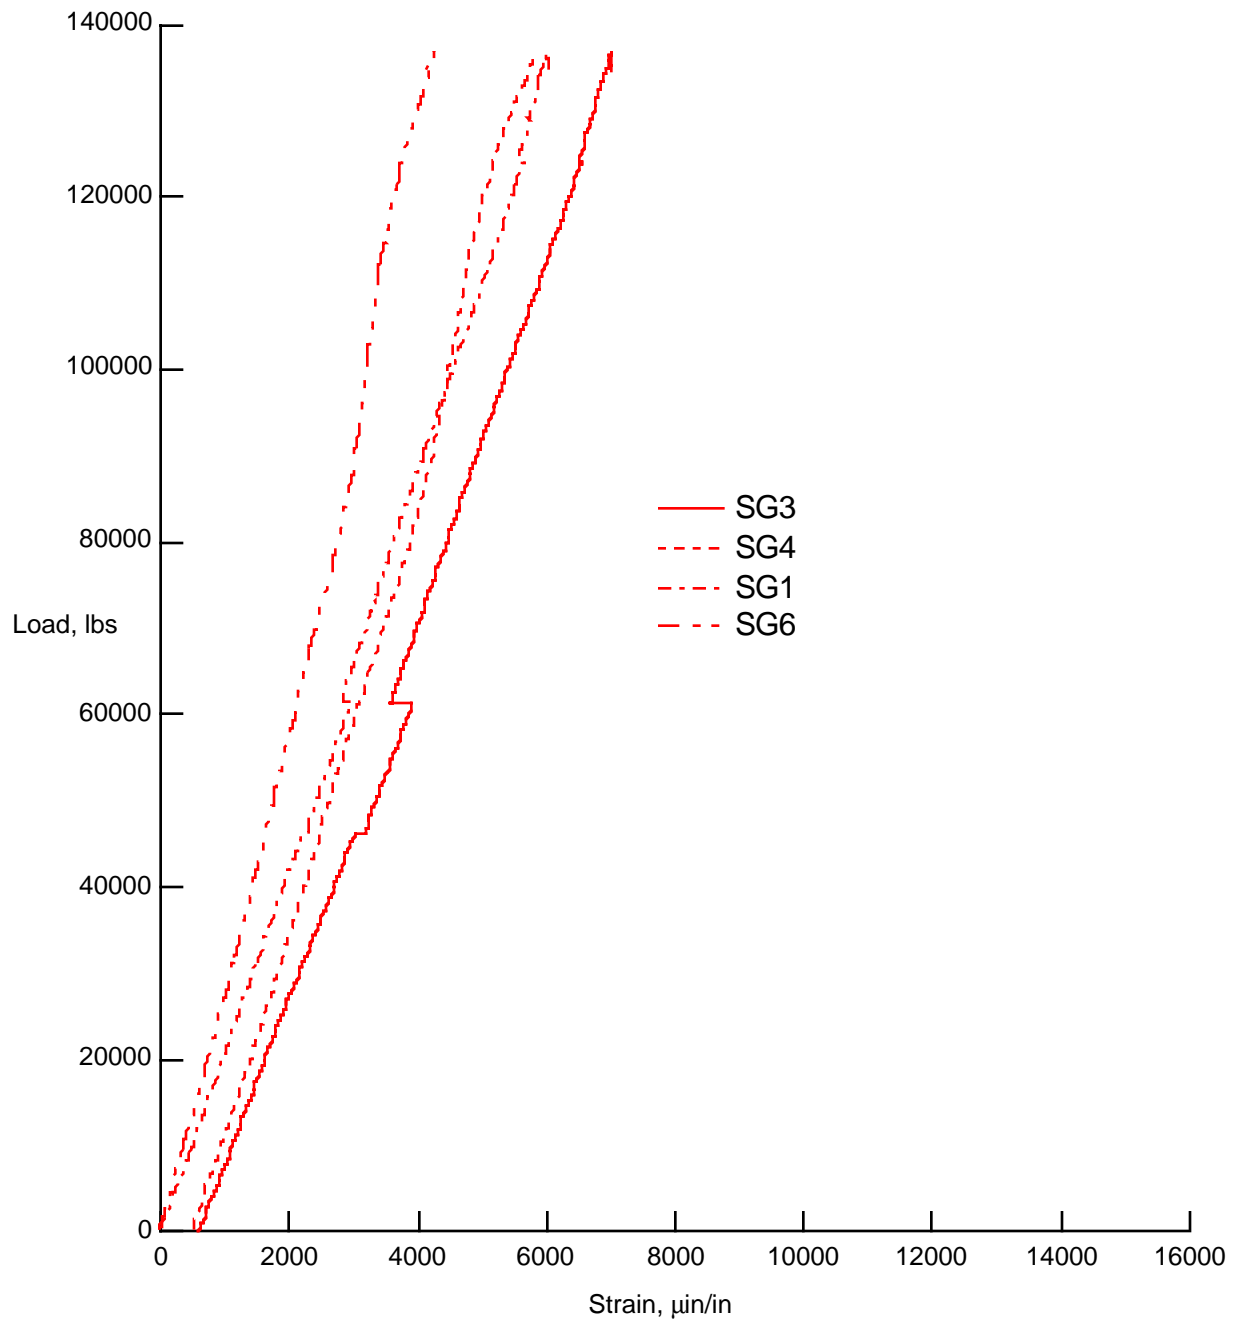
Figure 20. Strains measured on the composite sandwich for the PMC to PMC specimen tested at room temperature.

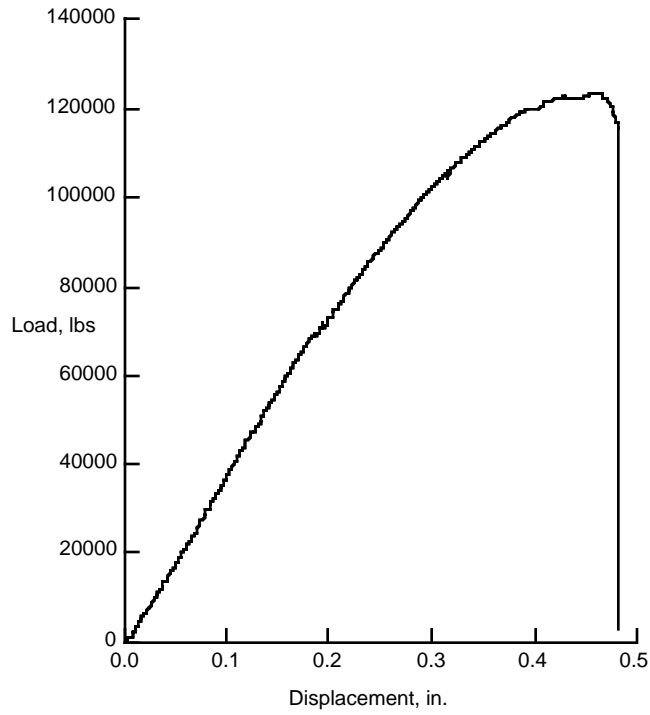
Figure 21. Load versus displacement for the PMC to SPF/DB joint specimen tested at room temperature.

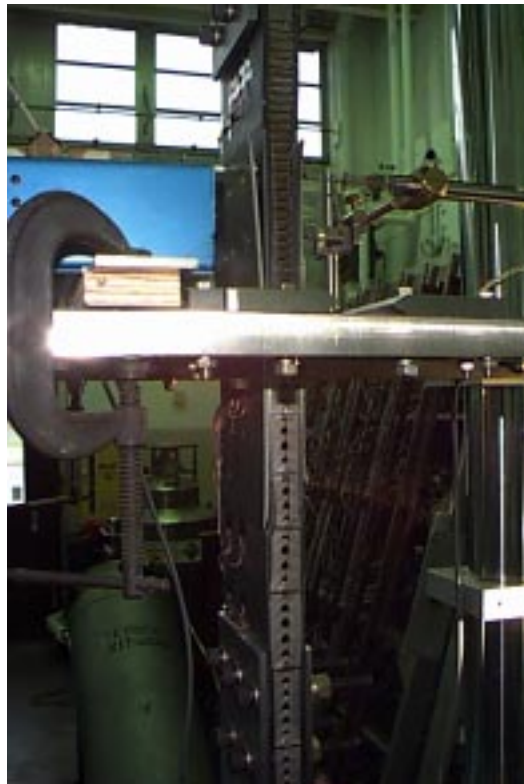
Figure 22. Failed PMC to SPF/DB specimen tested at room temperature.

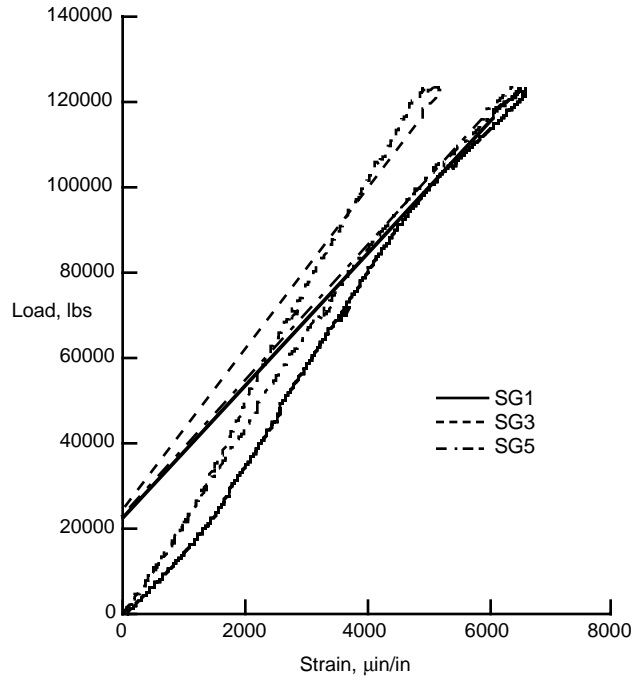
Figure 23. Strains measured at center of top splice plate for the PMC to SPF/DB joint specimen tested at room temperature.

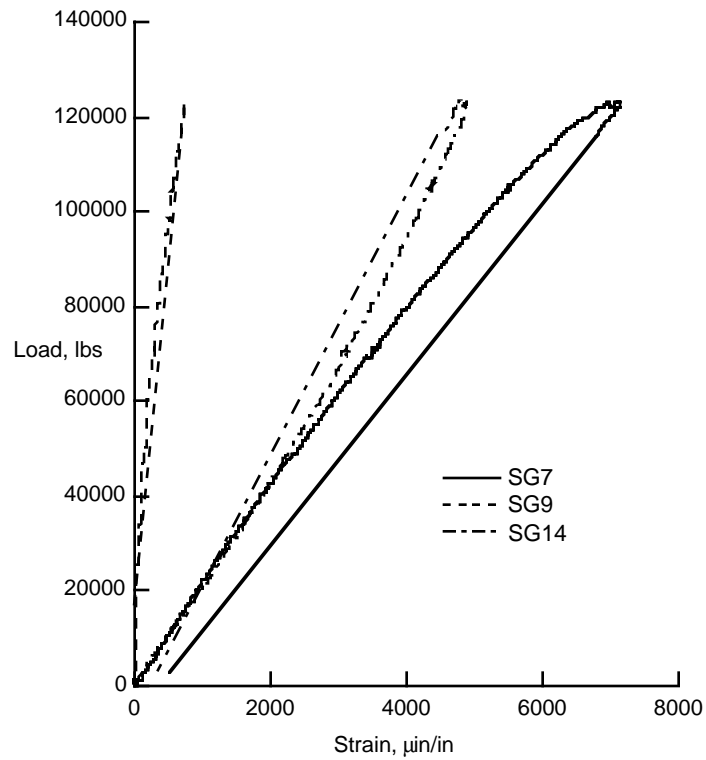
Figure 24. Strains measured on the SPF/DB component for the PMC to SPF/DB joint specimen tested at room temperature.

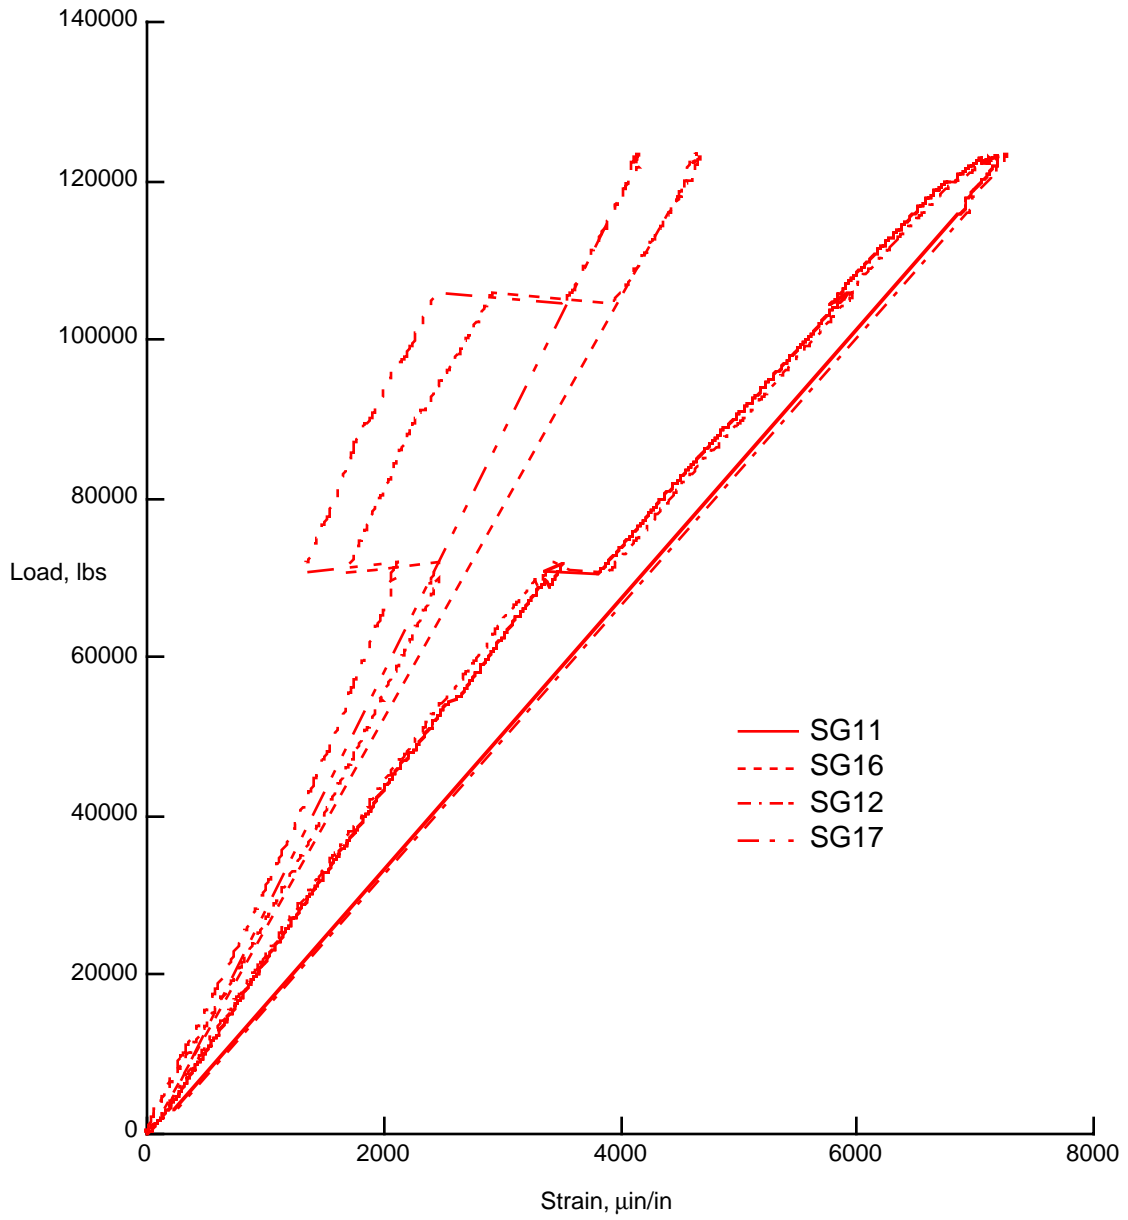
Figure 25. Strains measured on the PMC sandwich component for the PMC to SPF/DB joint specimen tested at room temperature.

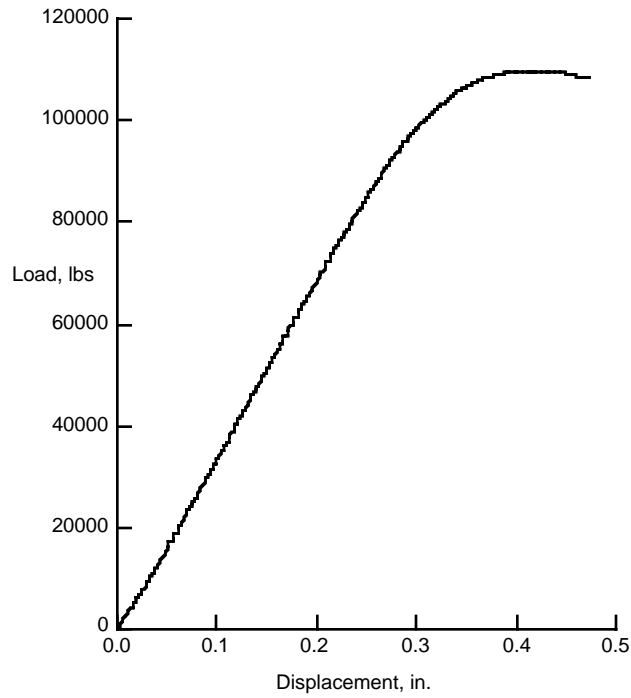
Figure 26. Load versus displacement for the PMC to PMC joint specimen tested at 350°F.
