NASA / TM-1998-208742

Room Temperature and Elevated Temperature Composite Sandwich Joint Testing

Testing of composite sandwich joint elements has been completed to verify the strength capacity of joints designed to carry specified running loads representative of a high speed civil transport wing. Static tension testing at both room and an elevated temperature of 350°F and fatigue testing at room temperature were conducted to determine strength capacity, fatigue life, and failure modes. Static tension test results yielded failure loads above the design loads for the room temperature tests, confirming the ability of the joint concepts tested to carry their design loads. However, strength reductions as large as 30% were observed at the elevated test temperature, where all failure loads were below the room temperature design loads for the specific joint designs tested. Fatigue testing resulted in lower than predicted fatigue lives.

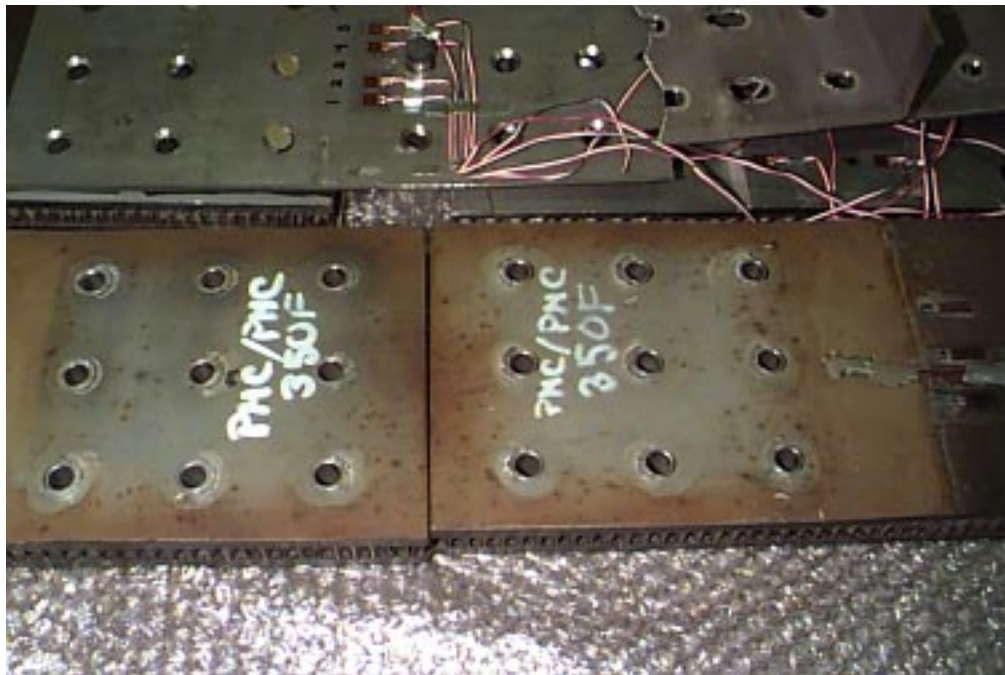
Figure 27. PMC to PMC joint specimen after testing at 350°F and having the splice plates removed for examination of the composite sandwich components.

For the elevated temperature tests, a Thermatron heater was used to blow hot air through a duct and into an oven that was built to enclose the specimen. The oven box along with a specimen mounted in the test fixture can be seen in Figure 16. The specimens were heated while the test machine maintained a preset load of approximately 100 lbs. Six back-to-back thermocouples were located on the specimen and monitored during heating until a nearly uniform temperature of 350°F was reached. Once acceptable temperatures were achieved, load was applied to the specimens at the displacement rate of 0.04 in./min. During the application of the load to the specimens, the temperatures ranged from 342°F to 352°F on the PMC to PMC joint specimen and from 344°F to 350°F on the SPF/DB to PMC joint specimen. The load-displacement diagram for the PMC to PMC specimen tested at 350°F is given in Figure 26. After an ultimate load of 110 kips was achieved, a 25% increase in the displacement was observed as the load slightly dropped. The specimen was then considered failed and the applied load was removed. Examination of the specimen after testing revealed a slight bending in the splice plates, apparently due to fastener bending. Removal of the splice plates showed significant bearing damage in the composite sandwich as can be viewed in Figure

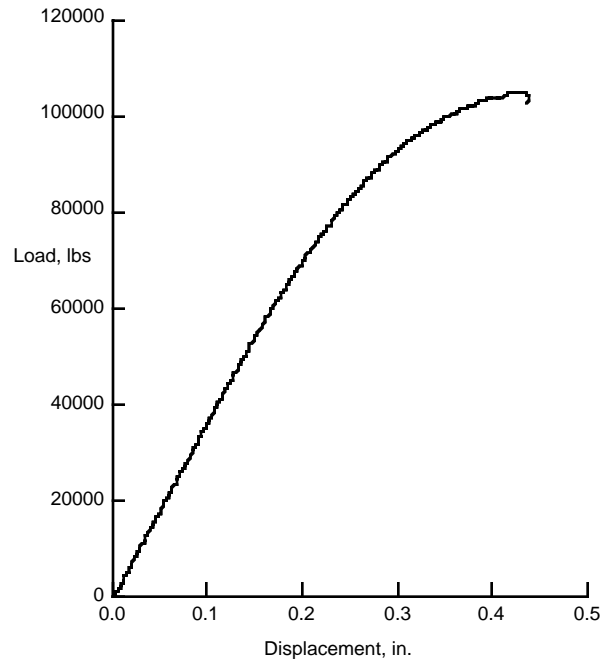
Figure 28. Load versus displacement for the PMC to SPF/DB joint specimen tested at 350°F.

27. The load-displacement diagram for the PMC to SPF/DB joint specimen tested at 350°F is given in Figure 28. An ultimate load of 105 kips was achieved before the inner splice plate experienced a tension failure at the outer row of fasteners as shown in Figure 29. The appearance of the failed specimen was very similar to the room temperature specimen which also experienced a tension failure of the inner splice plate. After removal of the splice plate, examination of the specimen tested at 350°F showed severe bearing damage in the composite sandwich.

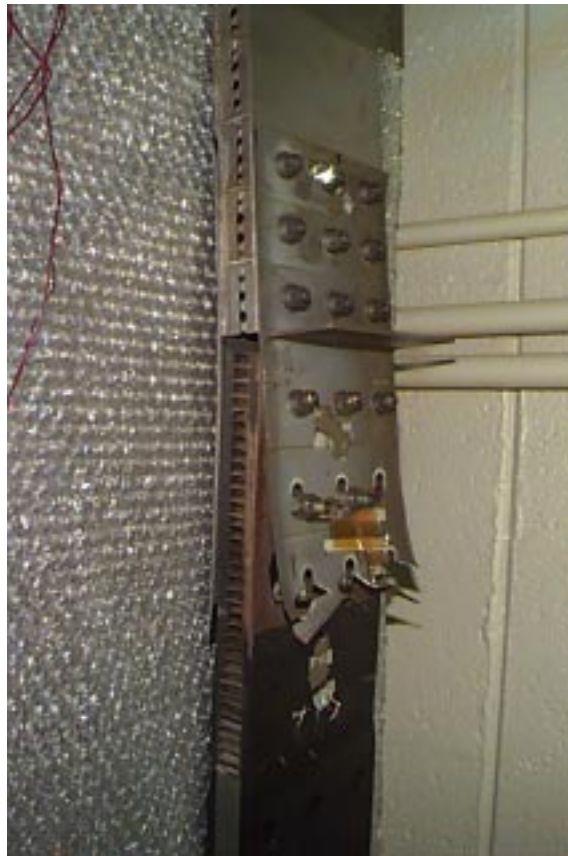
Figure 29. Failed PMC to SPF/DB joint specimen tested at 350°F.

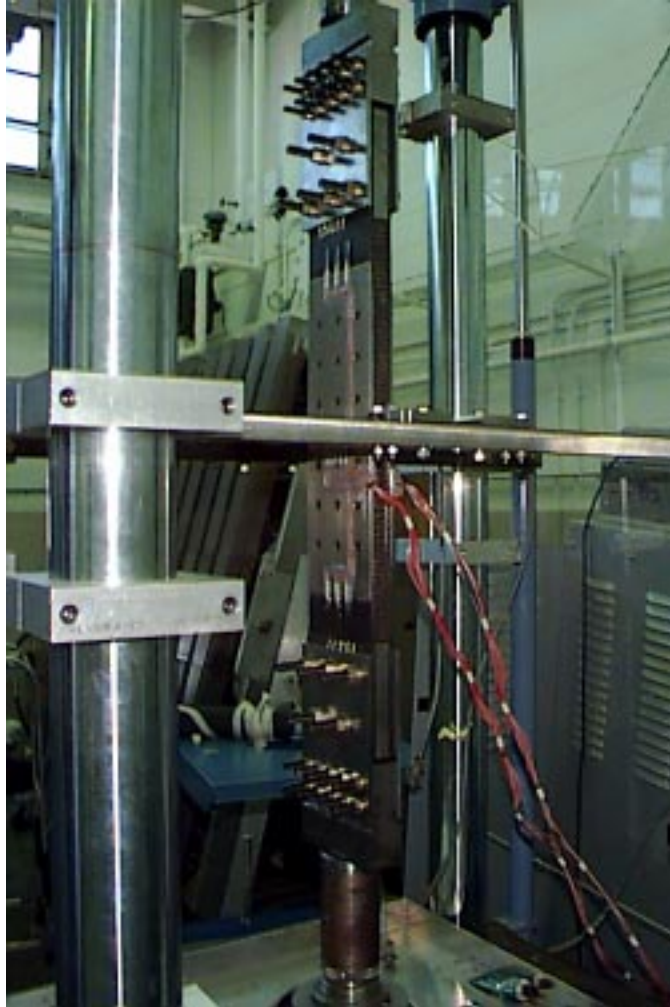
Figure 30. PMC to PMC joint specimen mounted in test machine for fatigue testing.

The fatigue tests were conducted in the same 220 kip test machine as the static tests. A photograph of the PMC to PMC joint specimen mounted in the test machine is shown in Figure 30. The fixture connecting the specimen to the test machine is shown in the figure. It consisted of back-to-back steel splice plates connected to another steel end fitting in a multifastener arrangement on each end of the specimen. This differs from the static test fixture where a pin connection was utilized. A 50 ft-lb torque was applied to each fastener used in the fixture to prevent slipping at the fixture connection.

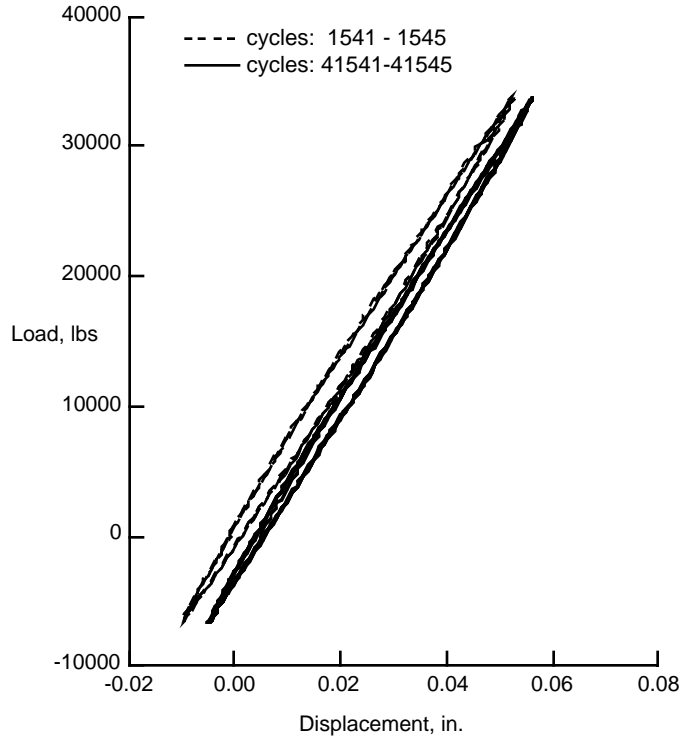
Figure 31. Load versus displacement test data for the PMC to PMC joint specimen tested under cyclic loading.

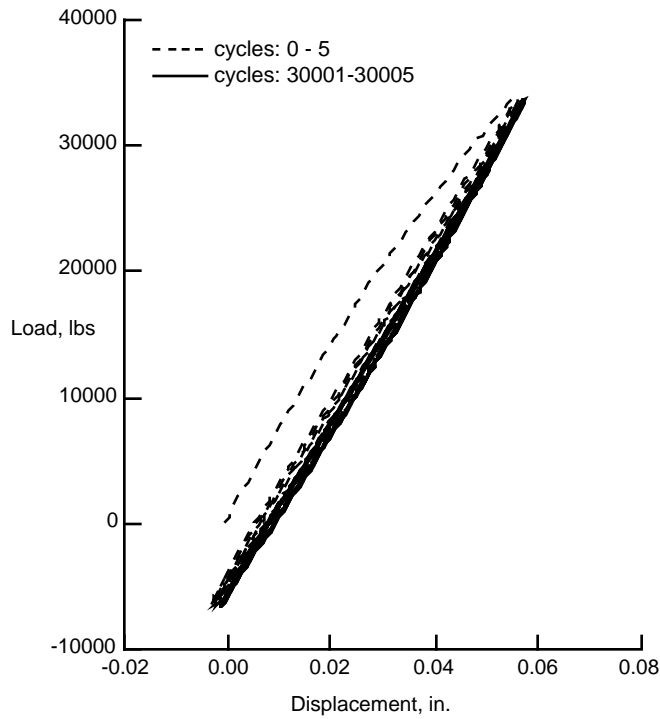
Figure 32. Load versus displacement test data for the PMC to SPF/DB joint specimen tested under cyclic loads.
