APPLICATION OF LASER BASED ULTRASOUND FOR NDE OF DAMAGE IN THICK STITCHED COMPOSITES

ABSTRACT

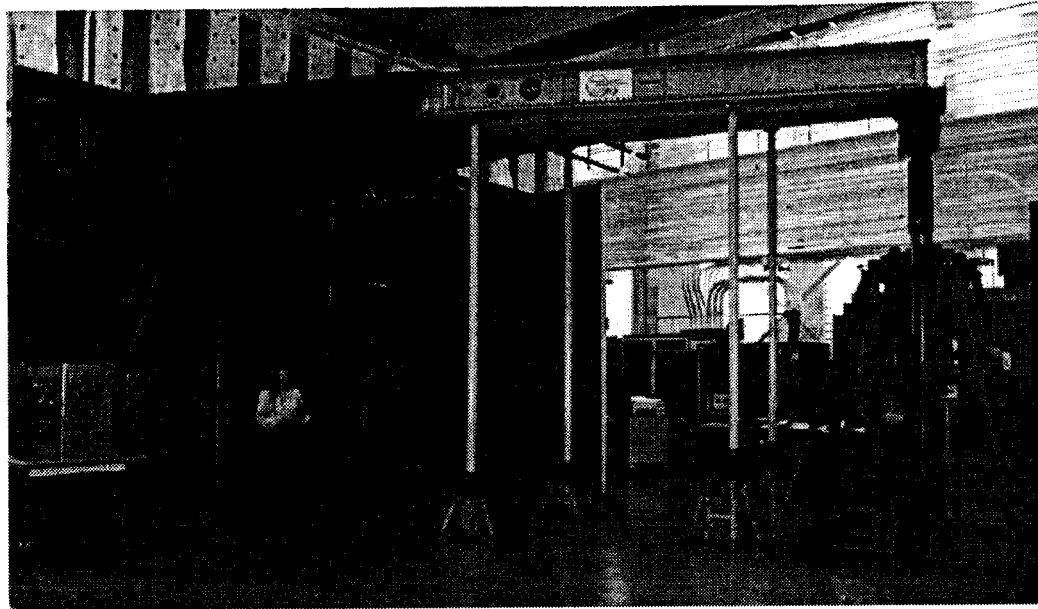
Specimens evaluated in this study were obtained from a composite wing stub box that had been structurally tested to failure. The stub box is shown in Figure 2, between the extension box and a transition box. The skin consists of ten stacks of [45/-45/0_2/90/0_2/-45/45] AS-4-3501-6 graphite epoxy material stitched together, resulting in a 0.58 inch total thickness. Stitched reinforcements of kevlar are in rows spaced 0.2 to 0.5 inches apart with stitch spacing approximately 0.1 inches.

Figure 2. The Composite Wing Stub Box (above the person in photograph) is located between a metal extension box (show center to right side of the photo) and a metal transition box attached to the wall. The metal boxes were used to form realistic loads in the Wing Stub Box.

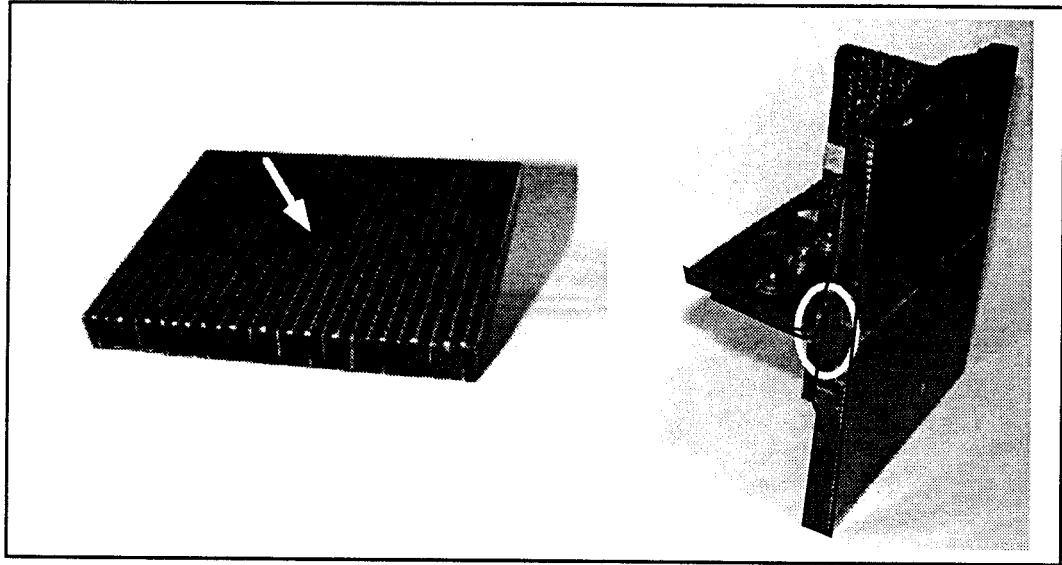
A flat plate specimen was impact damaged in a drop weight test machine to create internal delaminations. A one inch diameter impact head weighing 25.25 lb. was dropped from a height of 3 ft 11.5 inches to generate an impact energy of 100 ft-lb. This produced a dent approximately 1 mm in depth and small localized cracks on the back surface of the panel. A second specimen has bi-directional T-stiffeners attached to the skin with through-the-thickness stitches. Stiffeners are made of the same material as the skin. During wing box structural testing this joint failed in regions along the intercostal/skin interface. These samples (see Figure 3) show no damage from the top surface.

Figure 3. Thick Stitched Composite Samples, (left) Impacted Plate with dimensions 4.5" x 5.5" x 0.58" and (right) Bi-directional Skin/Stiffened Plate with interlaminar failure (circled in photograph) with dimensions 7.0" x 7.0" x 0.58".

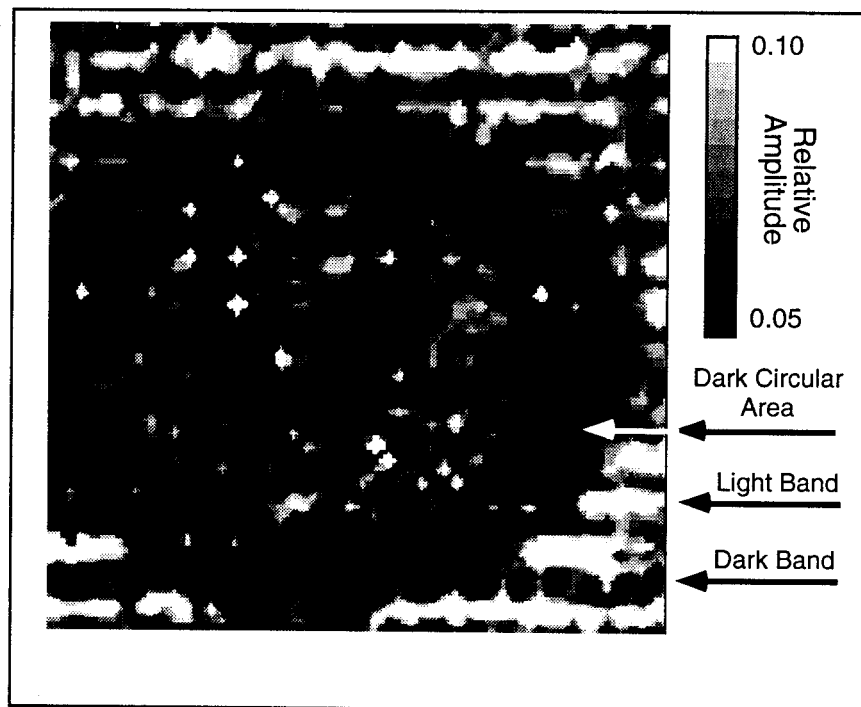
Through-the-thickness stitches in composites produce several effects on ultrasonic imaging. One is caused by increased interlaminar shear strength which moderates the damage and subsequent image. In conventional composites, impact damage image would present itself as an irregular shape about the impact site, preferentially oriented along ply directions in the lamina. In stitched composites, the impact site tends to be circular because through-the-thickness stitches increase interlaminar shear strength which slows and contains delamination progression. Secondly, these through the thickness stitches also perturb ultrasound transmission (Long, et al 1990) because the sound velocity is greater in the stitching than the surrounding material. These perturbations cause a phase-distorted wavefront at the material surface or point of ultrasonic detection and produce a reduced signal amplitude. Both these effects are visible in Figure 4, as a dark circular area and light and dark bands. This figure was generated by measuring the amplitude of the back surface ultrasonic echo. Spacing between the bands is approximately 0.2 inches and corresponds to stitch spacing in the sample. Representative A-scan signals from these areas are shown in Figure 5. A conventional ultrasonic signal with a back surface echo is shown in Figure 5a, which represents a signal from light band regions. The back wall echo occurs approximately 10 microseconds after the front wall signal. A representative signal from the dark band region, shown in Figure 5b, lacks a back surface echo and has reduced interior echoes. A signal from the dark circular area, shown in Figure 5c, also lacks a back surface echo but has large echoes

occurring during the first five microseconds from internal damage near the front surface. This circular region is approximately 2.25 inches in diameter and results from the one inch diameter impactor that created only a millimeter depth indentation on the sample surface. A third interesting feature in Figure 4 is seen at the center of the damage, where there is evidence that sound penetrates to the back wall at certain points in spite of the damage. The stitches may be partially responsible for the transmission of ultrasound within this area of impact. If the through-the-thickness stitches do not break during the impact, it is possible that they act as waveguides for the sound to travel to the back wall and back. While in other location in the damage area, sound travel to the back wall is blocked. Therefore, at these locations no phase cancellation occurs and some waveguided signals are detected. For comparison to the laser based ultrasonic scan of Figure 4, a water-tank C-scan was performed on the same impact sample and is shown in Figure 6. This water-tank, peak detected scan, was generated using a 5 MHz, 0.5 inch diameter transducer. Stitching and damage as mentioned above are clearly visible and comparable to the laser ultrasonic scan. However, The water-tank scan is smoother in appearance, possibly due to a coarser resolution of the transducer compared to that of the one tenth inch diameter laser detection beam. This may also explain why the laser scan shows some signal detection in the center of the damage area while the water-tank scan does not.

Figure 4. Peak detected back wall C-scan contour plot of impact damaged plate. Scan area is 2.5" by 2.5" and the scan spatial resolution is 0.05". The dark circular area is approximately 2.25" in diameter and horizontal lines correspond to stitching rows.

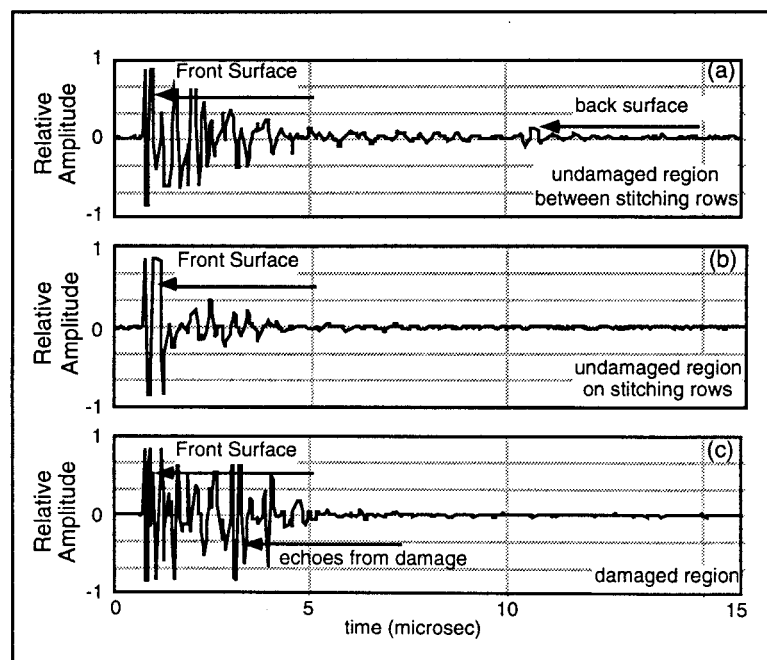
Figure 5. Representative A-scan signals from damaged and undamaged regions of impacted plate (a) form light band, (b) from dark band, and (c) from dark circular area.

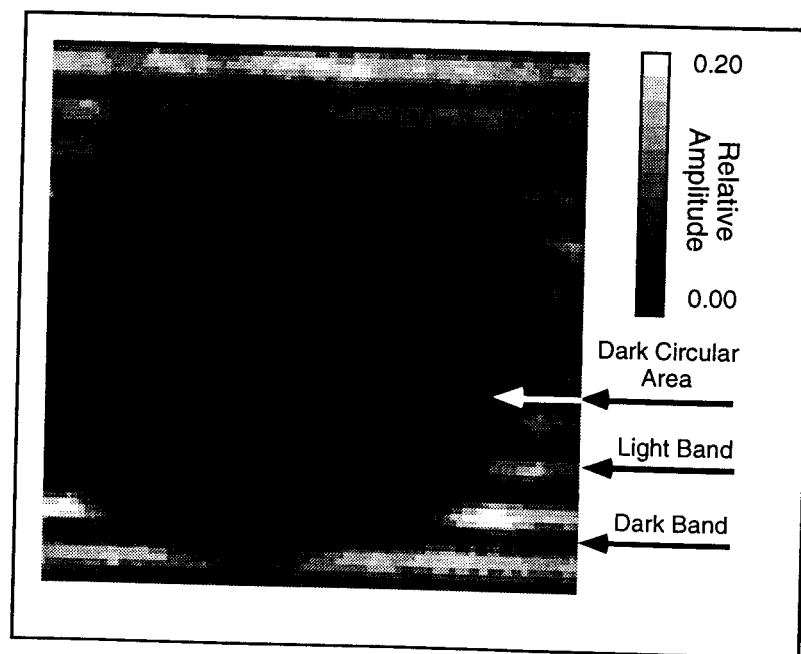
Figure 6. Water tank C-scan of impacted plate for comparison to Laser Based Ultrasound C-scan shown in Figure 4.

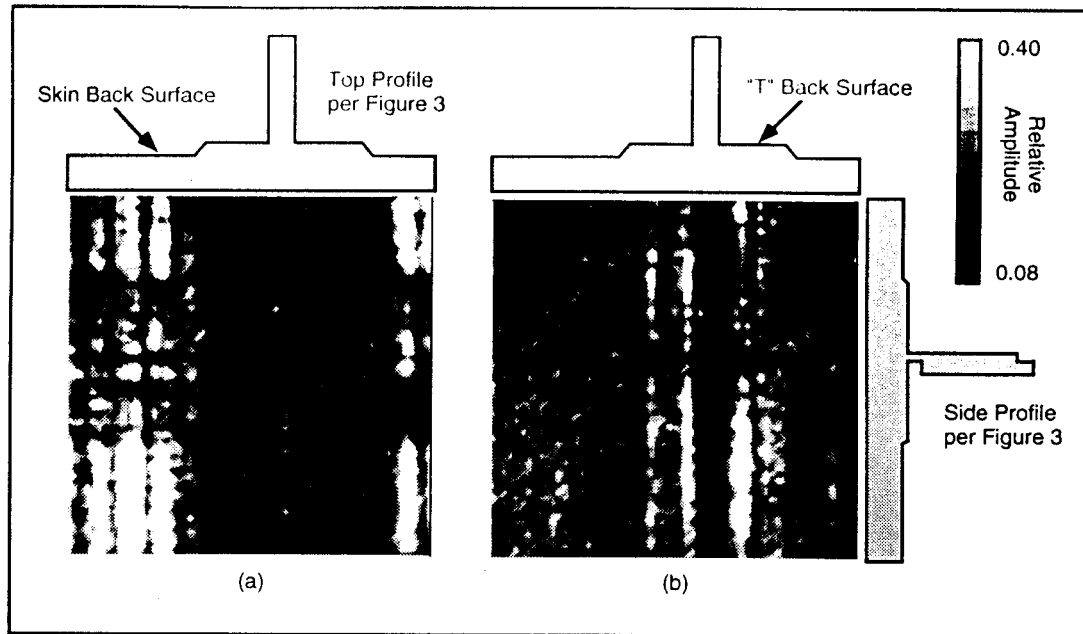
transducer and scan area was 7.0 inches by 7.0 inches, slightly larger than the laser ultrasonic scan. These scans in Figure 8, both show the horizontal and vertical stitching as well as the vertical web stiffener. However, the horizontal web stiffener is not well defined, as in the laser scan of Figure 7b, possibly due to signal interference with horizontal stitches. As in the previous peak detected scans of this stiffened sample, underlying structure can be identified but substantial evidence of damage can not.

Figure 7. Peak detected back wall C-scan contour plots of bi-directional skin/stiffened sample with; (a) gate over skin back surface and (b) gate over thicker "T" back surface.

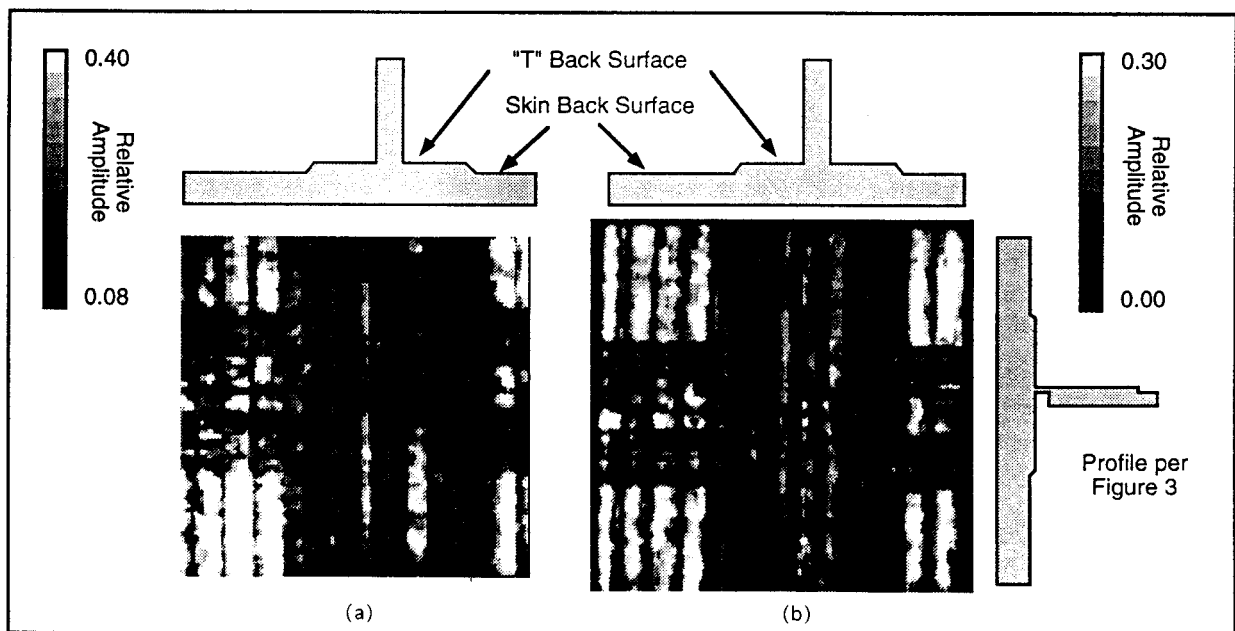
Figure 8. Peak detected C-scan comparison, (a) laser ultrasonic scan and (b) water-tank scan.

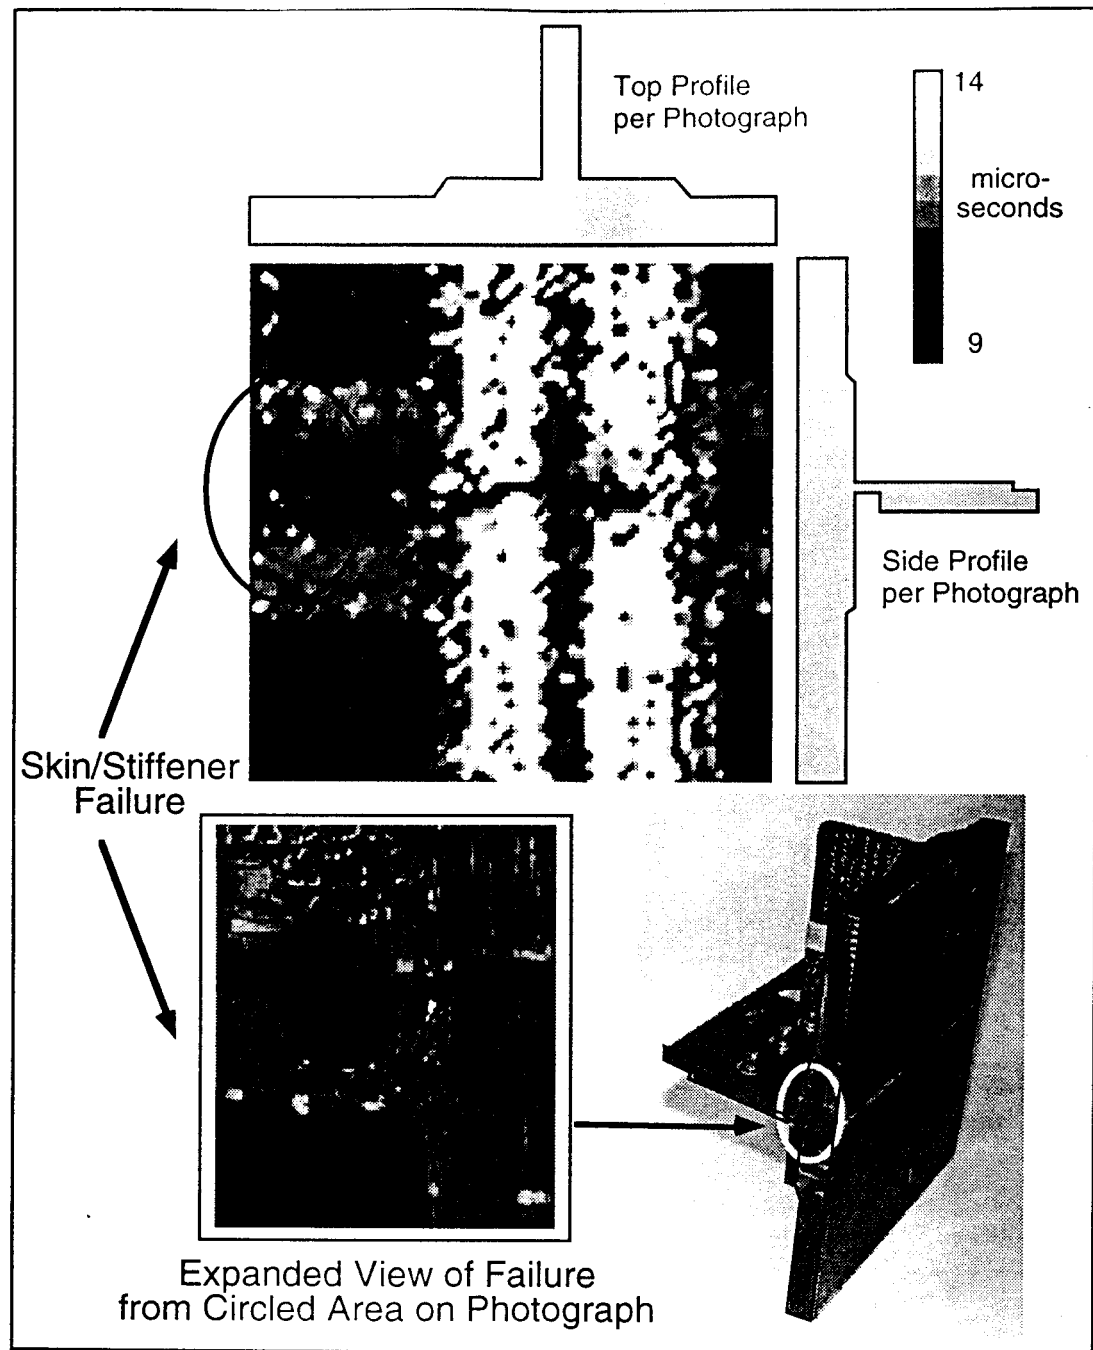
To highlight internal damage, a third image was created by plotting the location in time of the back wall echo instead of the amplitude. Damage would be highlighted if the echo occurred earlier than anticipated. The result in Figure 7, shows evidence of damage located above the horizontal stiffener region, on the left and right sides. The circled region on the scan corresponds to the left side of the sample and is circled and outlined in the picture. This delamination occurs about the same depth as the thinnest back wall section. Thus the time-of-flight to the delamination is similar to the time-of-flight to the back wall of the skin, seen in the four corners of the scan. If the sample was undamaged, these regions would be shaded gray instead of black. In an intact wing structure, this stiffener flaw would be internal to the structure and could be over looked if visual examination of back and side surfaces were not possible.

Figure 9. Time-of-Flight C-scan contour plot of bi-directional skin/stiffened sample showing skin/stiffener failure areas.
