STRUCTURAL RESPONSE AND FAILURE OF A FULL-SCALE STITCHED GRAPHITE-EPOXY WING

Dawn C. Jegley and Harold G. Bush
NASA Langley Research Center
Hampton, VA

Presented at the AIAA/ASME/ASCE/AHS 42nd Structures,
Structural Dynamics and Materials Conference

AIAA Paper No. 2001-1334-CP
Seattle, WA

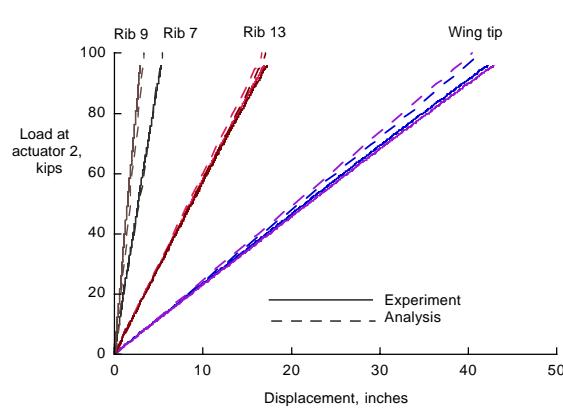
Fig. 7. Displacements at six outboard load introduction points.

Analytical and experimental displacements at the six most outboard actuator locations are shown in figure 7. Solid lines represent the measured displacements and dashed lines represent predicted displacements. Measured displacements are the elongation of the actuator rather than a measurement perpendicular to the floor. Since the initial position of all actuators active in the 2.5G condition is vertical, the difference between the displacement perpendicular to the floor and the stroke of the actuator is dependent upon the rotation of the actuator during loading. The largest displacement (and largest rotation) is for actuator 2 at the wing tip. The measured deflection is 40 inches and the initial position of the intersection of the actuator assembly and the test article is 168 inches above the floor. The angle between the initial vertical position of the actuator and the final tilted position can be calculated to be less than 2 degrees, resulting in a negligible difference between vertical displacement and stroke⁷.

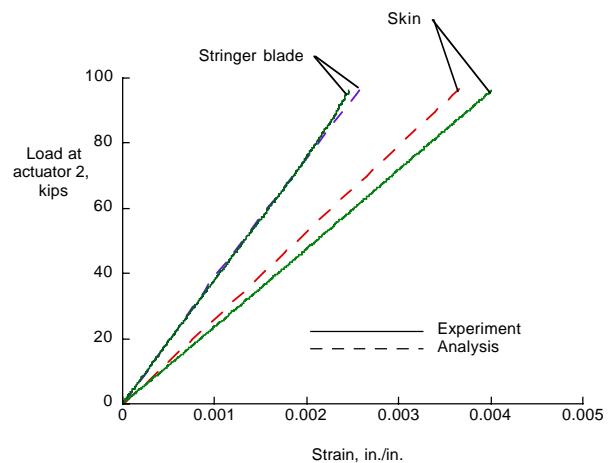
Fig. 9. Strain in stringer blade and skin at stringer 4 in the lower cover panel between ribs 12 and 13.

Strains in the lower cover panel at stringer 4 between ribs 12 and 13 and at stringer 7 between ribs 7 and 8 are shown in figures 9 and 10, respectively. Excellent correlation between experiment and analysis is seen in the skin between ribs 7 and 8 and in the stringer between ribs 12 and 13 until immediately prior to failure. The repair, which was not modeled in the analysis, is located between ribs 8 and 9 and may have some influence on these blade strains. Strains remain linear until immediately prior to failure. Strains in the lower cover runout of stringer 2 at rib 10 are shown in figure 11. Analytical strains at this runout agree well with experimental data.

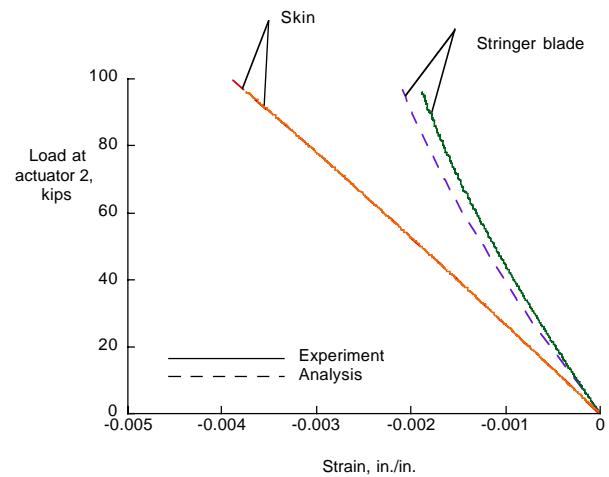
Fig. 14. Strain in stringer blade and skin at stringer 2 in the upper cover panel between ribs 8 and 9.

Strains in the upper cover panel at stringer 6 between ribs 12 and 13, at stringer 6 between ribs 9 and 10, at stringer 2 between ribs 8 and 9, and at stringer 8 between ribs 8 and 9 are shown in figures 12, 13, 14, and 15, respectively. For most of the cases, the agreement between analytical and experimental results is good. Excellent correlation between experiment and analysis is seen in the skin inboard from rib 12 and in the stringer outboard from rib 12 until immediately prior to failure. The repair, which was not modeled, is located between ribs 10 and 11 and may have some influence on experimental strain data. Strains do not remain linear in the upper cover panel. The maximum strains in any upper cover runout location are in the runout region at the rear spar at rib 9. Strains at this stringer runout 10.5 inches inboard from rib 9 are shown in figure 14. The blade is tapered in height as well as thickness at this location.
