**BEHAVIOR OF COMPRESSION-LOADED COMPOSITE PANELS  
WITH STRINGER TERMINATIONS AND IMPACT DAMAGE**

Dawn C. Jegley  
NASA Langley Research Center  
Hampton, VA

AIAA Paper No. 98-1785-CP  
Long Beach, California

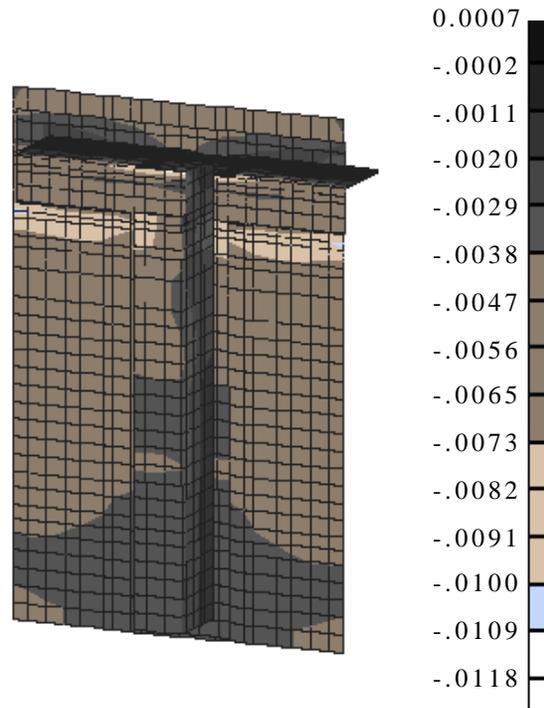
Figure 9. Axial surface strain for a load of 100,000 lb for panel U-1.

Analytically determined axial surface strains for a load of 100,000 lb are shown in figure 9. The maximum compressive axial surface strain occurs in the intercostal flange near the intercostal, but the maximum axial strain at the laminate midplane occurs in the stringer flange near the intercostal. Based on an allowable axial strain value at the laminate midplane for undamaged structure of .0093 in/in., failure should not occur due to axial strain for a load less than 108,500 lb. Lateral strains were small enough to have little effect on failure. However, the shear strain in the intercostal flange is predicted to exceed the shear strain allowable of .0126 in/in. for loads greater than 91,200 lb. Shear strain in the intercostal flange causes or contributes to failure of the panel since the panel failed at 98,200 lb.

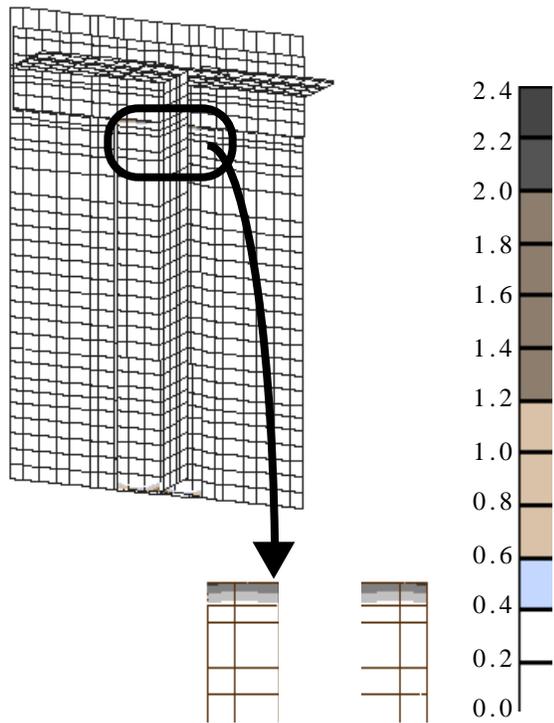
Figure 10. Normalized interlaminar stresses at skin-to-stringer flange interface for a load of 100,000 lb for panel U-1.

The maximum interlaminar stress in the stringer flange occurs at the end of the flange where it terminates at the intercostal flange. At this location the interlaminar failure parameter is approximately equal to 2.0 for a load of 100,000 lb. The maximum axial strain, shear strain and interlaminar shear strain occur in close proximity, and failure could result from a combination of strains.

Test results indicate that failure initiates at the interface between the skin and stringer flange. The separation of the stringer flange from the skin occurs immediately beneath the blade of the stringer. The analytical prediction of the location of failure agrees with the experimental results. The panel failed at 98,200 lb of load.

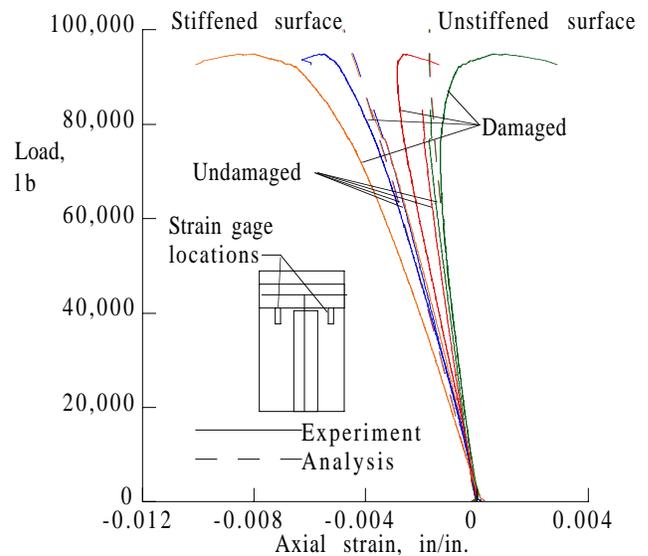
Figure 12. Axial strains near the intercostal flange in panel U-2.

After being subjected to impact damage, the panel was loaded to failure. The impact damage had little effect on the far-field behavior or on the global behavior of the panel. The local effect of the impact damage can be seen in figure 12, in which results are shown for strain gages within one inch of the impact sites. Surface damage closer than one inch from the impact site was too severe to allow strain measurements.

The allowable midplane strain for damaged structure is .0053 in/in. The analysis predicts a strain at the impact site of .0053 in/in. for a load of 147,000 lb. Failure through the impact site would not be expected for loads less than 147,000 lb. Since the failure load is significantly less than 147,000 lb, the midplane strain at the impact site cannot be used to predict failure of this panel.

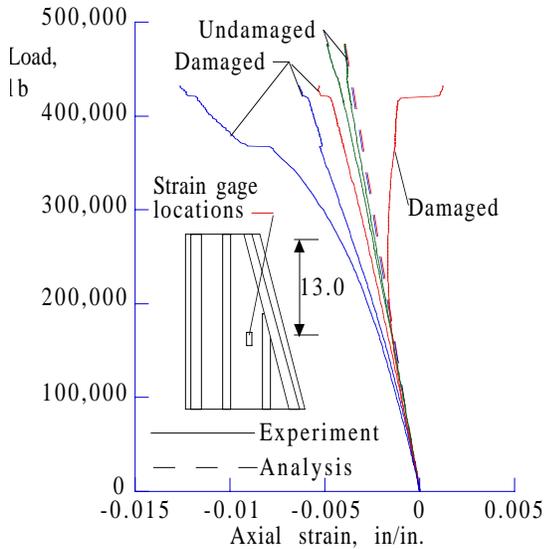
Figure 14. Axial strains in the skin at the impact site of panel L-1.

assume an indentation depth of approximately 0.1 inches. Damage to the panel is significantly more severe than appropriate for either of these methods. However, the predicted strain at the impact site exceeds the allowable axial strain for damaged structure with loads greater than 650,000 lb. By using the method described in reference 4, panel L-1 would be expected to fail at a load of 640,000 lb. The two methods produce similar results since there is little bending behavior near the impact site.

Panel L-1 failed through the impact site and the point of maximum strain in an undamaged skin with a load of 435,000 lb, and with damage 1.6 times as severe as required by the criterion. The panel failed with a stress at the impact site of 35.2 ksi, which is approximately 89 percent of the design stress. An undamaged panel would have had a strain of approximately .0037 in/in. at the impact site for the load at which the damaged panel failed. The maximum midplane strain (based on the measured surface strains) near the impact site was equal to .0052 in/in. The predicted maximum strain in the panel away from the impact site is equal to .0043 in/in., which is significantly less than the allowable strain in undamaged structure. These results indicate that failure was caused by the strain in the region of the impact site. A photograph of panel L-1 after failure is shown in figure 15.

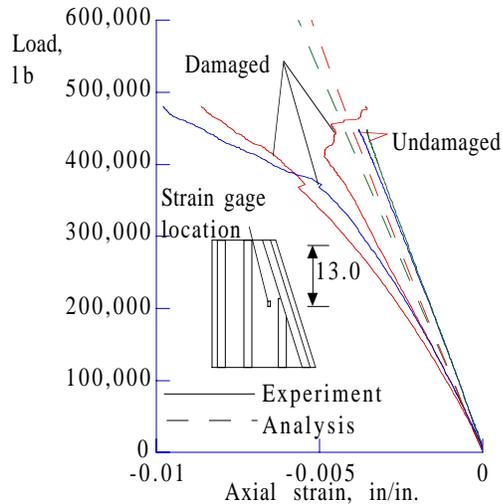
Figure 17. Axial surface strains in the skin at the impact site of panel L-2.

The panel was subjected to impact damage resulting in an indentation with a depth of 0.11 inches. The allowable strain of .0053 in/in. at the impact site is exceeded for loads greater than 580,000 lb. Applying the method of reference 4 results in a predicted failure load of 570,000 lb. The panel failed through the impact site for a load that is approximately 85 percent of that predicted by analysis. The panel failed with a stress at the impact site of 44.6 ksi, which is 113 percent of the design stress.

Test data indicate that the load at which the maximum midplane strain (based on the surface strain gages) near the impact site reached .0053 in/in. was 397,000 lb. The panel failed at a load of 484,000 lb. The maximum midplane strain in the region of the impact site was .0062 in/in., which is 1.16 times the allowable strain value. The predicted maximum strain in the panel away from the impact site is .0058 in/in., which is significantly less than the allowable strain value in undamaged structure, so failure was caused by the strain in the region of the impact.

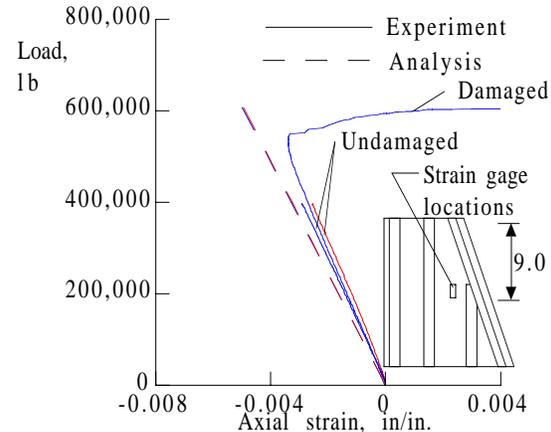
Figure 18. Axial surface strains in the skin at the impact site of panel L-3.

skin next to the tapered stiffener, but on the unstiffened side of the panel. Axial strains predicted by finite element analysis and measured during the preliminary and final loading are shown in figure 18 for strains at the impact site. Impact damage has little effect on strain at the impact site or far from the impact site. The relatively mild impact of 100 ft-lb did not disable the strain gage on the stiffened side of the panel at the impact site. Analysis accurately predicts the far field strains and strains at the impact site.

Analytically, a damage allowable strain value of .0053 in/in. at the reference surface of the skin at the impact site corresponds to a load of 648,000 lb. Applying the method described in reference 4 results in a predicted failure of 640,000 lb. The actual failure occurred through the impact site at 611,000 lb. Damage to the resin layer on the surface prevented strain from being measured at the impact site. The reference surface strain near the impact site was approximately .005 in/in. The panel failed at a strain that is slightly less than the allowable strain at the impact site. Failure prediction based on the damage allowable strain value and the analysis indicates that the panel failed at 95 percent of the prediction based on the method of reference 4 for impact damaged structure. However, that prediction is based on the assumption of a 0.1-inch-deep dent, rather than a dent depth of less than .01 inches that was applied to panel L-3. The predicted maximum strain in the panel away from the impact site is equal to .0067 in/in., which is significantly less than the allowable strain value in undamaged structure, so failure was caused by the strain in the region of the impact. The panel failed with a stress of 50.0 ksi at the impact site, which is 115 percent of the design stress.
