DETECTION OF INTERGRANULAR CORROSION IN COLD PLATE FACE SHEETS

William P. Winfree, Stephen W. Smith, Robert S. Piascik, Patricia A. Howell
NASA Langley Research Center,
Hampton, VA

Abstract

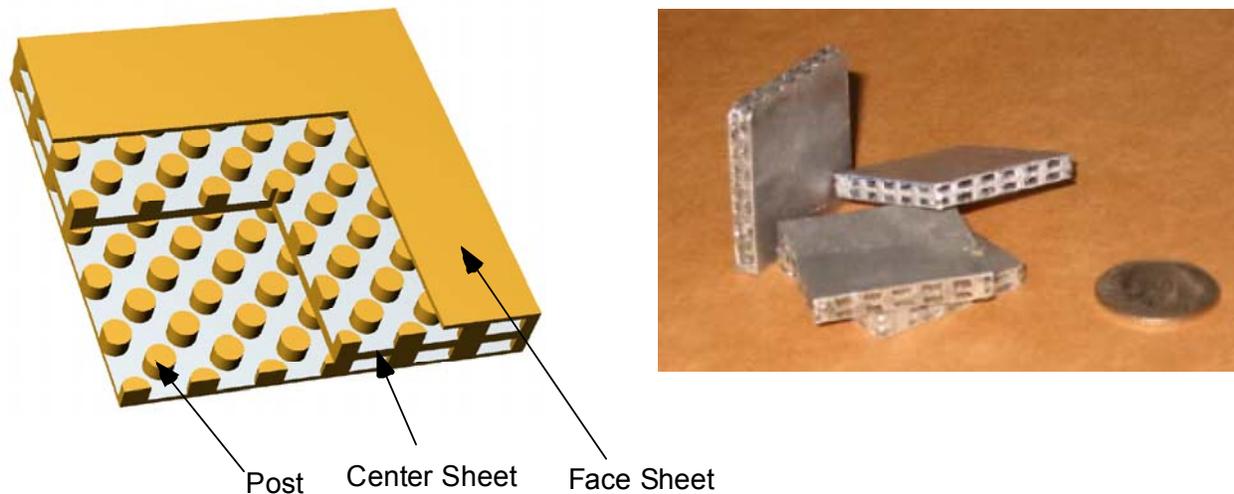
Figure 1. Diagram of typical portion of the specimen and photograph of several of the specimens with induced corrosion.

A diagram showing a typical region of the cold plates is shown in Figure 1. The largest area of the cold plates consists of three separate sheets separated by posts. The cooling fluid flows around the post and is contained between the two face sheets. The cold plates are fabricated from aluminum (AA6061). During fabrication, a 1000°F brazing process was used to bond the face sheet to the posts of the cold plates. Following the brazing, the cold plate components are slowly cooled to avoid distortion of the bonded cold plate. This slow cooling process causes excessive grain boundary precipitation resulting in a material that is susceptible to intergranular attack (IGA). The IGA is likely caused by an aggressive crevice environment created from condensed water vapor located between the cold plate and support shelf.

The specimens used in this effort were obtained by sectioning a portion of one of the flight hardware cold plates that had been taken out of service¹. This portion was sectioned into specimens approximately 1 inch by 1 inch. This size optimized the use of the cold plate and produced specimens that could easily be imaged with the microfocus tomography system. Some of the specimens used in this effort are shown in the photograph in Figure 1.

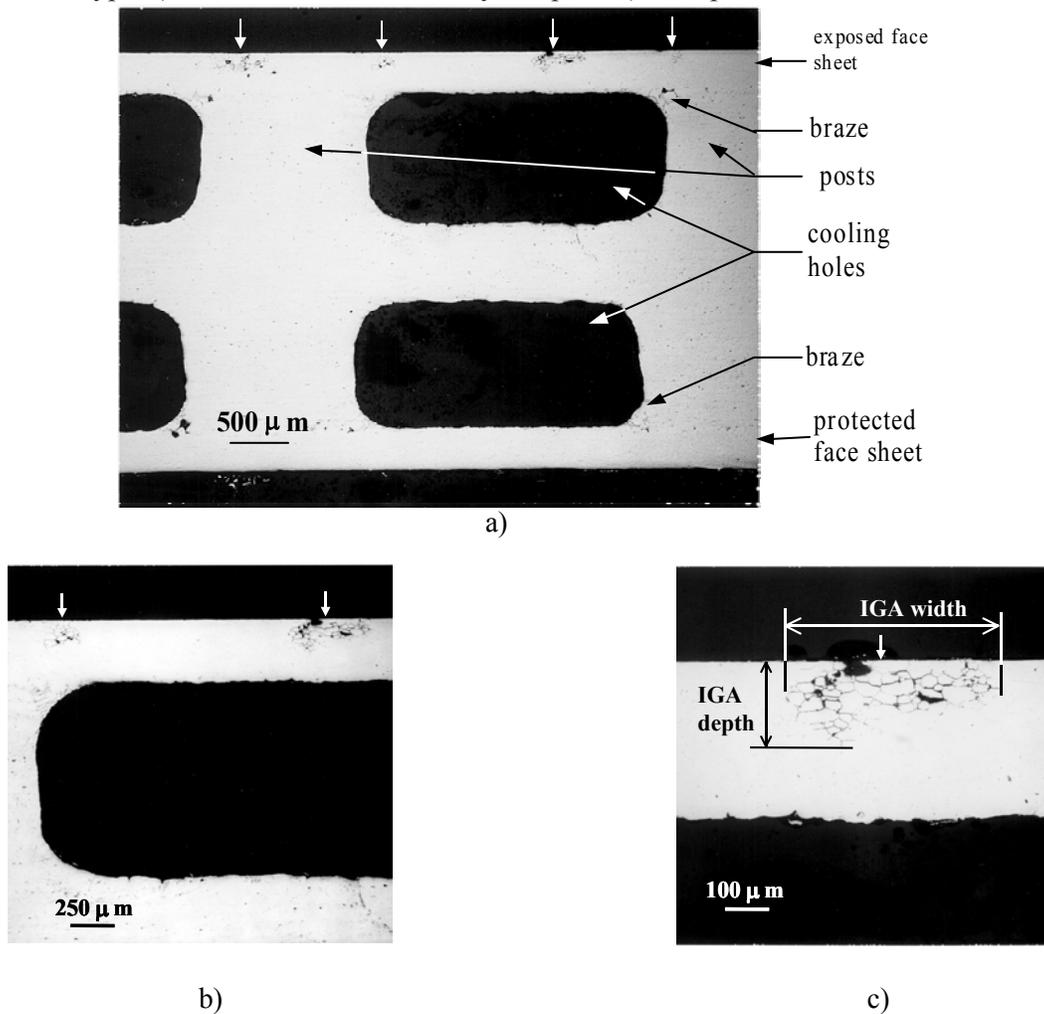
Figures 2 a-c. Optical micrographs for three different magnification of IGA produced in a cold plate specimen in the laboratory. The 1-inch by 1-inch specimen was coupled to a 1-1/2-inch by 1-1/2-inch steel cathode and exposed to the electrolyte solution for 24 hours.

Initial destructive examinations were performed on corroded cold plate samples to evaluate the morphology of the IGA and to compare these results with the IGA observed in cold plates removed from the orbiter. Figure 2 contains a series of optical micrographs for a corroded sample that was exposed to the electrolyte solution for 24 hours, sectioned and polished. Several discreet corrosion events, identified by arrows in Figures 2a and b, are identified along each section. Here, the 1-inch by 1-inch cold plate

sample was coupled to a 1-1/2-inch by 1-1/2-inch steel cathode and immersed in the electrolyte. The resultant IGA was very similar to that observed for in-service cold plates. For each event, a maximum penetration depth and width were recorded (see Figure 2c). Such measurements were performed for several specimens exposed to the electrolyte solution for various times. Figure 3 shows results of depth versus width of IGA for three specimens exposed to the electrolyte for 8 hours (Figure 2a) and three specimens exposed for 24 hours (Figure 2b). Each specimen was polished six times, to examine six different cross-sections. Microscopic measurements of width, depth and position for all IGA events were performed on each metallographic section, to provide an accurate assessment of the IGA events. As can be seen in Figure 3, the average depth and width for the observed IGA was greater when the cold plate samples were exposed to the solution for 24 hours (see Figure 3b) then when they were exposed for 8 hours (see Figure 3a). To ensure that the NDE standards contained a wide distribution of IGA events, two NDE standard types (24 hour and 8 hour electrolyte exposure) were produced.

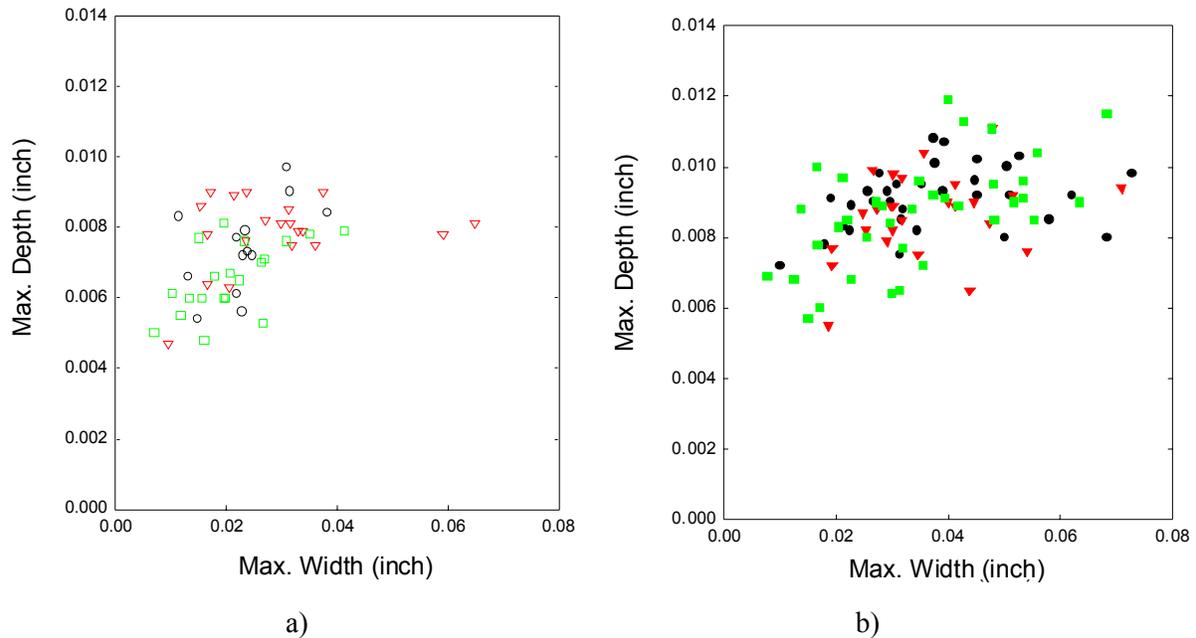
Figure 3. Plots showing depth versus width of IGA events measured using optical microscopy for cold plates specimens exposed to the electrolyte for a) 8 hours and b) 24 hours.

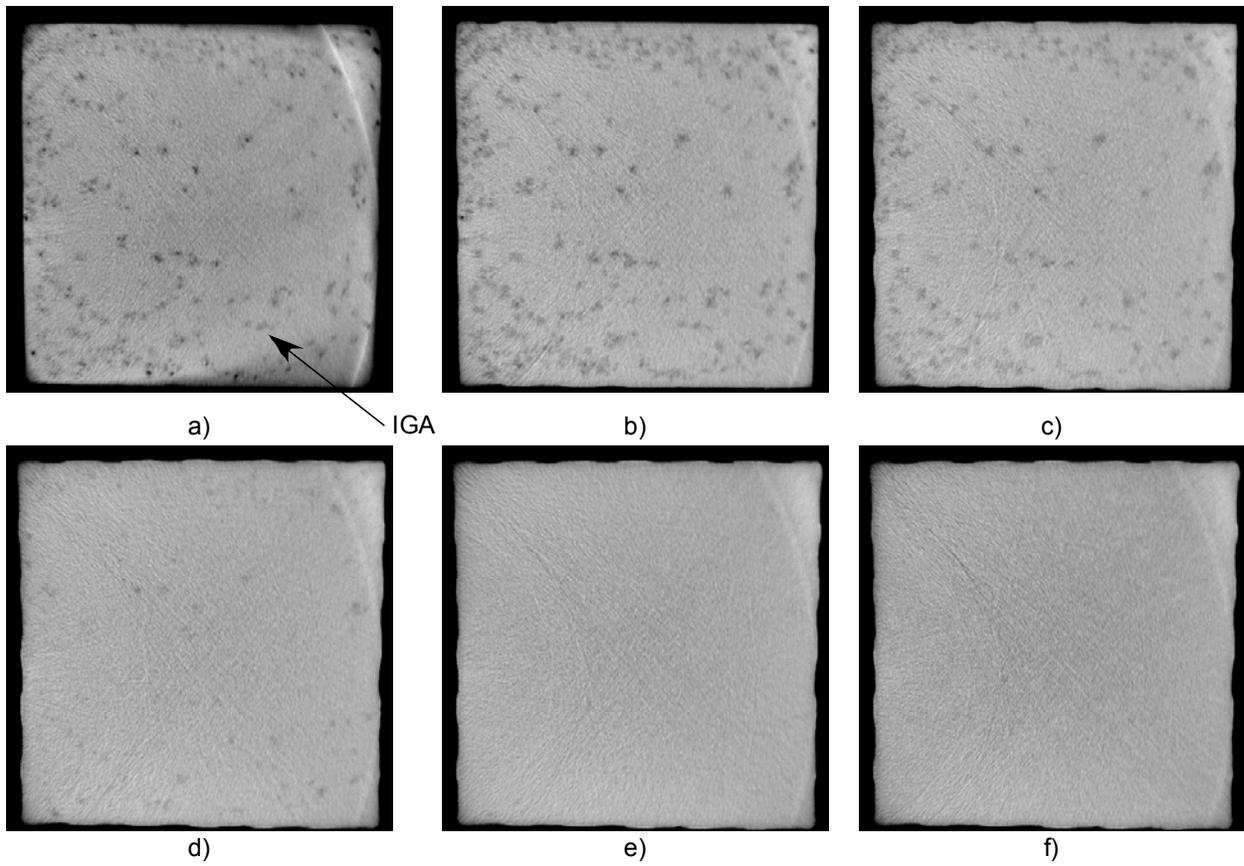
Figure 4. CT radiography images for a cold plate sample exposed to an electrolyte solution for 24 hours. The sensor head was located at a height that results in a mean sampling depth of 0.0135-inch. Average sampling depths are a) 0.0035-inch, b) 0.0055-inch, c) 0.0075-inch, d) 0.0095-inch, e) 0.0115-inch and f) 0.0135-inch

To validate the CT radiography results, metallography was performed to confirm IGA corrosion depth measurements. For each image in Figure 4, the suspected IGA events were identified in the images. The events identified in each image are shown in Figure 5. Because discrete depth images were produced, a mean maximum depth was determined for each IGA corrosion event. For example, a corrosion event is identified in region A in Figure 5a. Here, the event was observed for the 0.0035 and 0.0055-inch images (Figure 5 a and b) and was not observed at a depth of 0.0075-inch and greater (Figures 5 c-f). For this example, a mean maximum IGA depth of 0.0065-inch was determined for this event. Similarly, an IGA event would be determined to have a mean maximum depth of 0.0045-inch if it was identified at a depth of 0.0035-inch and not observed at the 0.0055-inch depth. If an event were identified in only one CT image, the event would be discarded from further consideration.

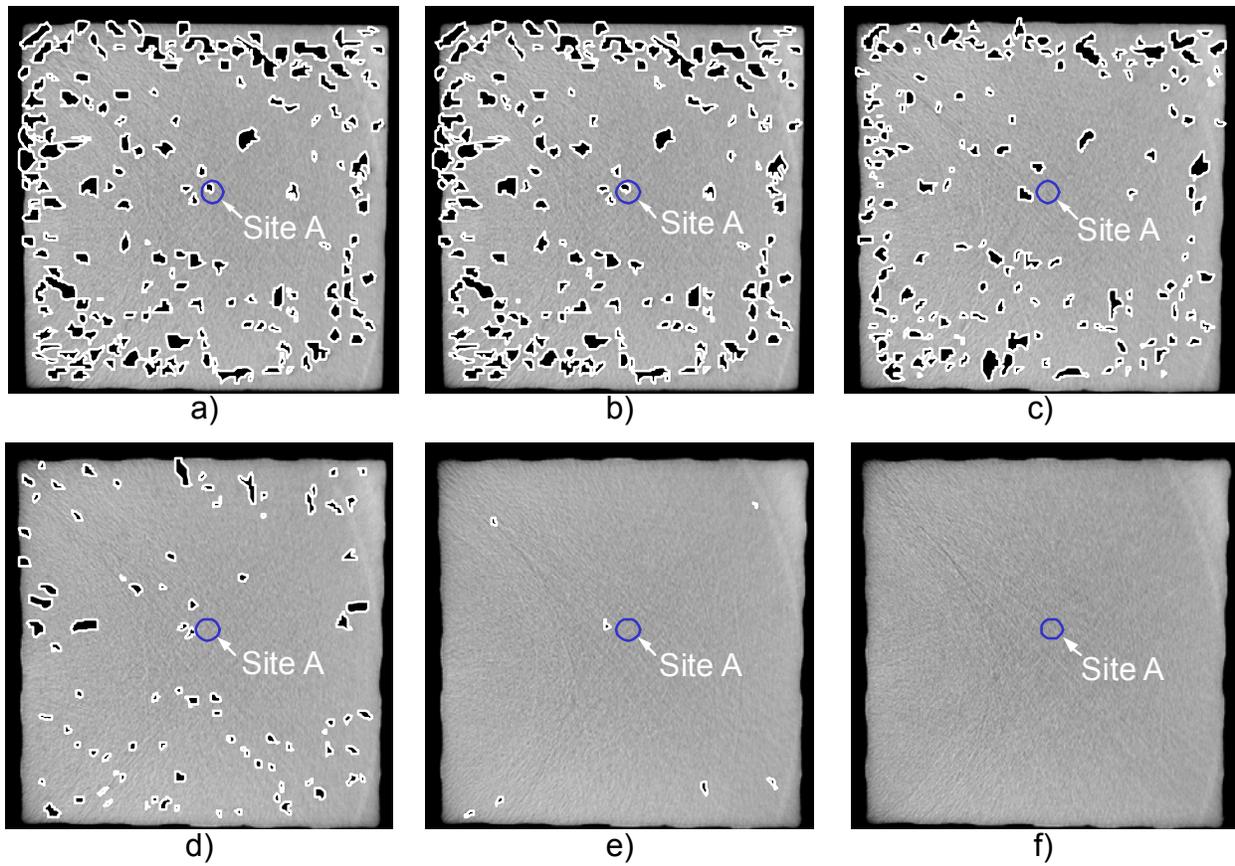
Figure 5. CT radiography images for a cold plate sample exposed to an electrolyte solution for 24 hours with IGA events identified. Average sampling depths are a) 0.0035-inch, b) 0.0055-inch, c) 0.0075-inch, d) 0.0095-inch, e) 0.0115-inch and f) 0.0135-inch. f) has no identified events.

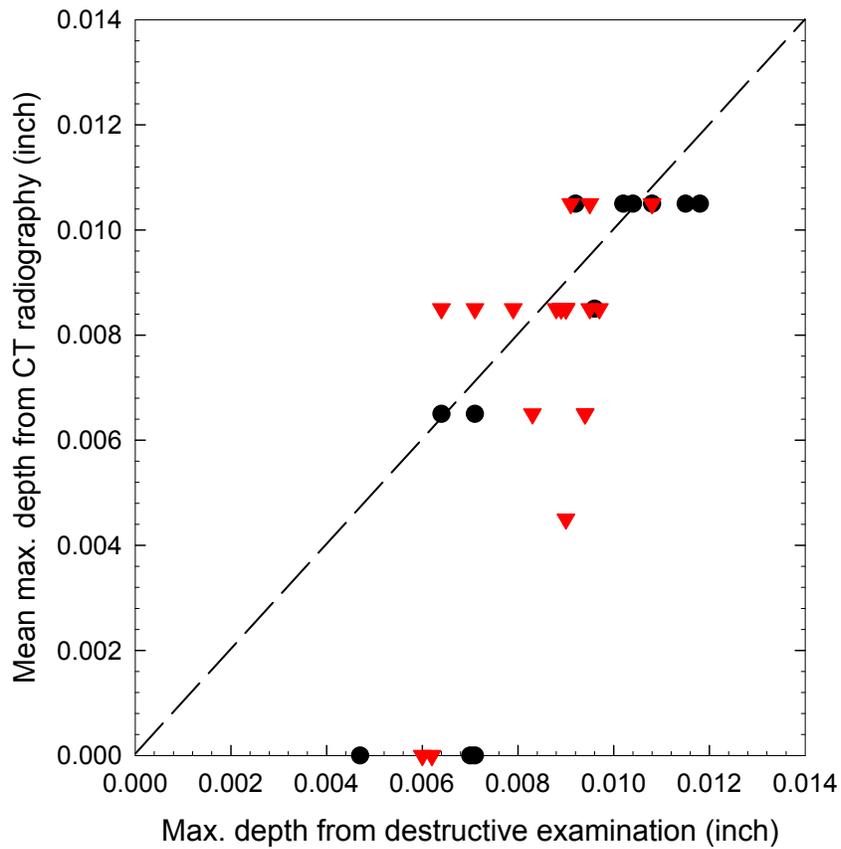
Figure 6. Plot of mean maximum depth of IGA events as determined by CT radiography versus maximum depth of the same IGA events as determined by a destructive examination for two cold plate samples exposed to an electrolyte solution for 24 hours while coupled to a steel cathode.

Two additional corroded (24 hour) specimens were examined to determine the accuracy of the CT radiography system in measuring IGA. The CT radiographic inspections were conducted at the same depths describe above; thus categorizing the IGA events at mean maximum corrosion depths of 0.0045, 0.0065, 0.0085, 0.0105 or 0.0125-inch. After CT radiography of the two corroded specimens was completed, a total of 32 metallographic cross-sections were microscopically examined. Each IGA corrosion event was characterized for depth, width and location and compared to the CT radiography results. Figure 6 is a plot of the mean maximum depth for 27 IGA events determined by CT radiography versus the maximum depth of the same events determined by the destructive examinations. Table I summarizes the statistical analysis of the data presented in Figure 6. A 95% confidence interval was determined for CT radiography results at the 0.0065, 0.0085, and 0.0105-inch mean maximum depths. If CT radiography indicates that an IGA event is 0.0105-inch deep, there is a 95% certainty that the event is between 0.0086 and 0.0122-inch in depth. Due to a lack of data, it was not possible to determine confidence intervals for CT results less than 0.0065-inch and greater than 0.0105-inch. Based on these results, the CT radiographic method enables nondestructive characterization of the IGA corrosion samples and provides good standards for development of an inspection technique.

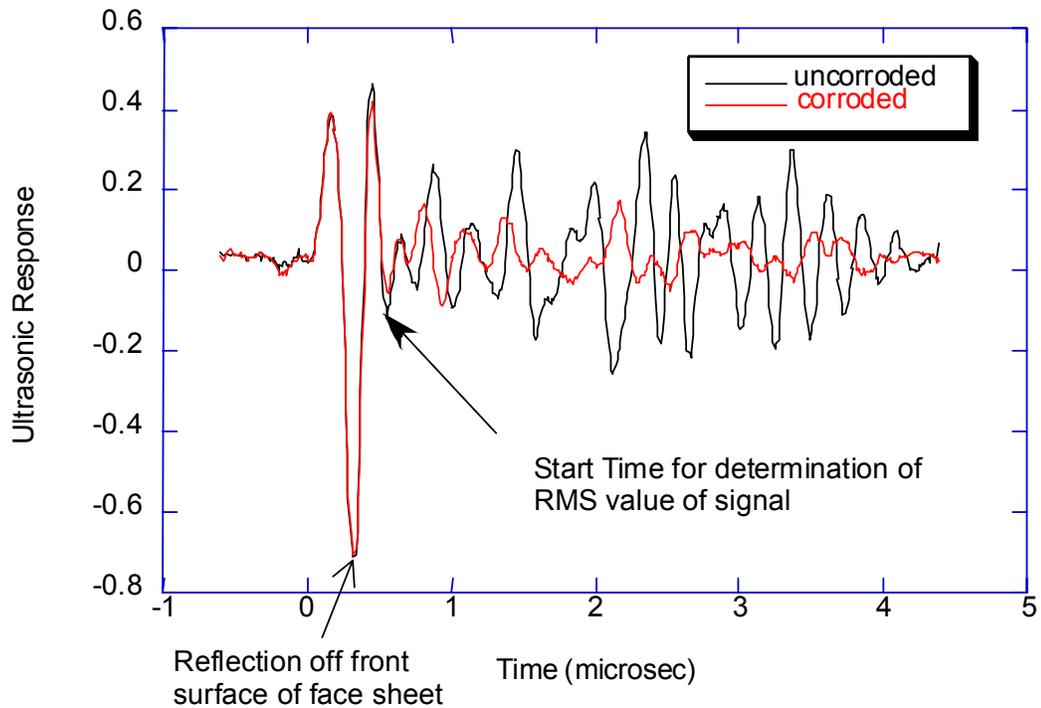
Figure 7. Ultrasonic response for immersion ultrasonic analysis for uncorroded and corroded cold plate samples.

Typical responses for corroded and uncorroded points on the specimen are shown in Figure 7. The initial response at both points is a strong reflection off the front surface. A frequency analysis indicates the measurement system bandwidth was approximately 3 to 6 MHz. This is too narrow to enable discrimination of the individual echoes from the back surface of the face sheet, which has a resonance

frequency of approximately 6 MHz. However, the RMS value of the ultrasonic response following the front surface echo is clearly less for the corroded point, than for the uncorroded point.

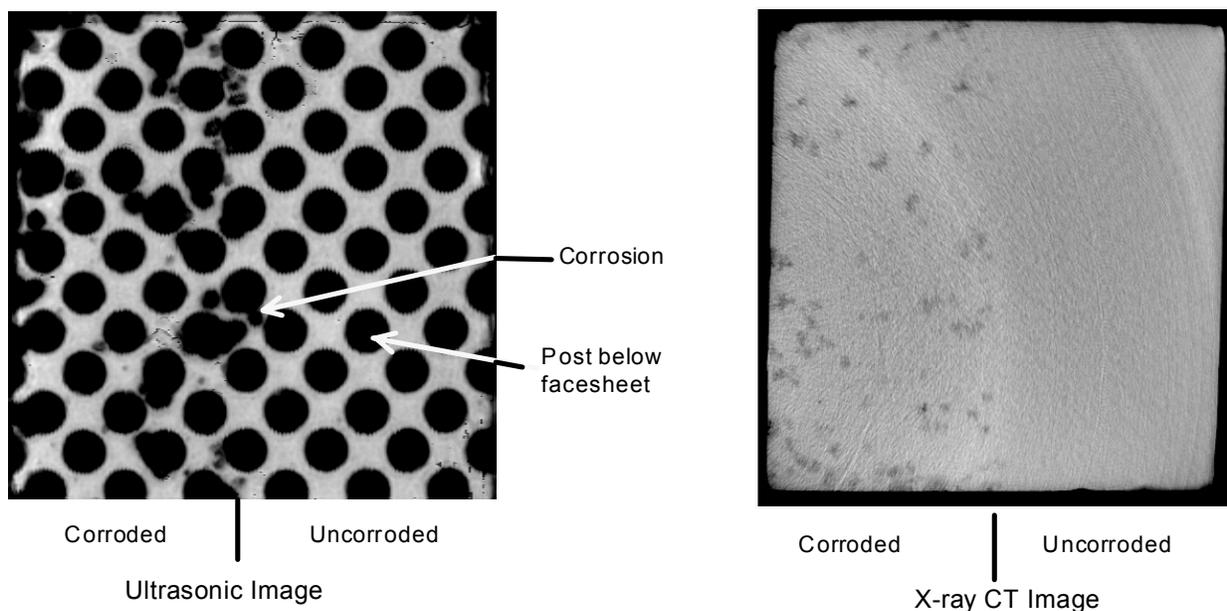
Figure 8. Immersion ultrasonic results for a corroded cold plate sample. The right half of the specimen was coated with wax to prevent corrosion, while the left half of the specimen was exposed to an electrolyte solution for 24 hours while coupled to a steel cathode.

To image the corrosion, the RMS value of the ultrasonic response between 1 and 4 microseconds was calculated from the digitized waveforms. From these values it is possible to create an image such as shown in Figure 8. For comparison, a microfocus tomography image of the same specimen is also shown. Where there are posts below the face sheet, there are no echoes within the gated time, and the RMS value of the signal is small. This yields the round dark regions that are clearly visible in the image. Unlike the CT radiography technique, immersion ultrasonics does not provide a direct method for evaluating the penetration depth of the IGA events. An exact comparison of the ultrasonic and CT radiography was not possible due to difficulties registering the two images. However, qualitative agreement between the two images is reasonable. Future efforts will focus on a more quantitative comparison.
