EVALUATION OF THIN KEVLAR-EPOXY FABRIC PANELS SUBJECTED TO SHEAR LOADING

Donald J. Baker *
Vehicle Structures Directorate - ARL
NASA Langley Research Center
Hampton, VA 23681

The results of an analytical and experimental investigation of 4-ply Kevlar-49-epoxy panels loaded by in-plane shear are presented. Approximately one-half of the panels are thin-core sandwich panels and the other panels are solid-laminate panels. Selected panels were impacted with an aluminum sphere at a velocity of either 150 or 220 ft/sec. The strength of panels impacted at 150 ft/sec was not reduced when compared to the strength of the undamaged panels, but the strength of panels impacted at 220 ft/sec was reduced by 27 to 40 percent. Results are presented for panels that were cyclically loaded from a load less than the buckling load to a load in the postbuckling load range. The thin-core sandwich panels had a lower fatigue life than the solid panels. The residual strength of the solid and sandwich panels cycled more than one million cycles exceeded the baseline undamaged panel strengths. The effect of hysteresis in the response of the sandwich panels is not significant. Results of a nonlinear finite elem

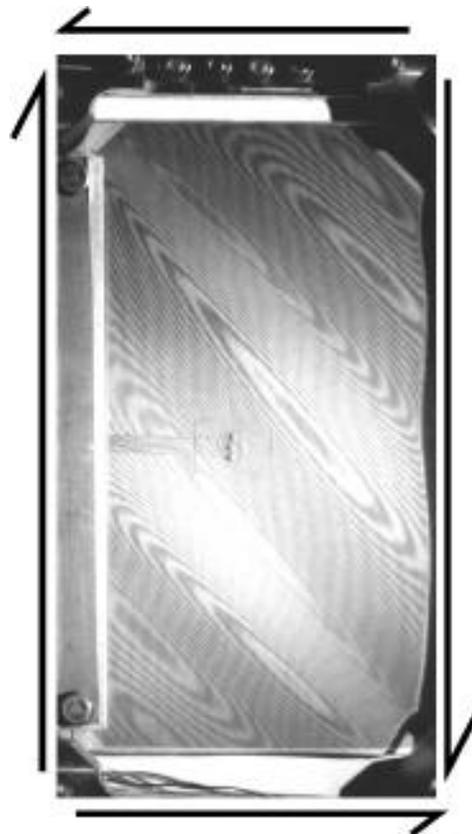
Figure 11. - Out-of-plane deflections as determined from moiré pattern for $N_{xy} = 851$ lbs/in.
