EXPLOSIVE FRACTURING OF AN F-16 CANOPY FOR THROUGH-CANOPY CREW EGRESS

Laurence J. Bement
NASA Langley Research Center

Presented at the
The 38th Annual SAFE Symposium
October 9-11, 2000
Reno, Nevada

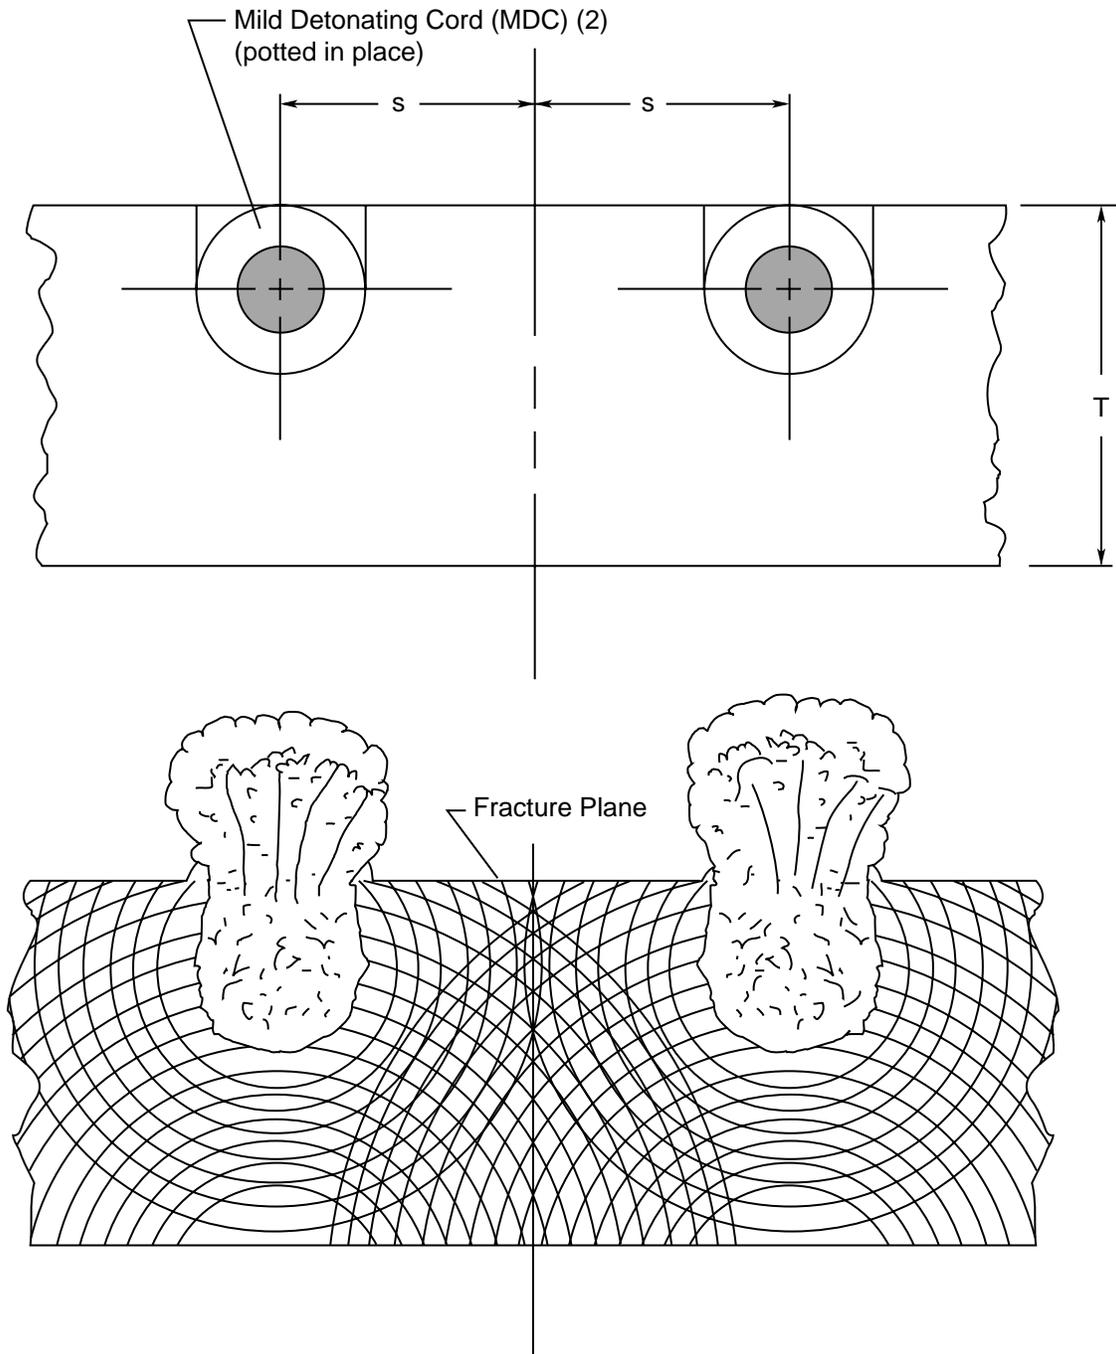
Figure 1. Cross sectional view of augmented shock wave severance principle.

The approach for this development, initiated in references 1, 2 and 3, was to utilize augmented shock wave severance principles. Parallel explosive cords, as shown in figure 1 in which the cords are proceeding into the plane of the paper, are initiated simultaneously. The several-million psi pressure generated by the explosive cords transfers into the polycarbonate and the resulting incident and reflected explosive pressure waves augment to induce the material to fail in tension. The preliminary effort began with evaluations on commercial grade polycarbonate. Then the F-16 canopy was selected for evaluation, since it is the first production polycarbonate canopy, and service-scraped canopies were available. Small (6 X 6-inch plate) specimens were cut from flat stock and canopies for testing. The evaluation progressed to small-scale (18 to 30-inch dimension), "mini-panels" to determine the performance of complete fracture patterns. Finally, three full-scale canopy tests were conducted.

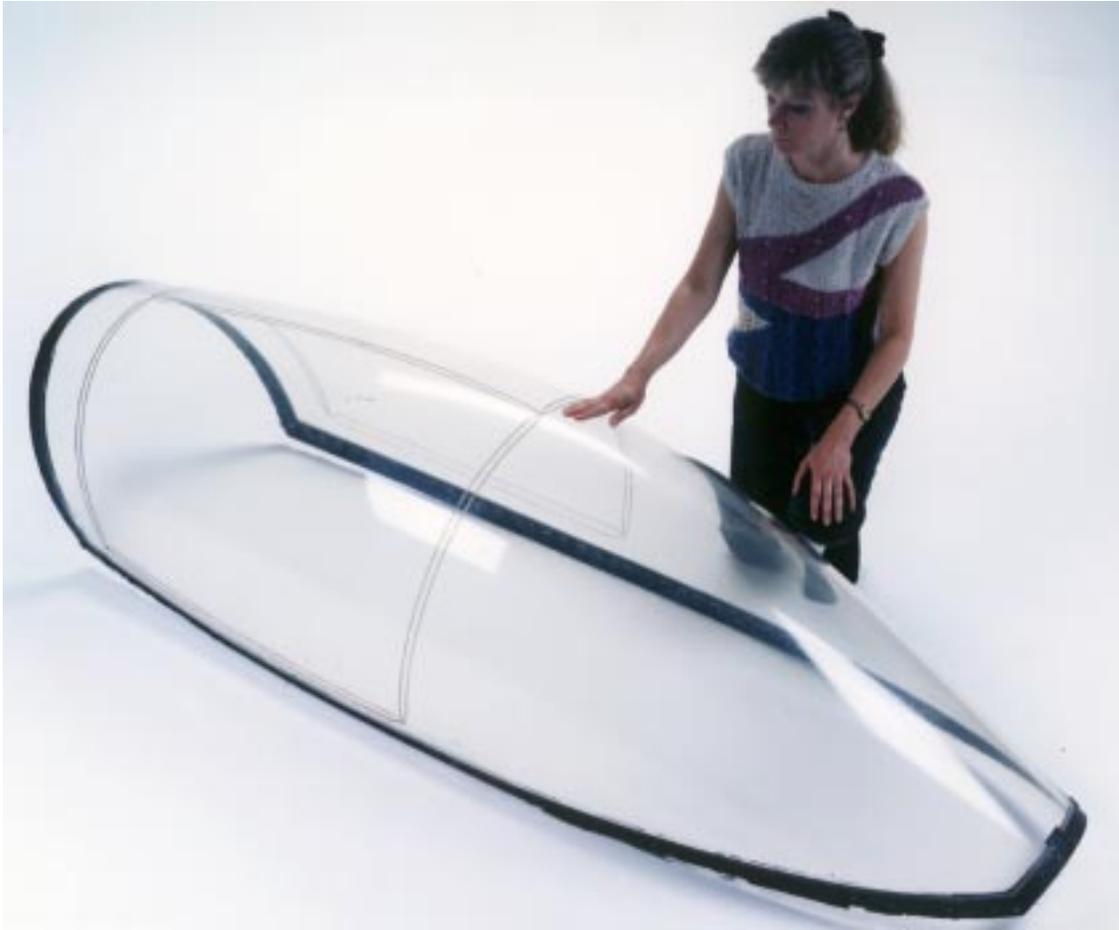
Figure 2. Concept for explosive fracture of F-16 aircraft canopy to allow through-canopy crew egress.

Explosive pattern - As shown in figure 2, the layout (grooves) for the explosive severance pattern for the first full-scale test was on the top centerline, forward and aft of crewmember, and around the lower extremity. The goal was to create a "French-door" opening. The initiation sites (2 for redundancy) were located at aft hinge points, which also is the closest access between the canopy and aircraft with the canopy open. On initiation, the explosive propagates upward and forward

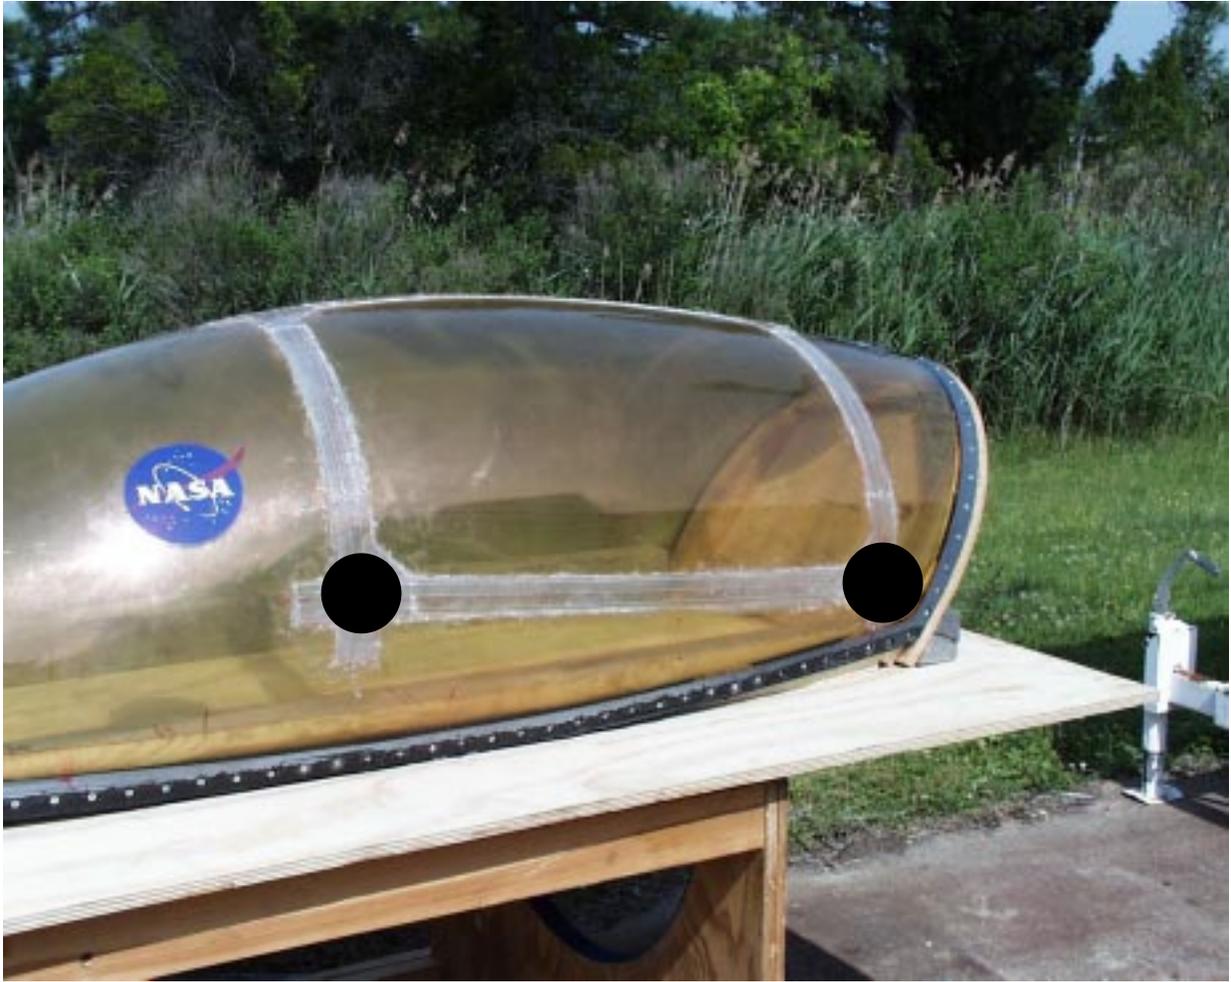
Figure 3. Test setup for third full-scale canopy test. (Explosive intersections have been blanked to accommodate ITAR restrictions.)

The third full-scale test, figure 3, was conducted with a three-cord configuration of plastic explosive in acrylic strips and modified intersection charges. (Note: These intersection charges have been masked to meet ITAR regulations.) Prior to installation of these strips, using RTV-3145 as a bonding agent, the 0.050-inch thick polyurethane middle layer was cut with a razor blade to negate its post-fire residual strength. To simulate the aircraft installation, the canopy was fastened to a rigid frame. The canopy was attached to wooden beams that were contoured to fit the interior of the canopy-mounting interface. The beams were then fastened to a sheet of 3/4-inch plywood. The test was conducted at approximately 85 degrees.

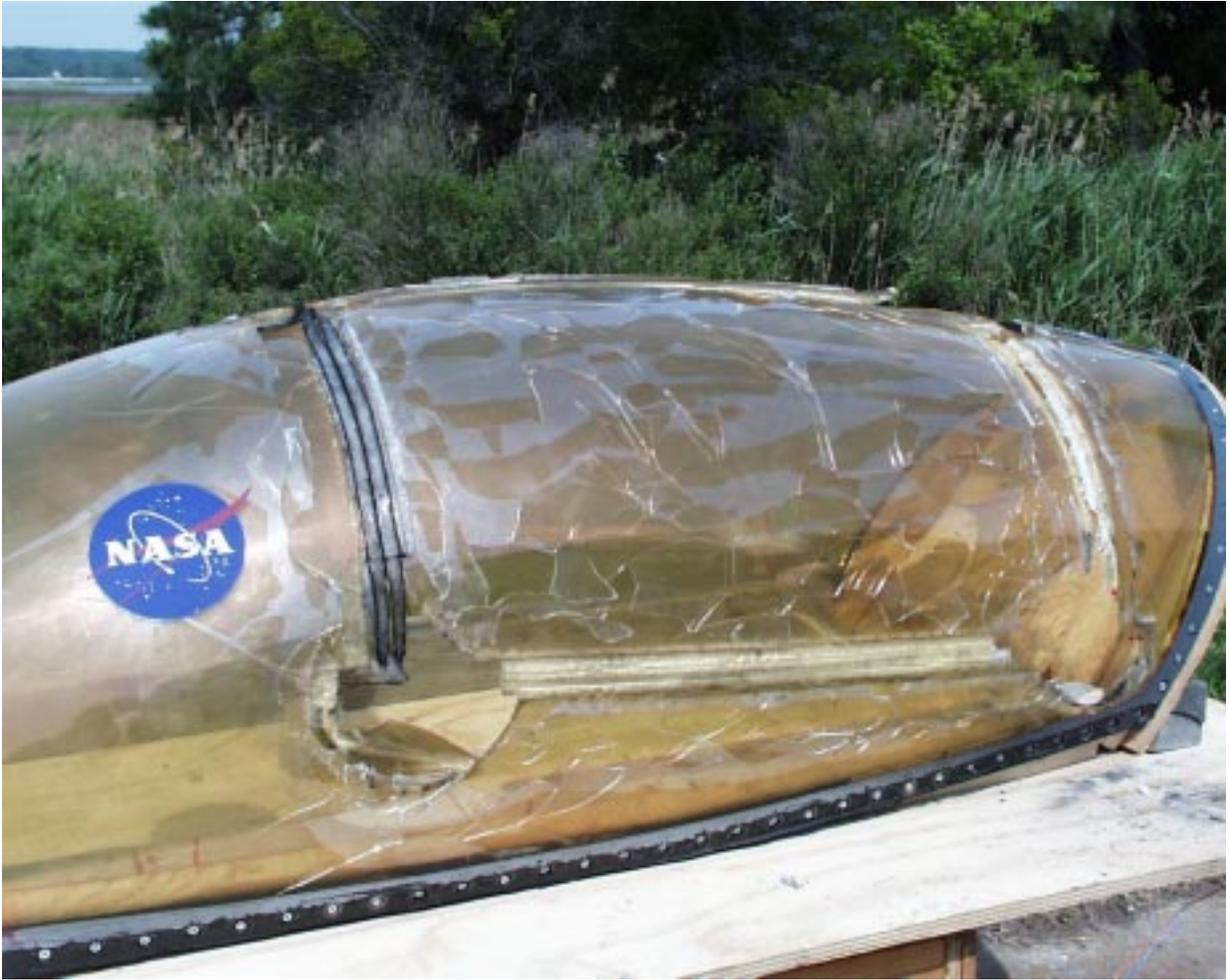
Figure 4. Results of the third full-scale canopy test, side view.

The results of the third full-scale test (figures 4 and 5) left the canopy essentially intact, as had been observed in the first two tests. Little deflection was observed in the high-speed video. The intersections had been punched out, and the aft transverse path was totally severed, as observed in the previous test. A major, totally severed crack occurred diagonally across the right-hand panel, figure 5. This piece was easily pulled out by hand, figure 6, as were the remaining portions, as shown in figure 7. Complete severance occurred on every fracture line.

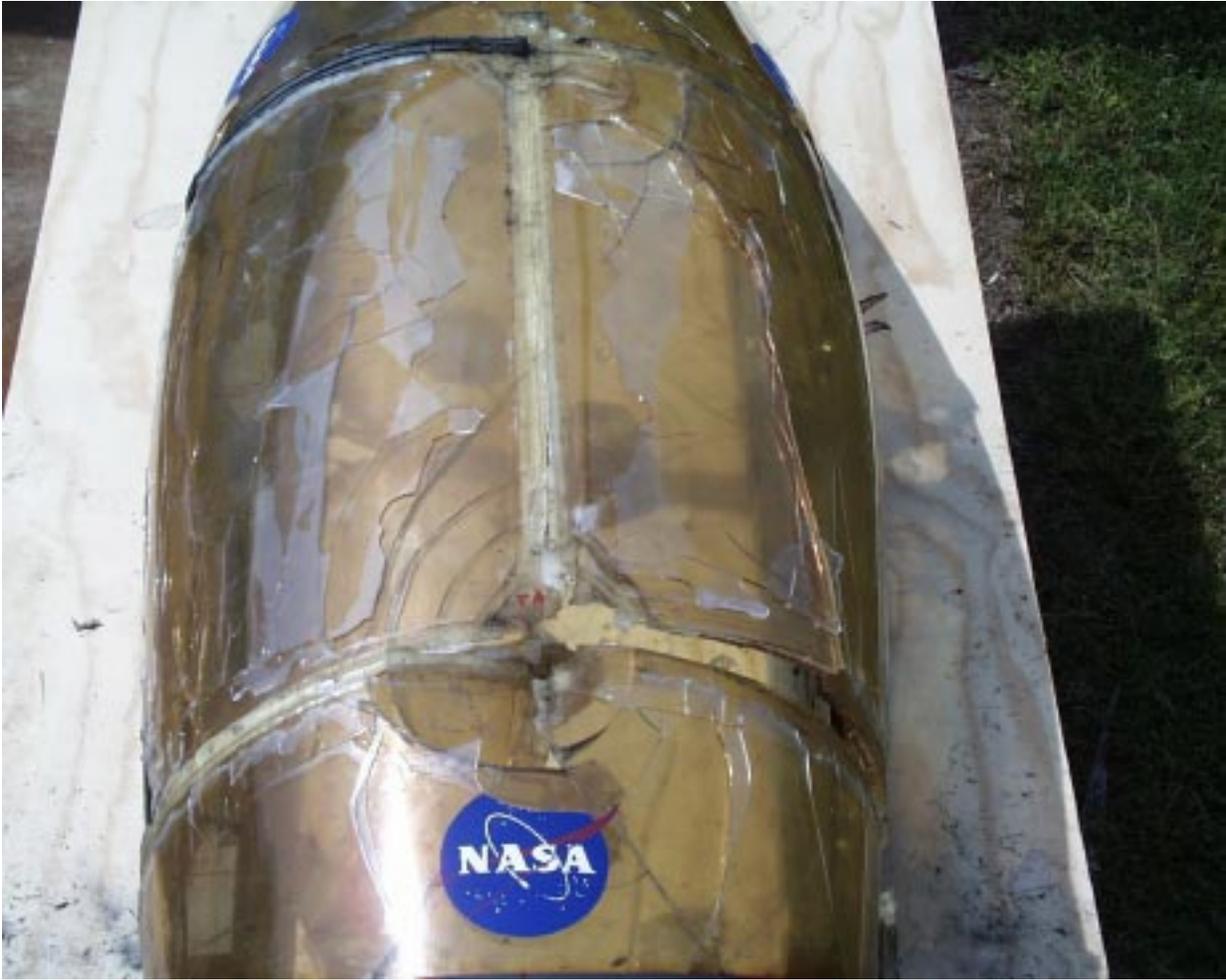
Figure 5. Results of the third full-scale canopy test, top view.

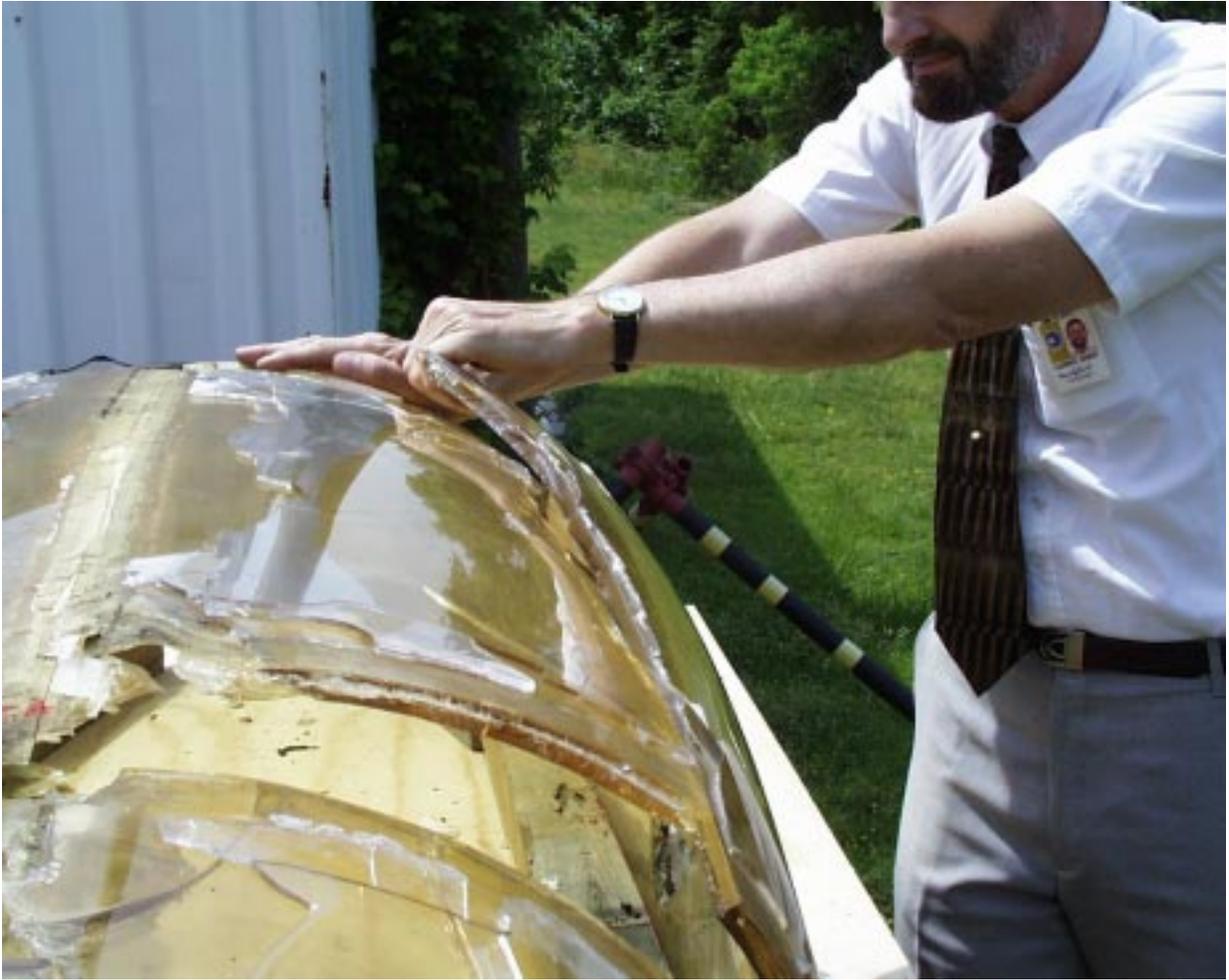
Figure 6. Manually removing the severed panels in the third full-scale canopy test.

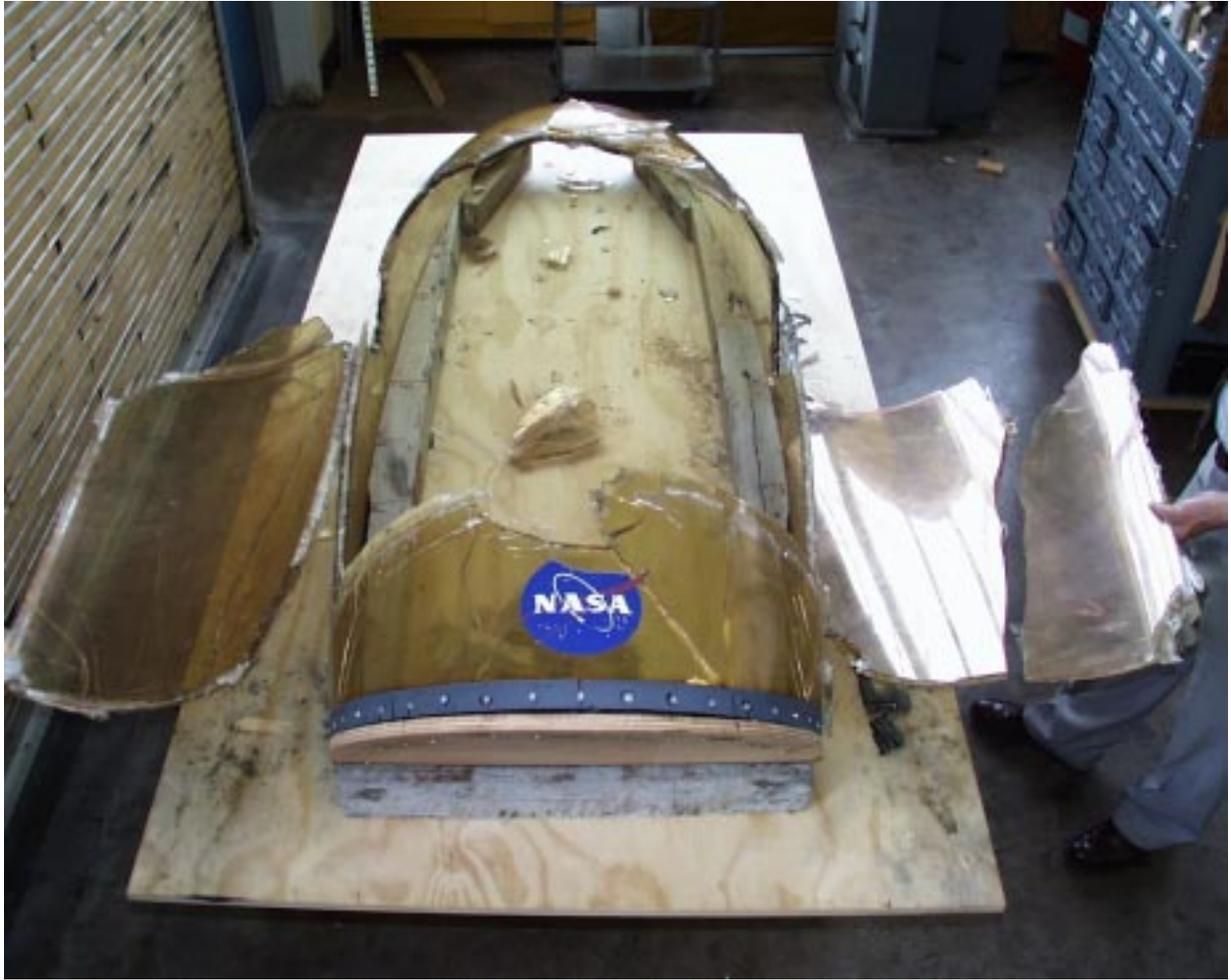
Figure 7. Final results of the third full-scale canopy test.
