Synchronized electronic shutter system (SESS) for thermal nondestructive evaluation

Joseph N. Zalameda

U. S. Army Research Laboratory, Vehicle Technology Directorate
Nondestructive Evaluation Sciences Branch MS 231
NASA Langley Research Center 23681

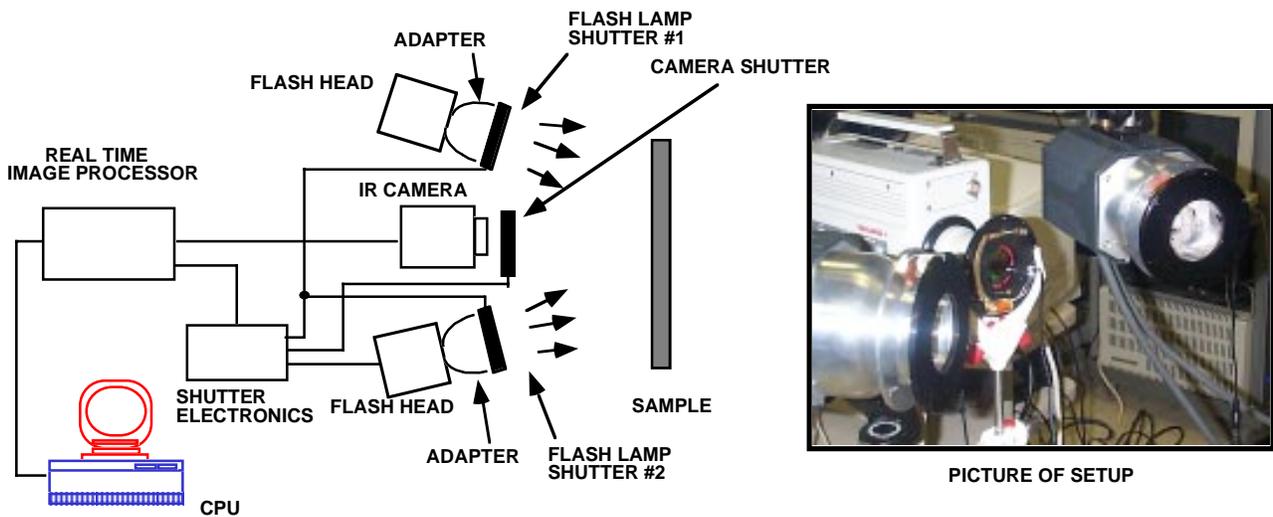
Figure 1. Schematic diagram of SESS implementation with picture.

The SESS is composed of three shutters, flash lamp shutter adapters, and the shutter control electronics as shown in figure 1 for a single side setup. The first shutter is placed over the infrared camera. The other two shutters are placed over the two flash lamp heads using the adapters. The shutters are synchronized electronically. The operational timing diagram is shown in figure 2. Before firing the flash lamps, the camera shutter is opened to acquire the necessary background data frame for offset calibration. During flash heating, the camera shutter is closed to prevent the photons from the high intensity flash from entering the infrared inspection camera. The flash duration has been measured to be approximately 0.008 seconds.⁶ Immediately after the flash the camera shutter is opened to measure the surface temperature. This can be synchronized to the start of the acquisition of the next camera data frame by adjusting a delay in the shutter electronics. To remove the residual effect of the flash lamps radiating heat after firing, a shutter is placed over the flash heads to block the infrared heat radiating from the flash head after firing. A custom flash lamp shutter adapter was designed and fabricated out of aluminum and easily replaces the lamp's reflector. The custom shutter adapter holds the shutter over the flash tubes and are fully open when the flash tubes are fired. The flash lamp also reflects the light onto the target of interest during firing. The flash lamp shutters are synchronized electronically with the camera shutter to open when the camera shutter closes. A second adjustable delay is used to insure the flash lamp shutters are immediately closed after the flash duration. This whole sequence requires a minimum of two image data cycles in time, one for the background image capture and the other to operate the SESS during flash heating. The electronic shutters for both the camera and flash lamp are 5 and 7 moving blade shutters respectively. The shutters are solenoid controlled, powered by 12 volts and are calibrated up to 60 hertz. The

camera shutter is normally open and the flash lamp shutters are normally closed. This reduces the shutters power requirements by reducing the power duty cycle. The focal plane array infrared camera detector size is 256x256 operating in the 3 – 5 micrometer wavelength band. The camera output frame rate was 60 hertz and was connected to a real time image processor for image storage, averaging, and analysis.

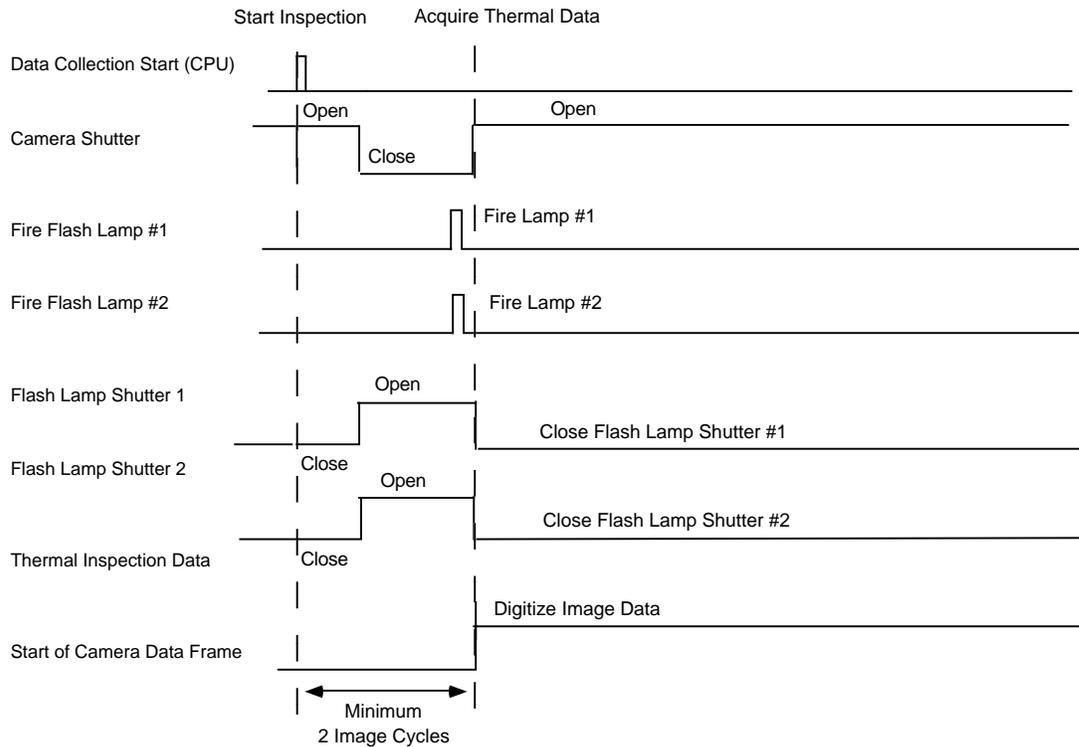
Figure 2. Timing diagram of SESS.

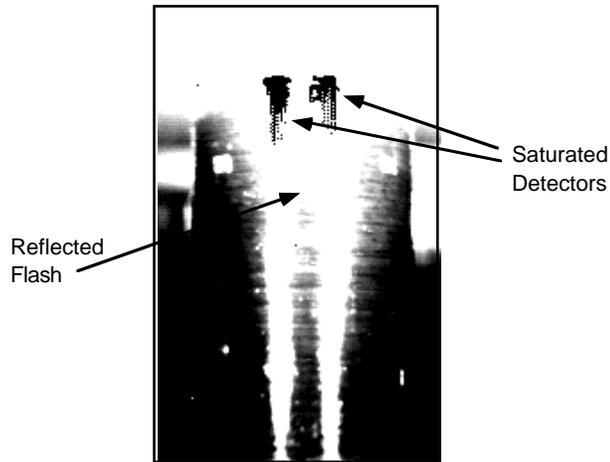
Figure 3. Temperature image during flash on composite cylinder without SESS.

Using the setup shown in figure 1 some results of the single side measurements are shown in figures 3, 4, and 5. Shown in figure 3 is a temperature image taken during the flash on a composite cylinder without the SESS. As can be seen very large temperatures are measured erroneously due to the reflected radiation during the flash. Also a comparison is made of two sets of thermal data without shutters and with the shutters (figure 4) taken on the same composite sample. The sample is an aluminum cylinder with graphite epoxy wound filaments as the outer shell. A delamination exists between the outer composite shell and the aluminum. As shown in figure 4, the lamp reflection can be seen in the temperature data as a slowly fading hot spot. This is entirely removed with the shutters. Also shown in figure 4 are the temperature data at the same location on the sample. The temperature data is offset corrected and normalized. As shown, the temperature data is different because of the influence of the lamps radiating heat onto the sample which is reflected back into the camera. This difference in the time versus temperature profile produces errors when analyzing the thermal image data. The transient nature of the flash head cool down is not known and its intensity would be dependent on the surface emissivity. To image the defect, a time derivative calculation is applied to the temperature images.⁷ The time derivative image processing helps to remove some of the lamp reflections while enhancing defect contrast. Shown in figure 5 are the processed thermal inspection time derivative images with and without the SESS. By using the SESS, the lamp effects are removed from the raw temperature image and the processed time derivative image.

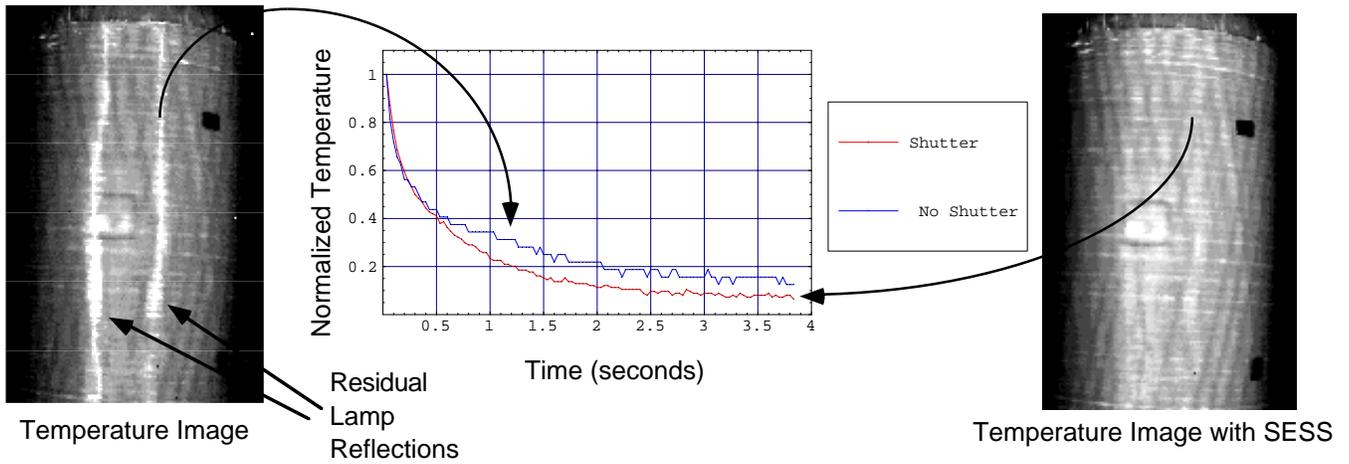
Figure 4. Temperature image after flash with and without SESS and time series plot comparison.

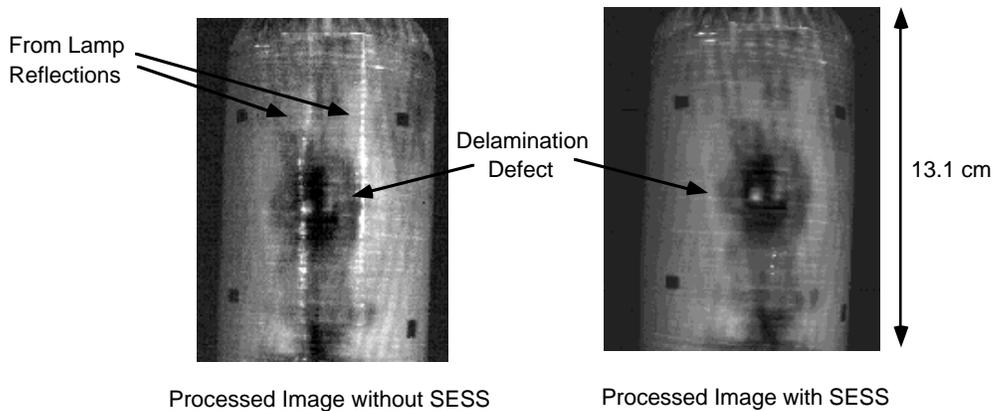
Figure 5. Processed inspection image of composite cylinder with and without SESS.

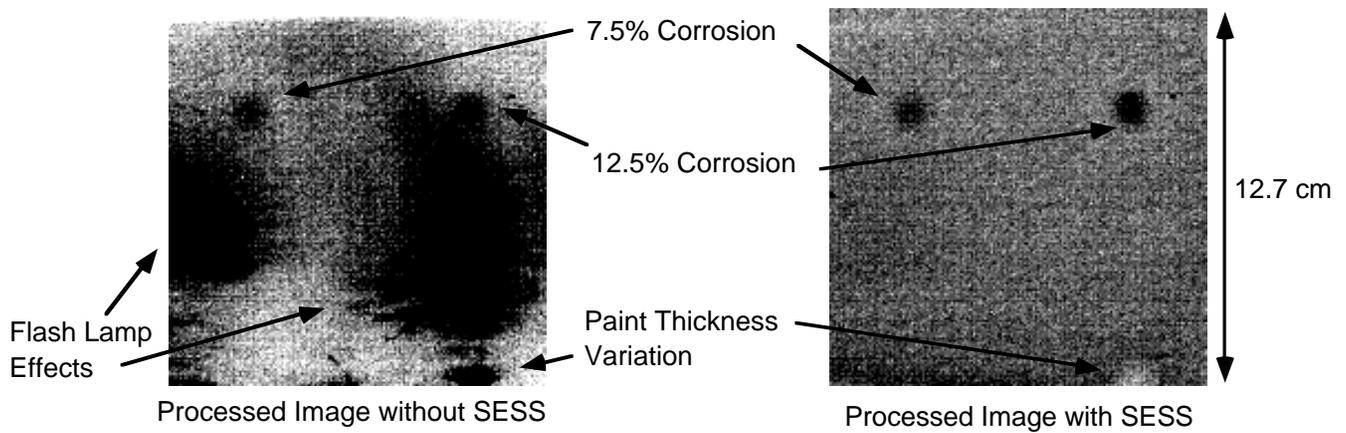
Figure 6. Inspection image of aluminum corrosion sample with and without the SESS.

A single layer aluminum corrosion sample was tested using the SESS setup shown in figure 1. The corrosion sample was a flat plate and painted with flat black paint to increase the surface emissivity. The sample was 0.102 centimeters thick with 1.27 centimeters diameter circular material loss regions of 0.0025, 0.0076, and 0.0127 centimeters in thickness for corrosion values of 2.5, 7.5, and 12.5 percent. The measurement parameters were 120 frames acquired at a camera frame rate of 60 hertz. As shown in figure 6, a comparison is made of the processed thermal images with and without the SESS for the detection of 7.5 and 12.5 percent corrosion. The processed thermal images were produced using a temperature normalization data reduction routine.⁸ The effect of the flash lamps are clearly seen in figure 6 as dark areas that can actually mask the corrosion area. Using the SESS removes the flash lamp effect so that only the defective areas are imaged. The 2.5 percent corrosion sample results are shown in figure 7 using a smaller field of view. In this case the corrosion is not detectable without using the SESS.

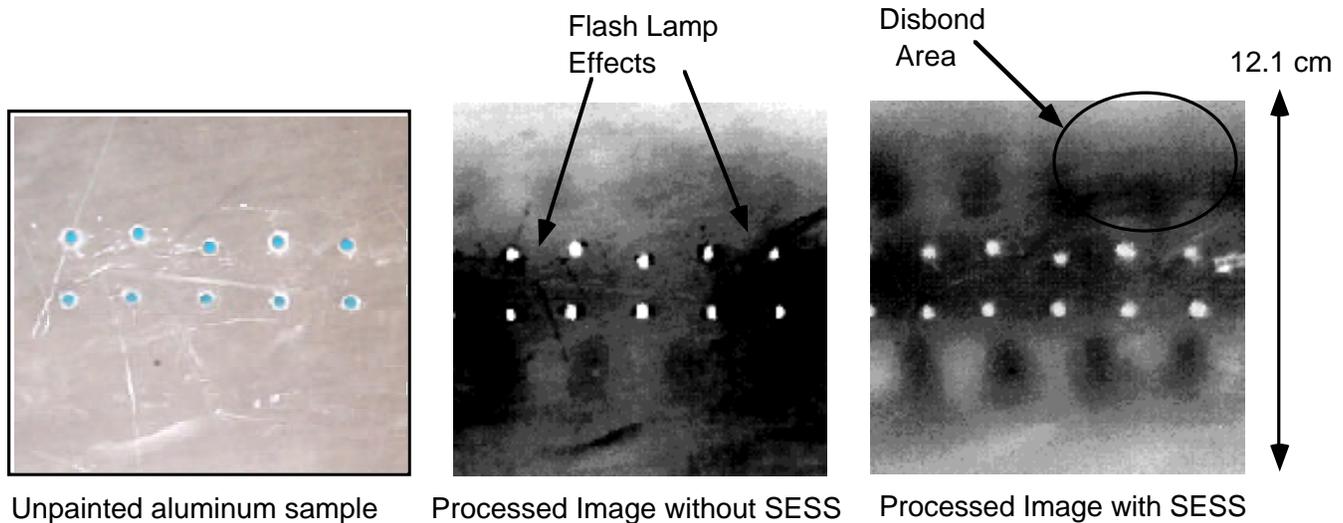
Figure 8. Thermal inspection of unpainted aluminum sample with and without SESS.

Thermal inspections were performed on an uncoated aluminum sample with an aluminum metal stiffener bonded to the backside. The aluminum sample was not shiny but gray from small surface abrasions. The sample was 0.066 centimeters thick and areas with the bonded metal were 0.145 centimeters thick. The processed thermal images were again produced using a temperature normalization data reduction routine. Shown in figure 8 is a picture of the sample and also the processed thermal images with and without using the SESS. The dark areas in the processed thermal images without the shutters mask the ability of the thermal inspection to reveal the bonded metal stiffener. Also the disbond area is not clearly detected. Using the SESS helps to image the disbond defect and the underlying structure of the stiffened panel.

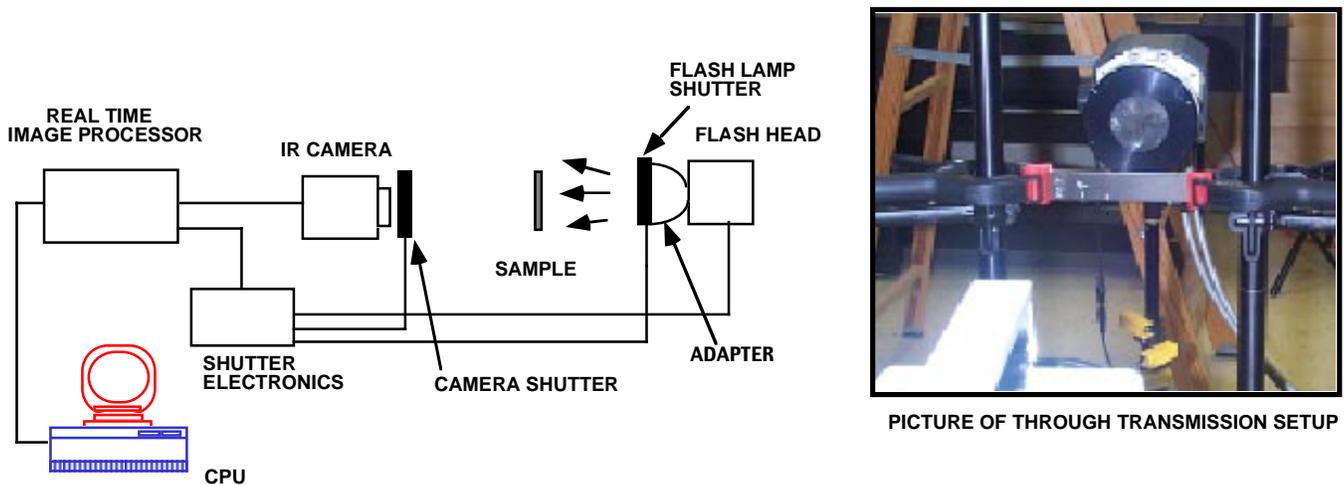
Figure 9. Schematic diagram of SESS through transmission implementation with picture.

Another advantage of having shutters on the flash lamps is for a through transmission thermal diffusivity measurement where the hot lamps radiate heat after flashing. The setup used is shown in figure 9. By using shutters on the flash lamps, custom-made baffles are not required for either the sample or on the lamp. For example, when inspecting samples smaller than the diameter of the flash lamp custom baffles were made specific to the size of the sample being tested. These baffles were used to block the flash lamps from radiating heat after firing. This is known as edge bleed over and would make the inspection of small samples difficult particularly around the edges because small temperature changes were being measured behind a hot background. This is shown in figure 10 for a flash test on a 2.54 x 12.7 centimeter composite sample 0.20 centimeters thick. Diffusivity images are also shown in figure 10 and were calculated using a curve fitting routine.⁹ The routine fits equation (1) below with the normalized temperature data.
