NASA/TM-2001-209037

Flight Demonstration of X-33 Vehicle Health Management System Components on the F/A-18 Systems Research Aircraft

*Keith A. Schweikhard, W. Lance Richards and John Theisen
NASA Dryden Flight Research Center
Edwards, California*

December 2001

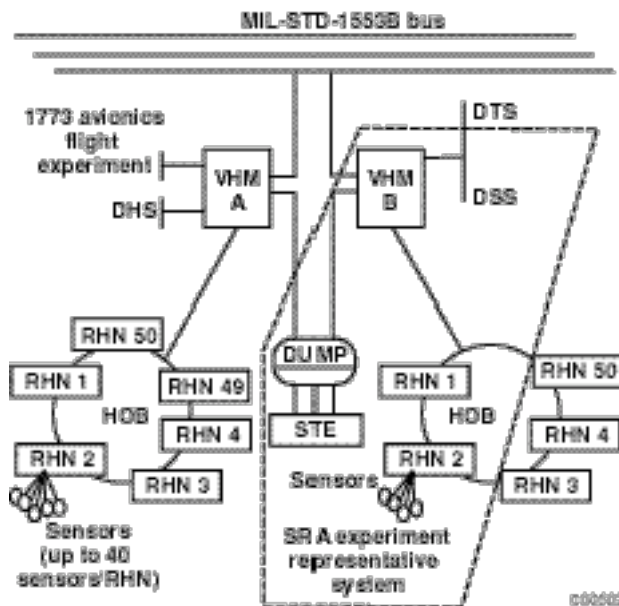
Figure 1. X-33/SRA configuration.

The X-33 VHM architecture (fig. 1) acquires data from a wide variety of sensors and systems. The system monitors and records all data on the vehicle, including all the flight bus data, all vehicle health data (structural, mechanical and system built-in test (BIT) status), and all the flight test instrumentation sensor data. This system interfaces to a NASA Jet Propulsion Laboratory avionics flight experiment that communicates over a MIL-STD-1773 fiber optic interface [2].

The VHM system uses a distributed sensing architecture to collect data from conventional sensors. The data are concentrated using 50 RHNs to gather structural, mechanical and environmental sensor data. Each RHN communicates with the VHM computer over a fiber optic health optical bus (HOB). The VHM computers (1) acquire data from the HOB, (2) monitor and record all MIL-STD-1553B data [3], and (3) gather fiber optic distributed temperature, hydrogen, and strain sensor data from digital signal processors which reside in the VHM computer. Optical sensors are mounted directly on the X-33 propellant tanks, while the driving optics and processing are housed in the VHM computers.

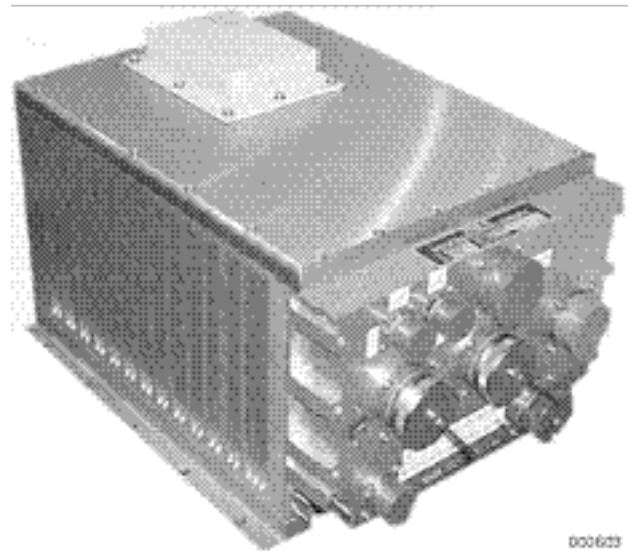
Figure 2. VHM-A/B.

The X-33 vehicle health manager-A (VHM-A) shown in figure 2 is one of two nearly identical versa-module-eurocard (VME)-based computers housed in a modified full air transportation rack chassis used to monitor and record data. VHM-A contains a commercial off-the-shelf or military off-the-shelf standard processor interfaced to a 4.5 gigabyte PC-based hard disk drive storage module and various input/output modules. VHM-A connects to 25 RHNs by means of the fiber optic HOB implementing an FDDI. The distributed fiber optic temperature sensors and MIL-STD-1553B bus monitors interface directly to the VHM-A computer. The VHM-A computer acts as a remote terminal by using a MIL-STD-1553B interface for VHM command and control information. VHM-B is nearly identical to VHM-A; the differences are that the VHM-B line replaceable unit contains the distributed fiber optic strain and hydrogen sensors. The VHM computer also handles telemetry downlink, recorder download, and system diagnostic functions.

The modified chassis design for the VHM computer (fig. 2) resulted in a box that would not fit in a standard avionics rack. As a result the computer was installed vertically on an instrumentation rack located in the gun bay on the SRA. This installation subjected the VHM computer to “off axis” loading for a significant portion of the test program.

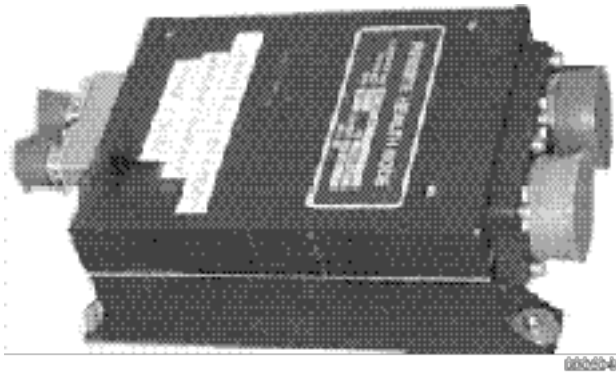
Figure 3. Figure 3 RHN.

The RHN shown in figure 3 acts as a data concentrator for analog sensor information. Each RHN communicates with its respective VHM computer over two independent HOBs using FDDI as the network protocol. The FDDI uses a full duplex, dual counter-rotating token ring topology to provide reliable communications in the event of a failure.

The main obstacle to integrating the RHN was connector placement on both ends of the RHN, as seen in figure 3. Fiber optic and power connectors were located on one end of each RHN. The sensor inputs on two connectors were located on the opposite end of the RHN. This design made it difficult to install and remove RHNs from the aircraft because it either required access to both ends of the RHN, or that RHN connectors be mated prior to mounting the RHN to the aircraft structure.

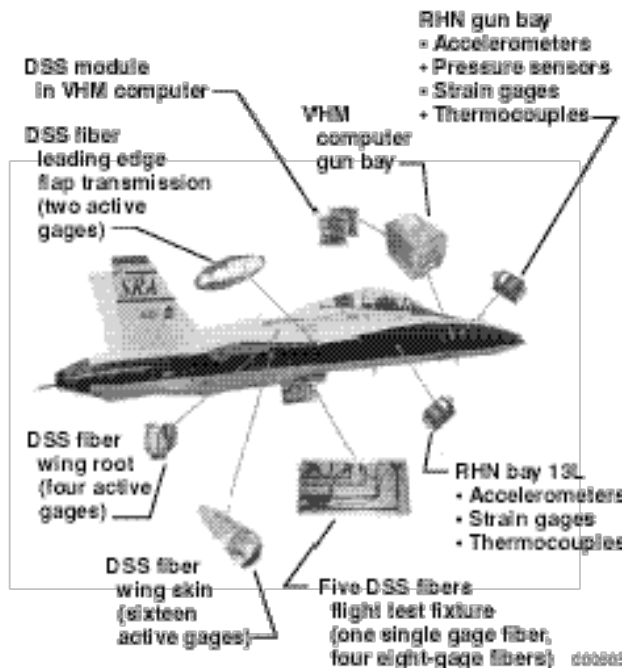
Figure 4. VHM experiment configuration.

High-risk components of the X-33 VHM system were identified for the SRA flight demonstration. These components comprised a representative subset of the overall X-33 VHM system architecture (fig. 1). Slight modifications were made to the X-33 VHM components to either validate technologies that would eventually be fielded in a VHM system or that were necessary to interface into the F/A-18 SRA. A diagram of the SRA experiment configuration is shown in figure 4.

Modifications to the SRA VHM experiment included: a single VHM computer with solid-state memory replacing the disk drive, a single FDDI module, a DSS module, and GEN II optical interconnects. Two RHNs were configured in a half-FDDI ring configuration.

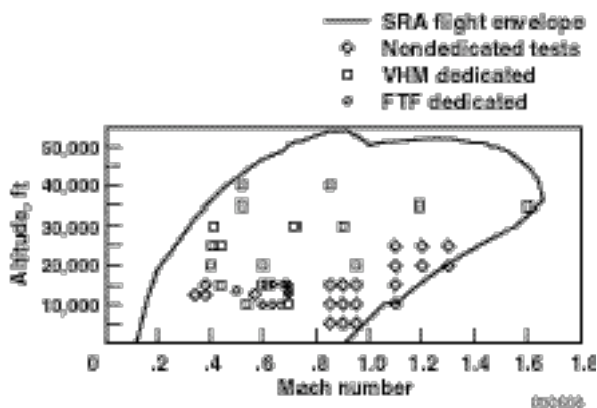
Figure 5. Flight envelope.

The VHM experiment began flying on the SRA at the end of September 1999. Flight tests concluded in early April 2000. The experiment was installed on the aircraft for 53 flights and flew for over 46 hours. These missions covered a large portion of the SRA flight envelope. Figure 5 shows the flight conditions accomplished during the test program. Thirteen of the 53 flights were dedicated to testing the VHM system. Eleven of the thirteen dedicated VHM flights were used to characterize the DSS using the FTF. The remaining two dedicated flights were used to gather RHN data in regions of the aircraft flight envelope not covered during the nondedicated flights. The remaining 40 flights were dedicated to testing other experiments being flown on the aircraft. Data were collected during these 40 missions, but there were no test maneuvers specifically dedicated to the VHM experiment.

Two of the fifteen dedicated flights were used to gather RHN data in regions of the flight envelope that were not reached during nondedicated flight test, nor during FTF flights. Constant speed climbs and descents, and dynamic maneuvers were performed at eighteen flight conditions highlighted in figure 5. The aircraft was dynamically loaded to 6 g and subjected to high pitch- and roll-rate maneuvers during these flights. The aircraft reached altitudes of over 40,000 ft and speeds of Mach 1.6 during these test maneuvers.

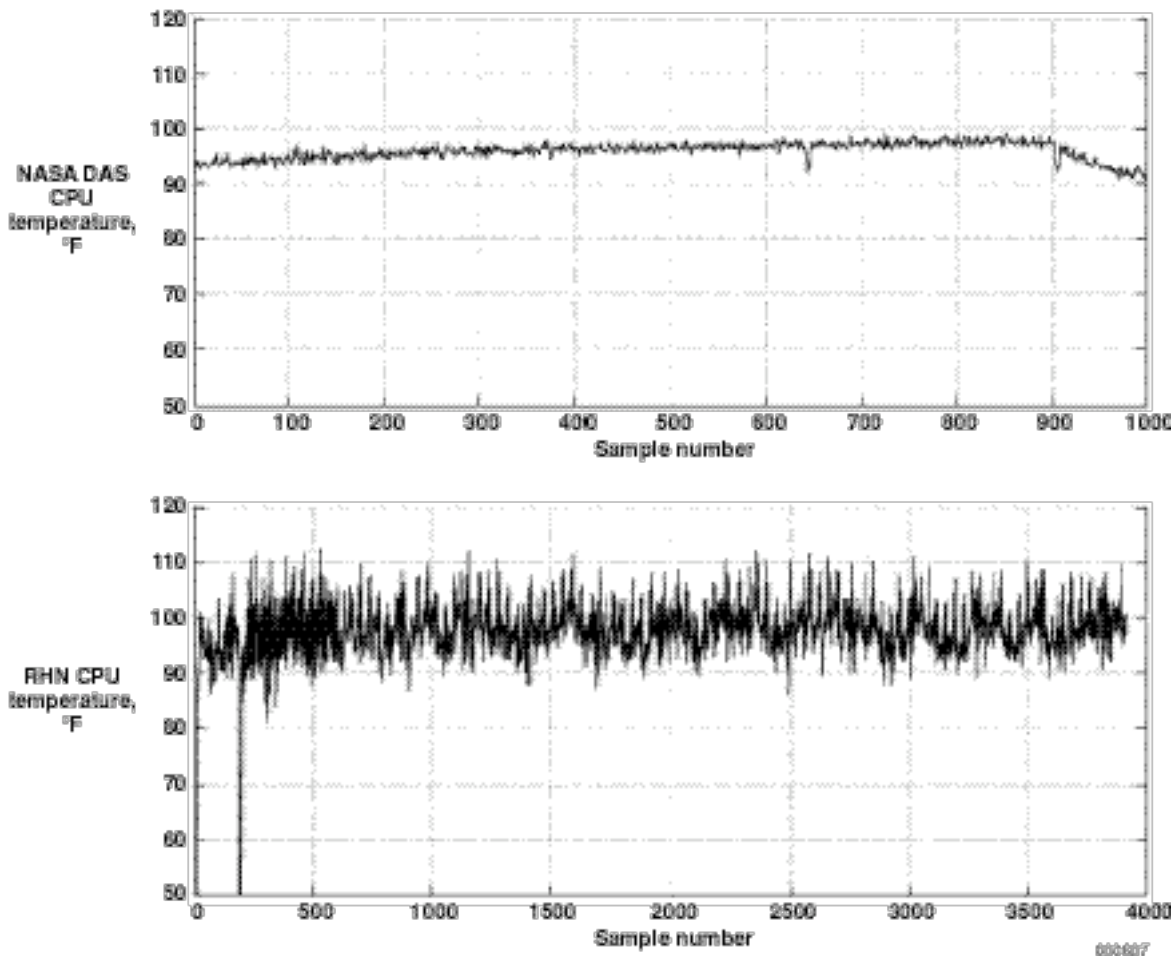
Figure 6. Flight data.

The RHNs performed without failure during the entire flight program. The data correlated well with the NASA DAS but exhibited higher levels of noise on the individual channels. Figure 6 shows elevated noise levels for colocated thermocouples recorded using the VHM System and the NASA DAS. RHN-B data were lost for the first 21 flights
