NASA/TP-2003-212643

Evaluation of Alternate Concepts for Synthetic Vision Flight Displays With Weather-Penetrating Sensor Image Inserts During Simulated Landing Approaches

October 2003

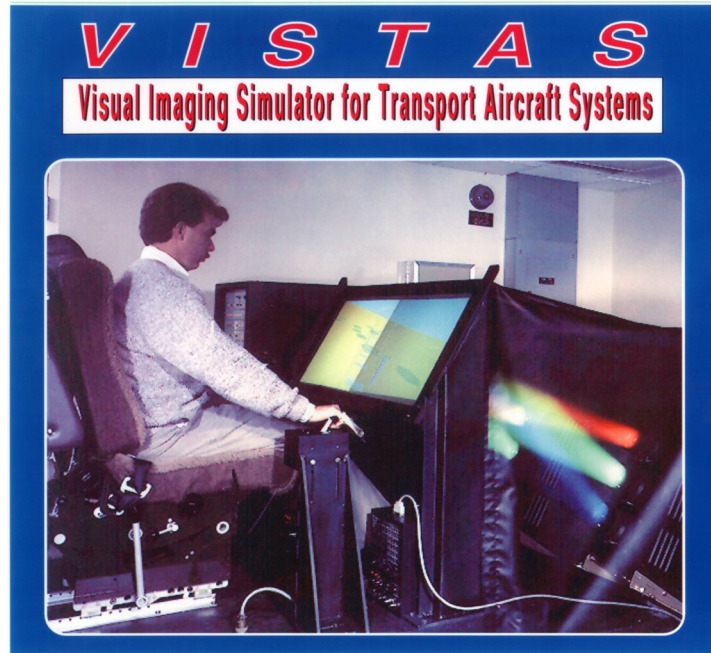
Figure 1. The Visual Imaging Simulator for Transport Aircraft Systems.

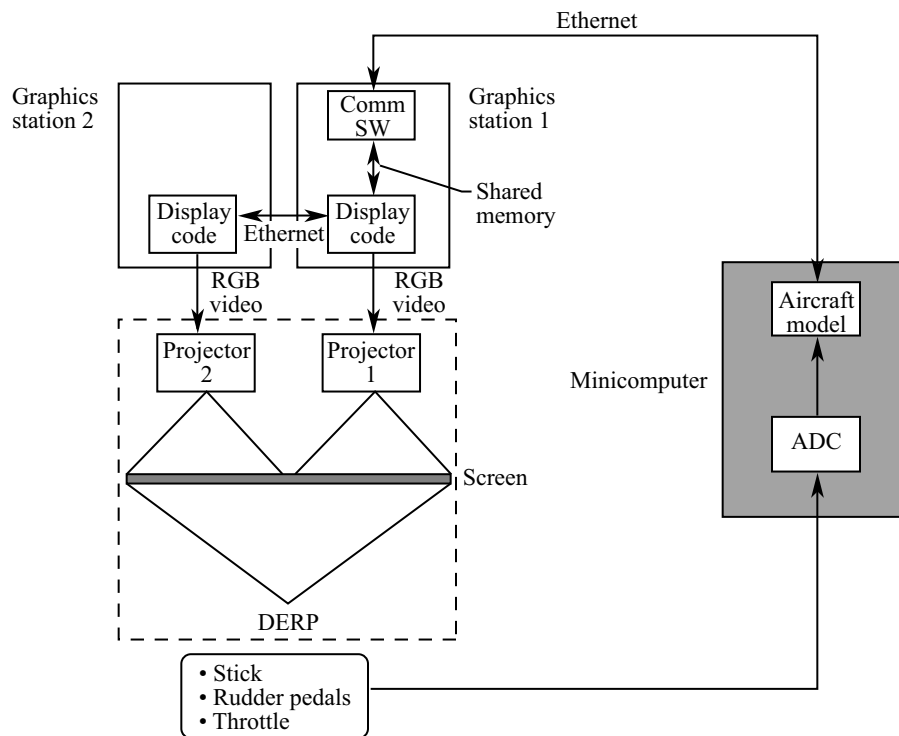
Figure 2. Arrangement of the VISTAS dual projection system.

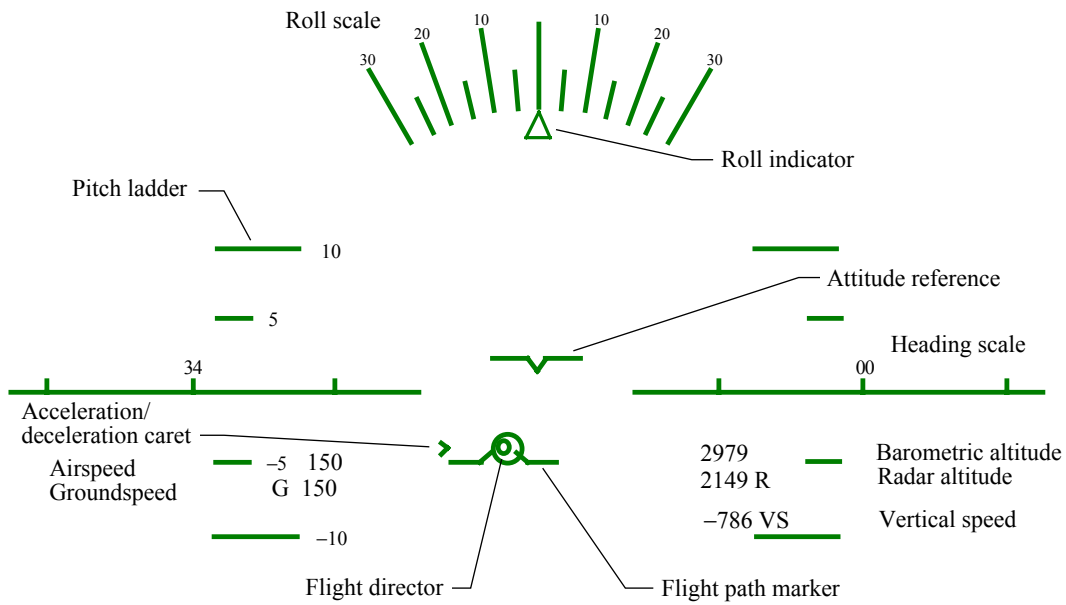
Figure 5. Symbology set.

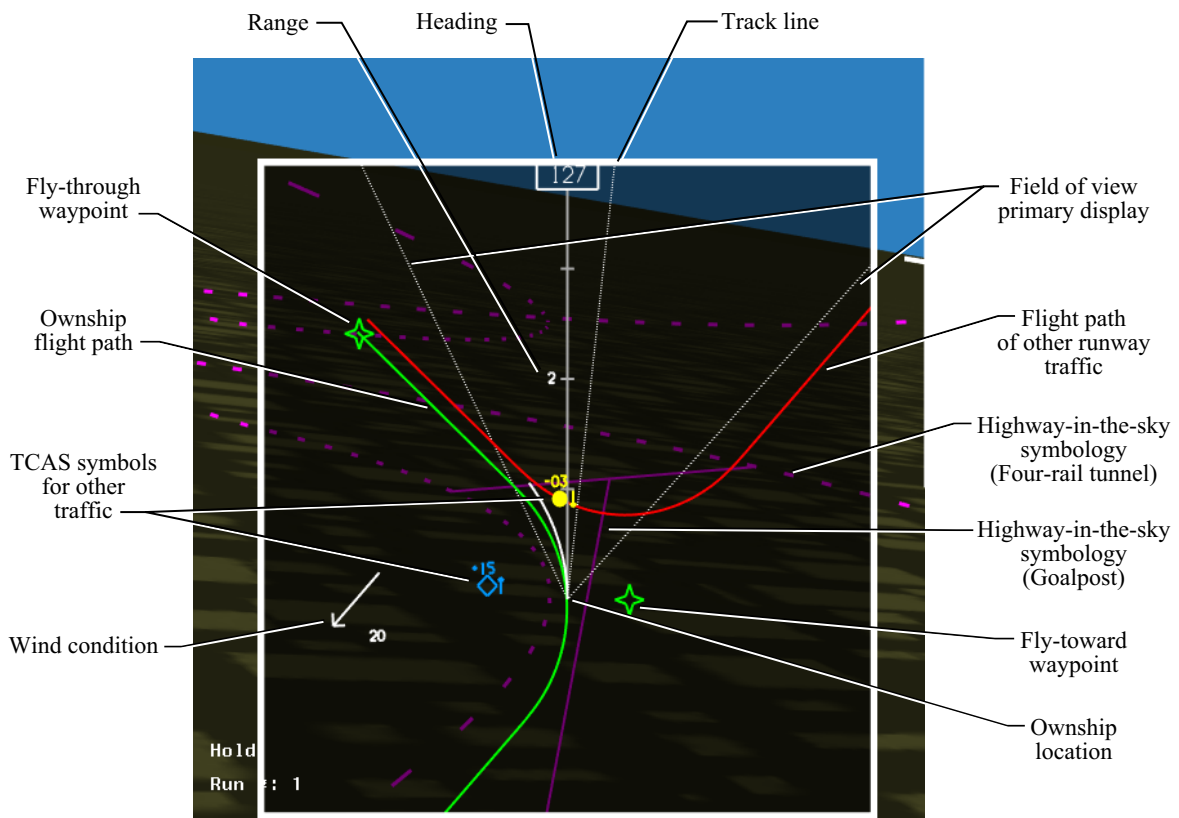
Figure 6. Navigation Display overlaid on outside scene.

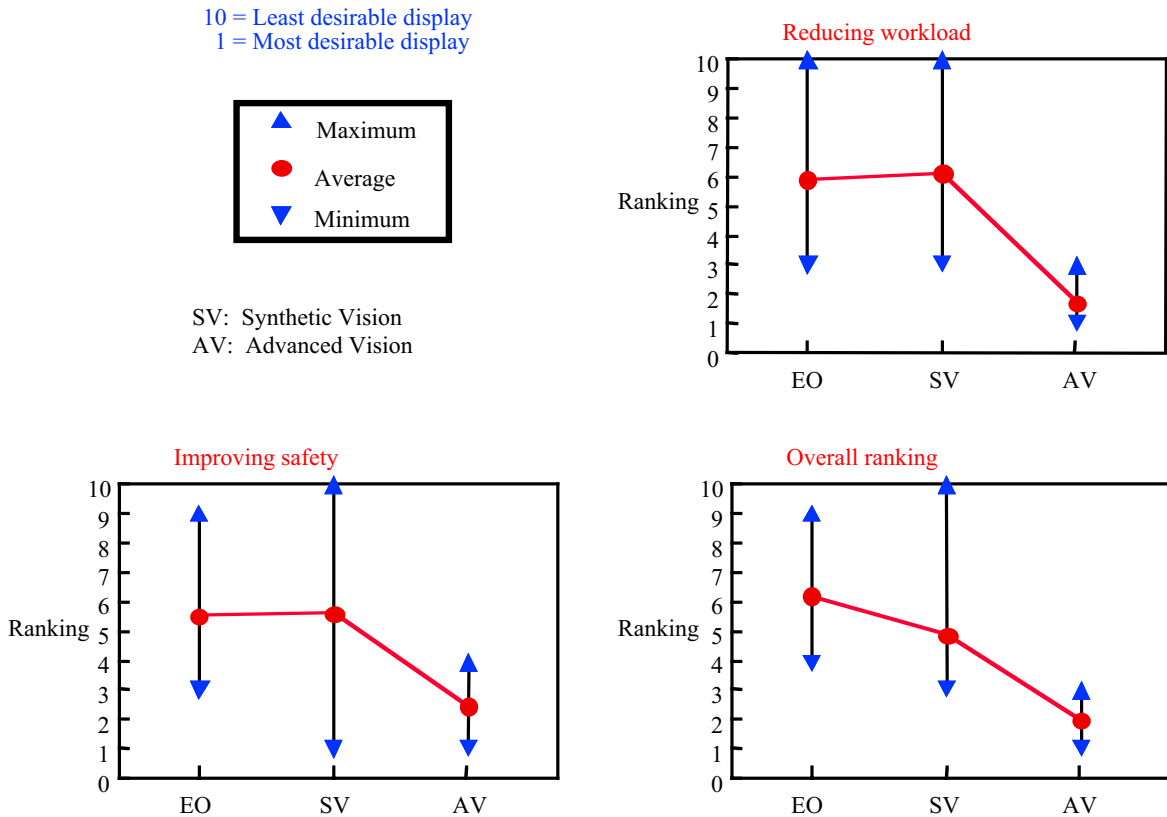
Figure 12. Summary of subjective rank ordering comparisons of display conditions.

With a total of 48 questionnaires composed of numerous questions each, only a summary of the subjective results is possible for the purposes of this paper. Such a summary would indicate that from the subjective results, an overwhelming preference for the AV display condition was expressed. As examples, figure 12 presents the results of comparative rank ordering of the display conditions by the pilots for several categories, on a scale from 1 to 10 (1 being the most desirable display and 10 being the least desirable display). The mean ranking is presented, along with the maximum and minimum rankings (not plus or minus the standard deviations). The

categories presented compare the display conditions over all scenarios of the experiment and include the effectiveness in reducing pilot workload, the potential for improving safety, and the overall ranking for the entire experiment. In each case, the AV display condition is clearly the preferred concept.
